STATE OF ILLINOIS DEPARTMENT OF TRANSPORTATION

Contract Number: 62957

SUGGESTED BEAM STRAIGHTENING METHODS

BEAM STRAIGHTENING DETAILS CHURCH STREET / I-94 COOK COUNTY SN 016-0825

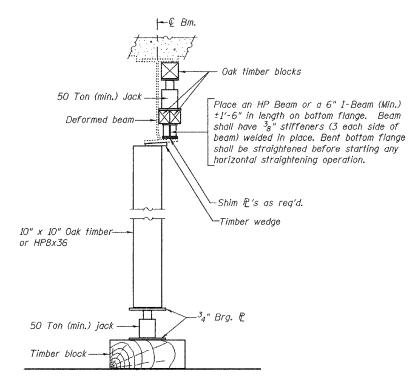
SUGGESTED VERTICAL STRAIGHTENING DETAIL

(To correct flange rotation.)

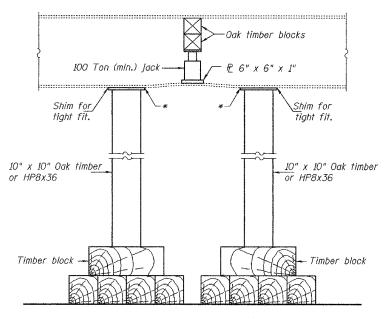
SUGGESTED VERTICAL STRAIGHTENING DETAIL

(To correct localized vertical flange deformations.)

* Edge of plate shall line up with edge of deformation.

Braces and jack assembly shall be placed on same side of web. Bent bottom flange shall be straightened before starting any horizontal straightening operations.
