# Asbestos Abatement Survey

**Parcel No.: 1P10139**

**603 Water Street**

**Joliet, Will County, Illinois 60436**

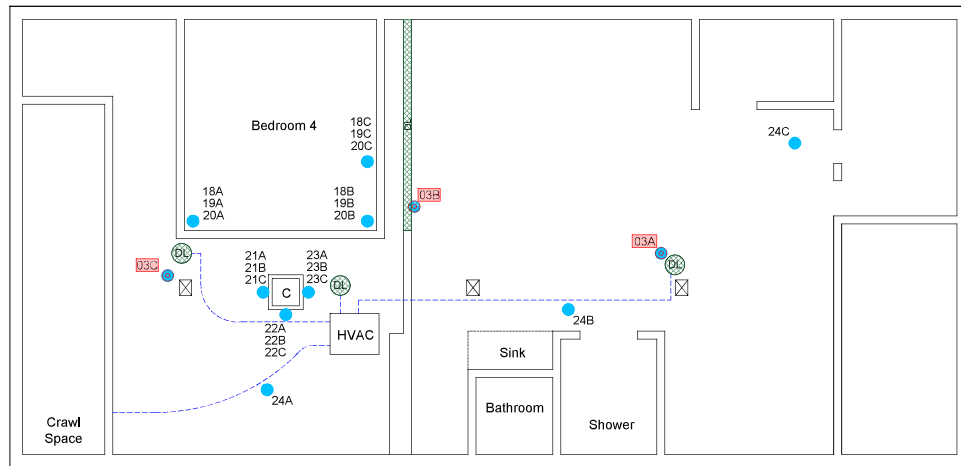
30227204-01 - IDOT / Asbestos Surveys WYO #33  
Job No. 25-01-016-20  
Route 1-80 Parcel TP10139  
603 Water Street  
Joliet, VIII County, Illinois  
ASBESTOS ABATEMENT SURVEY  
ASBESTOS CONTAINING MATERIAL LOCATIONS - BASEMENT  
FIGURE 5

- LEGEND**
- ASBESTOS SAMPLE
  - ⊙ POSITIVE SAMPLE
  - DUCTING
  - HA-03 Duct Wrap Insulation (30 SF Total)

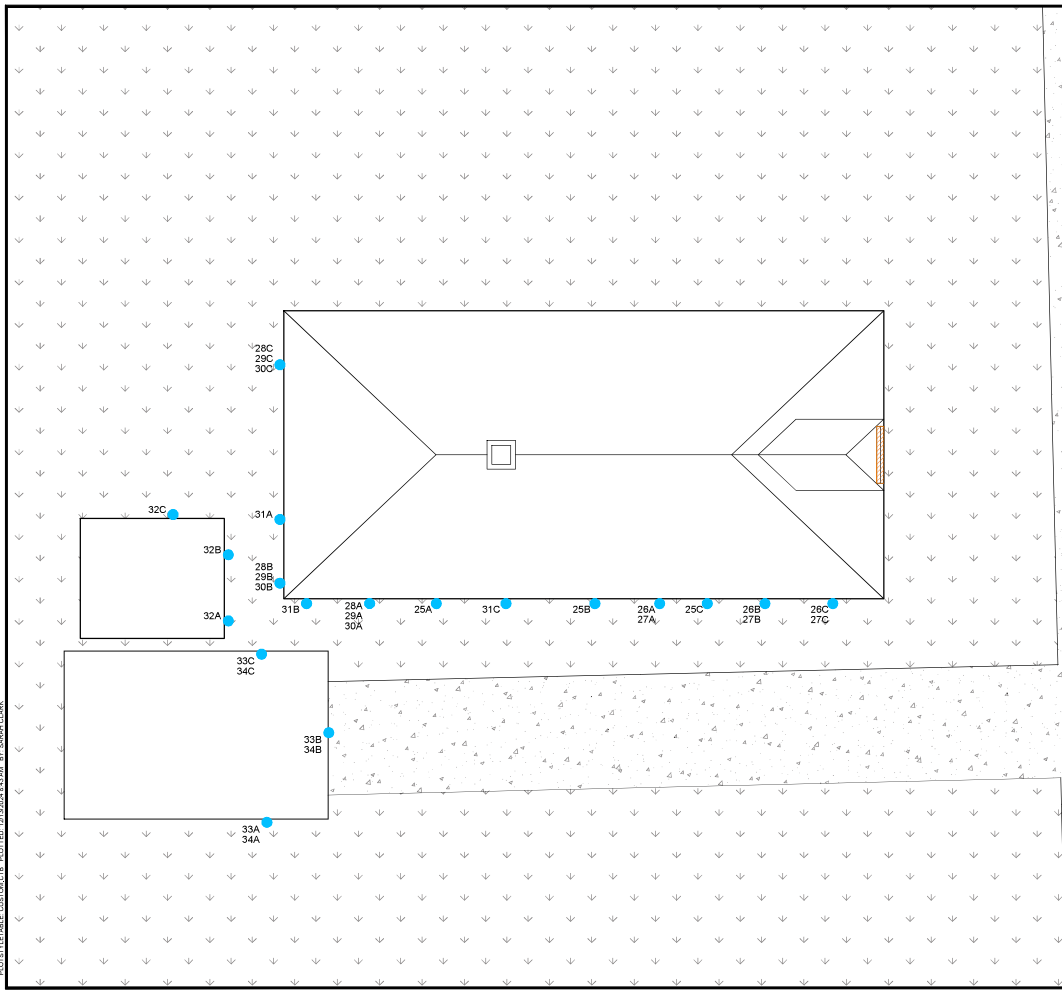
- ASBESTOS SAMPLE
- HA-35; White Rough Window Glazing  
(Apx. 60 LF Total)

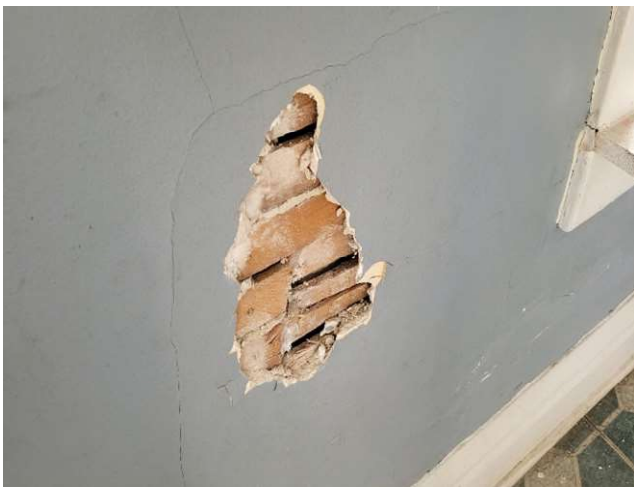
**HA-1: Gray Plaster Skimcoat  
HA-2: Gray Plaster Basecoat**

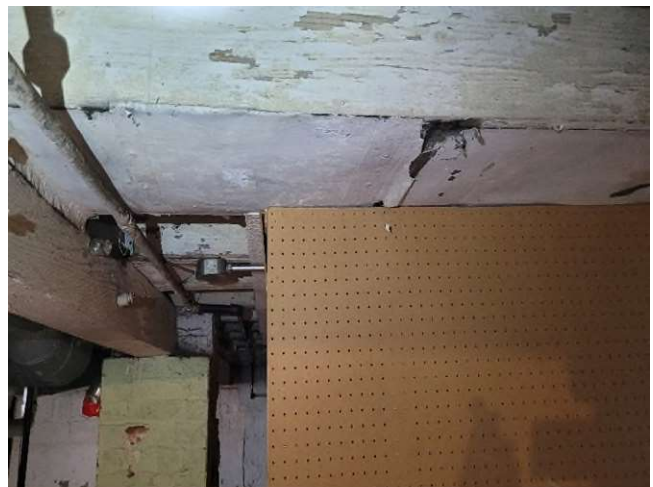
- HA-3: Gray Duct Wrap Insulation
- HA-13: Brown 9" x 9" Floor Tile (Under HA-12)
- HA-17: Yellow Mastic associated with HA-13
- HA-35: White Window Glazing

**HA-3: Gray Duct Wrap Insulation**

ACMs identified at the site that may be disturbed during demolition activities, must be removed by a licensed asbestos abatement contractor utilizing industry standard work procedures in accordance with all federal, state, and local regulations governing asbestos.

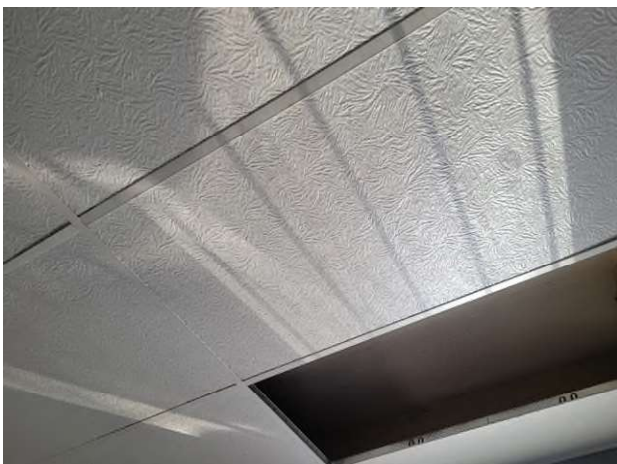
**HA-4: White 2' x 4' Acoustical Ceiling Tiles (Smooth Wavy Texture)**

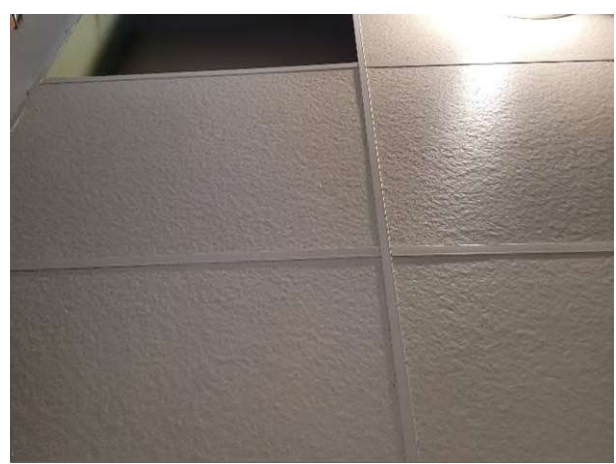
**HA-5: White 2' x 4' Acoustical Ceiling Tiles (Pin Holes)**

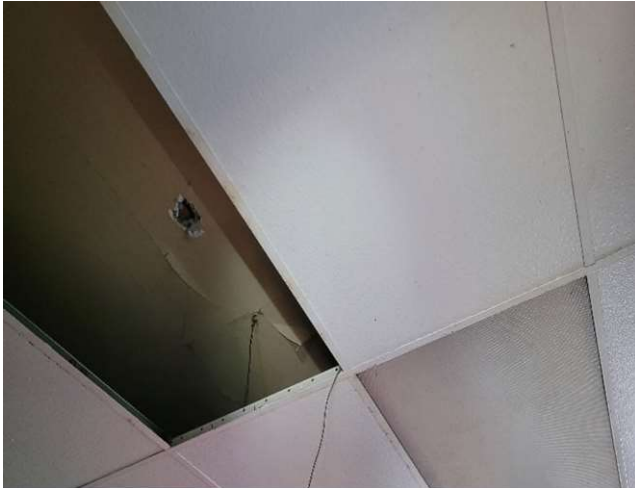
**HA-6: White 2' x 4' Acoustical Ceiling Tiles (Smooth Texture)**

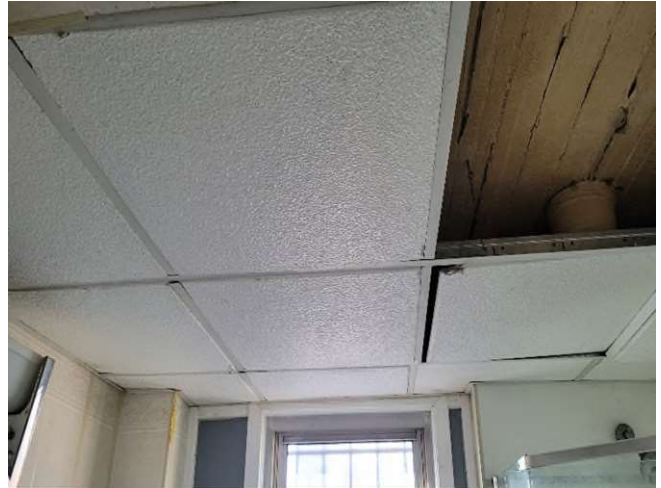
**HA-7: 2' x 2' Acoustical Ceiling Tiles (Pin Holes)**

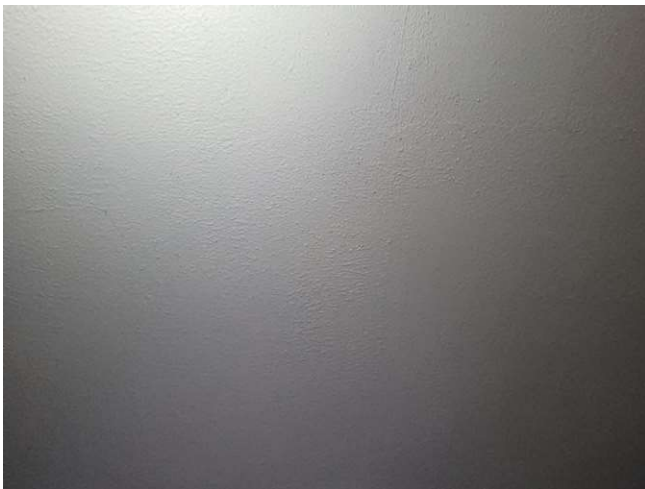
**HA-8: White Textured Ceiling Paint**

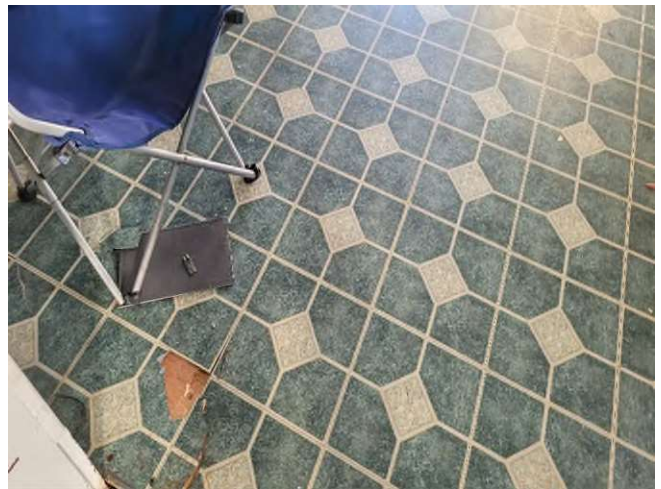
**HA-9: Self-Adhesive 12' x 12' Blue with White Diamonds Floor Tile**

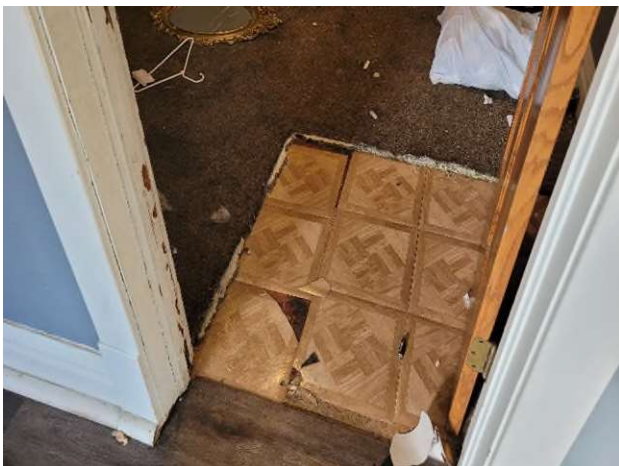
**HA-10: Self-Adhesive 12' x 12' Brown Wood Pattern Floor Tile**

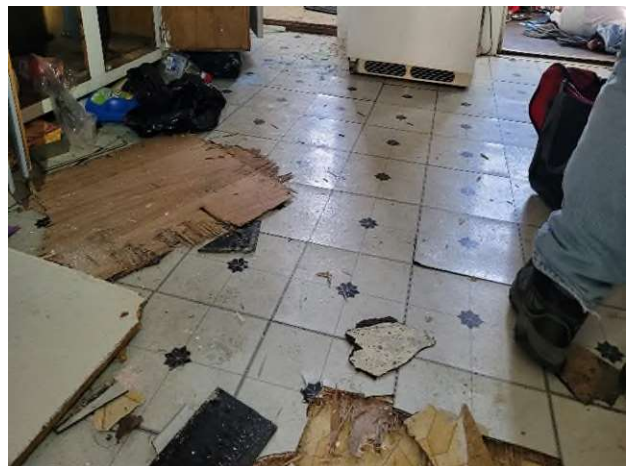
**HA-11: Self-Adhesive 12' x 12' White with Black Stars Floor Tile**

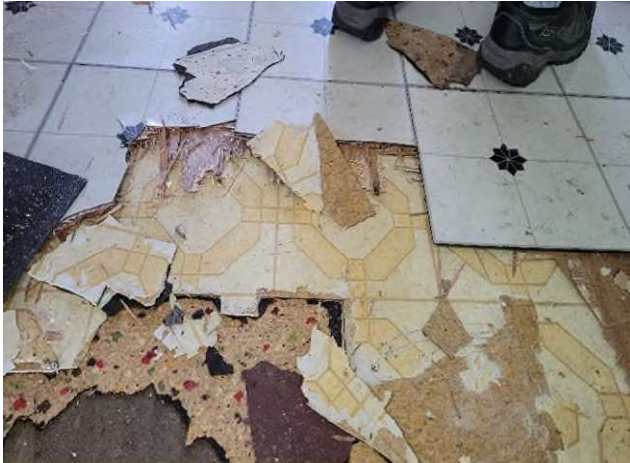
**HA-12: Yellow Linoleum Flooring with Octagonal Pattern and Beige Paper Backing**

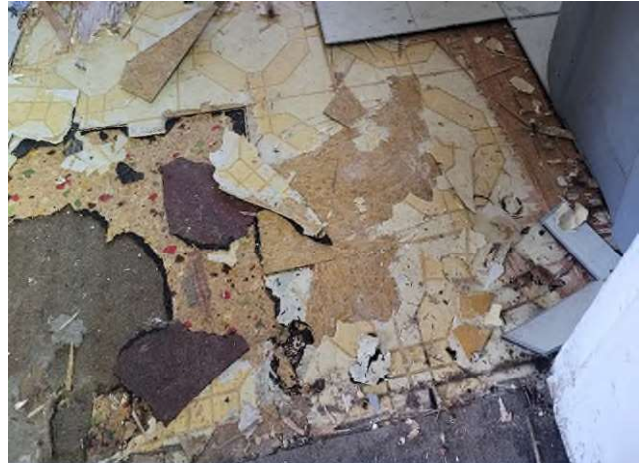
**HA-13: 9" x 9" Brown Mottled Floor Tile**  
**HA-17: Yellow Mastic associated with HA-13**

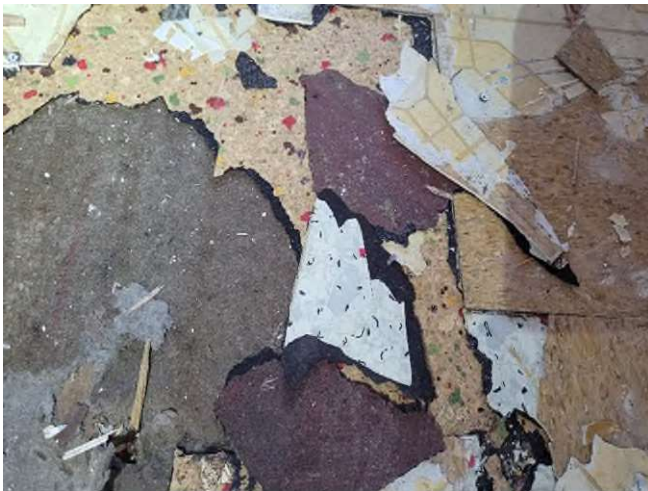
**HA-14: White Linoleum with Black, Gray and Red Specks and Black Paper Backing**

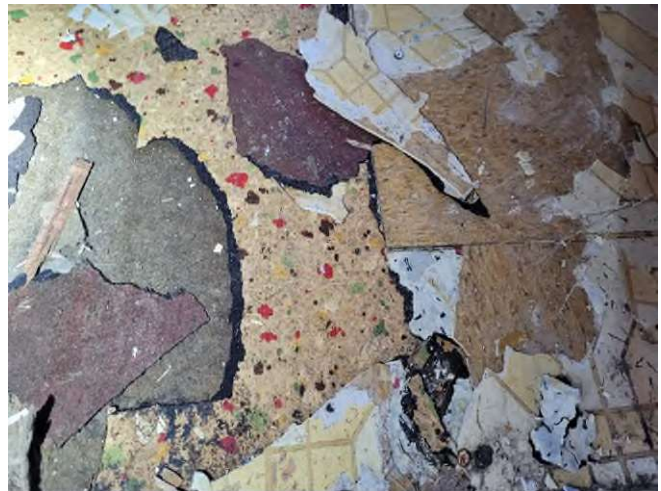
**HA-15: Brown Linoleum with Red and Black Specks and Brown Paper Backing**

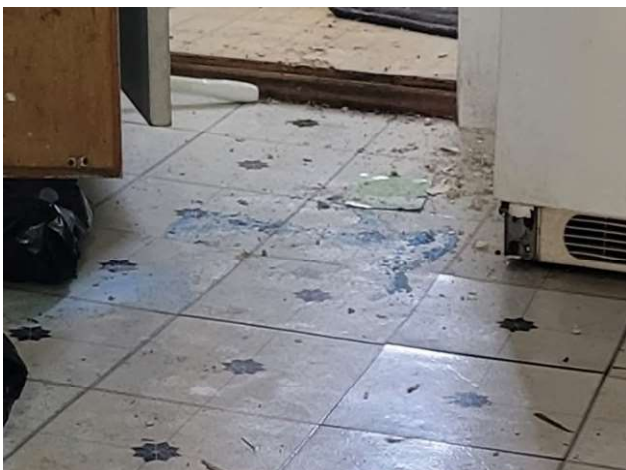
**HA-16: Beige Linoleum with Brick Pattern and Tan Paper Backing**

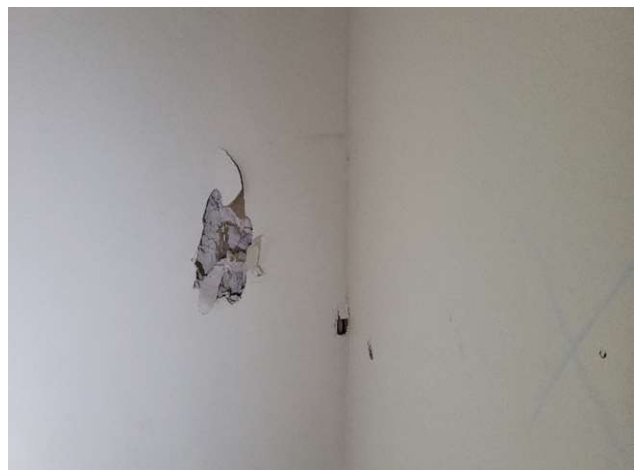
**HA-18: White Gypsum Board**  
**HA-19: White Drywall Tape associated with HA-18**  
**HA-20: White Joint Compound associated with HA-18**

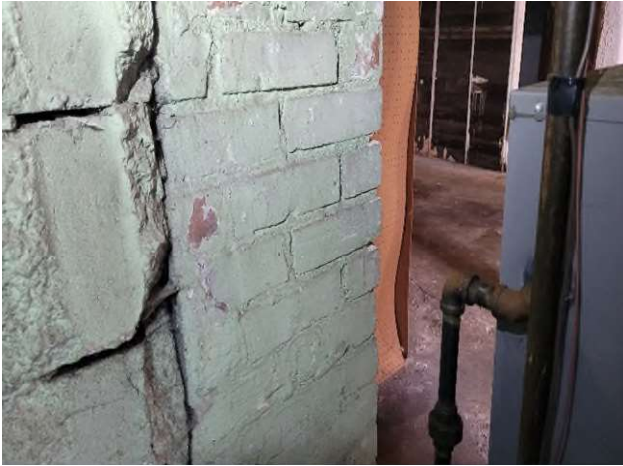
**HA-21: Gray Chimney Brick Mortar**

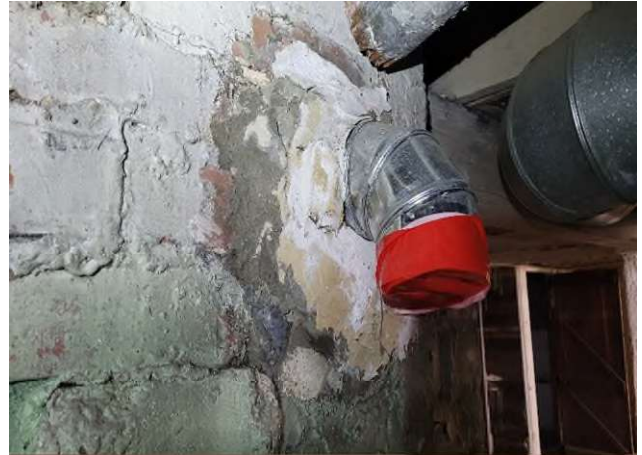
**HA-22: White Chimney Flue Mortar (Patch)**  
**HA-23: Dark Gray Chimney Flue Mortar**

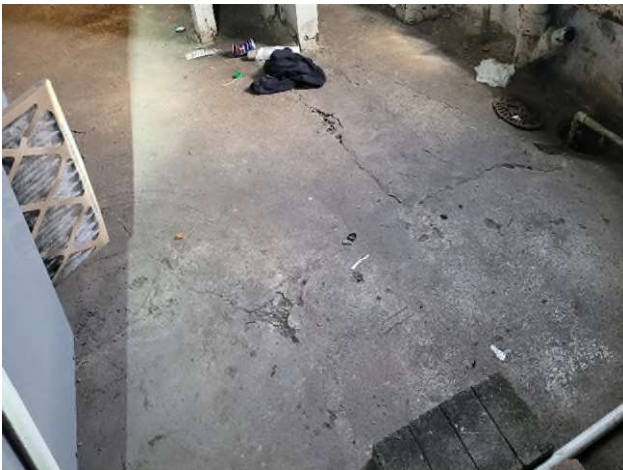
**HA-24: Gray Concrete Foundation**

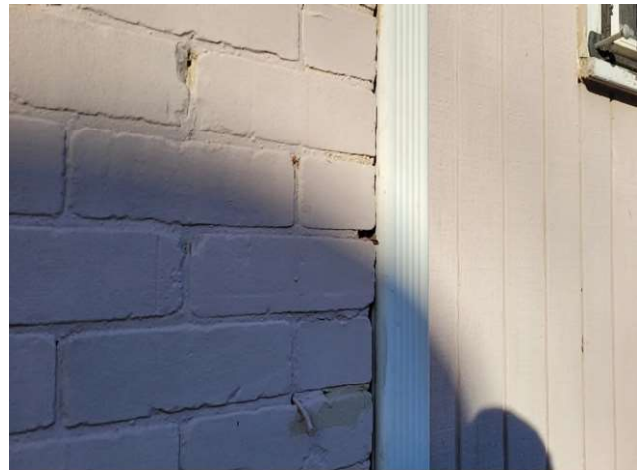
**HA-25: Gray Exterior Brick Mortar**

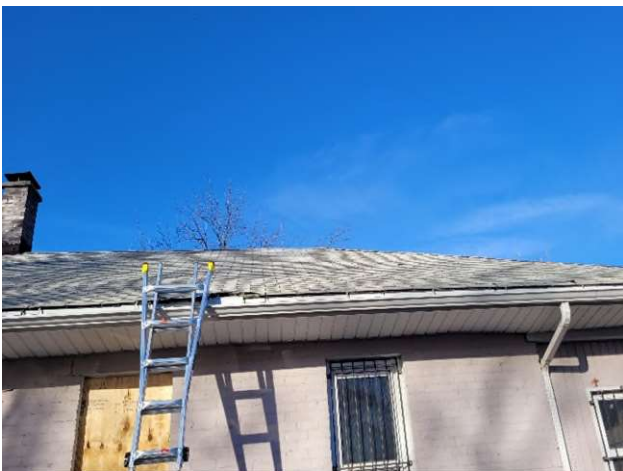
**HA-26: White/Black Roofing Shingles**  
**HA-27: Black Roofing Paper**

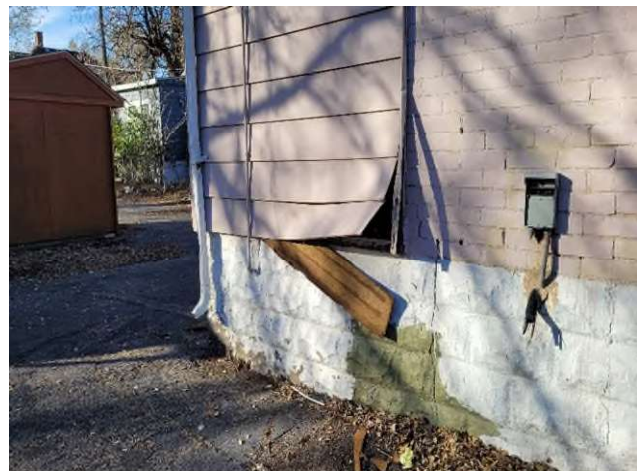
**HA-28: Brown Wood Fiber Board behind Aluminum Siding**

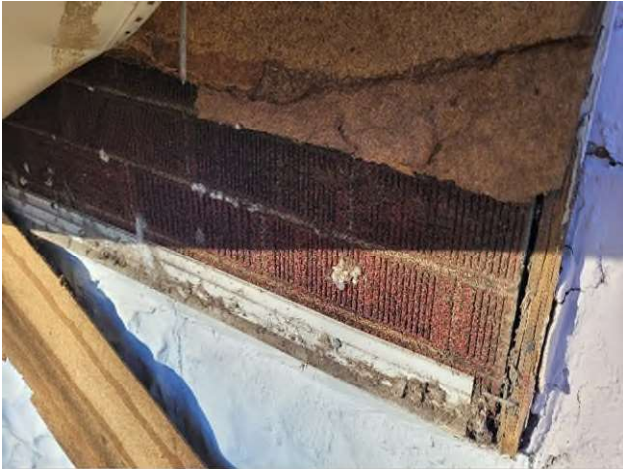
**HA-29: Red/Black Asphalt Siding with Fiber Board Backing**

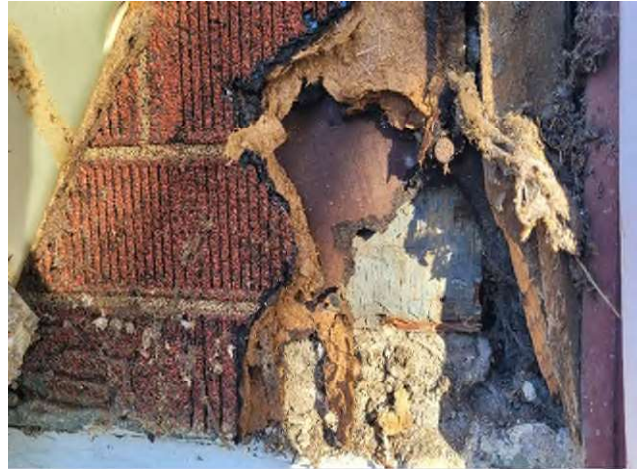
**HA-30: Light Brown Paper with Dark Brown Backing**

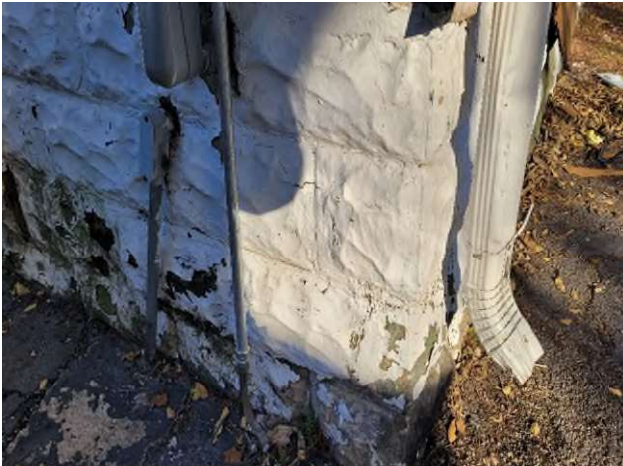
**HA-31: Exterior Foundation CMU Mortar**

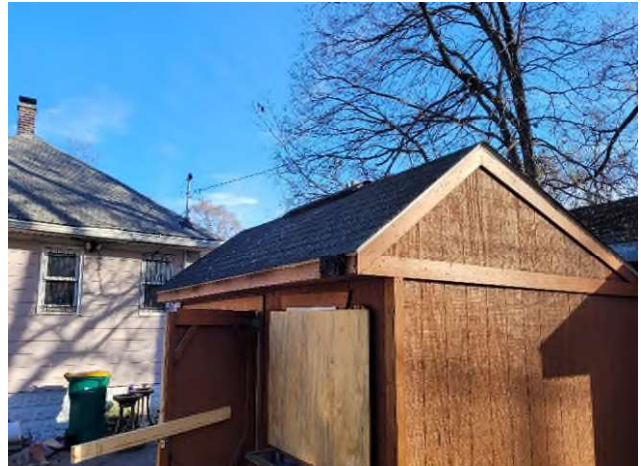
**HA-32: Black and Green Roofing Shingles (Shed)**

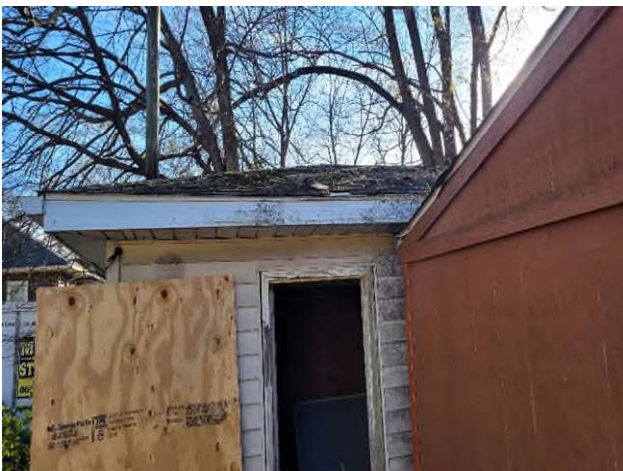
**HA-33: Black Roofing Shingle (Garage)**  
**HA-34: Black Roofing Paper (Garage)**

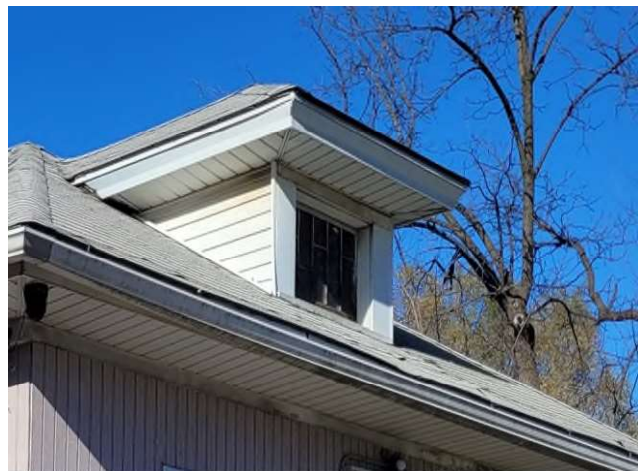
**HA-35: White Window Glazing**
