## DRAINAGE STRUCTURE IMPROVEMENT DETAIL LOCATION #3 STA. 825 + 00

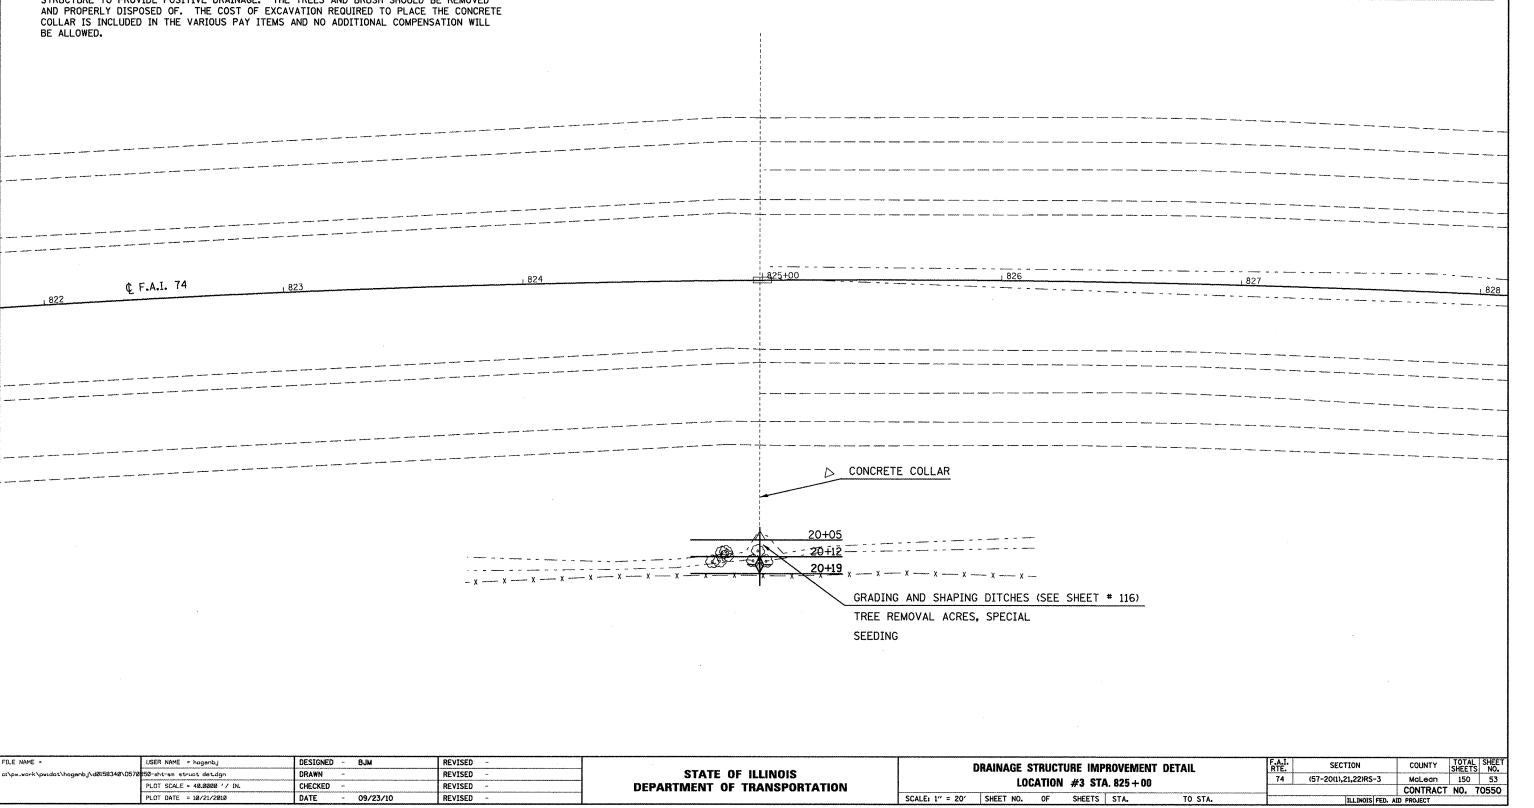
THE EXISTING STRUCTURE AT STATION 825+00 CONSISTS OF A 24" R.C.C.P. WITH A MEDIAN INLET. THE STRUCTURE IS IN FAIR CONDITION WITH THE FOLLOWING DEFICIENCIES. WHILE THE JOINT BETWEEN THE DOWNSTREAM END SECTION AND THE FIRST SECTION OF PIPE IS INTACT, THE NEXT JOINT UPSTREAM IS SEPARATED AND IS CAUSING A SINKHOLE IN THE FORESLOPE. ALSO, THE DOWNSTREAM END SECTION IS SILTED-IN APPROXIMATELY 18". THE DOWNSTREAM OUTFALL IS RESTRICTED BY SILTATION, TREES AND BRIGH

THE PROPOSED SCOPE OF WORK IS TO EXCAVATE TO AND SEAL THE SEPARATED JOINT WITH A CONCRETE COLLAR. THE SILTATION SHALL BE CLEANED OUT OF THE DOWNSTREAM END OF THE STRUCTURE. THE DOWNSTREAM CHANNEL SHALL BE CLEANED AND GRADED AWAY FROM THE STRUCTURE TO PROVIDE POSITIVE DRAINAGE. THE TREES AND BRUSH SHOULD BE REMOVED AND PROPERLY DISPOSED OF. THE COST OF EXCAVATION REQUIRED TO PLACE THE CONCRETE COLLAR IS INCLUDED IN THE VARIOUS PAY ITEMS AND NO ADDITIONAL COMPENSATION WILL
