STATE OF ILLINOIS  
DEPARTMENT OF TRANSPORTATION

FLANGE REPAIR DETAILS  
SN 016-1068

| 94 | 2014-0741 | COOK | 13 |

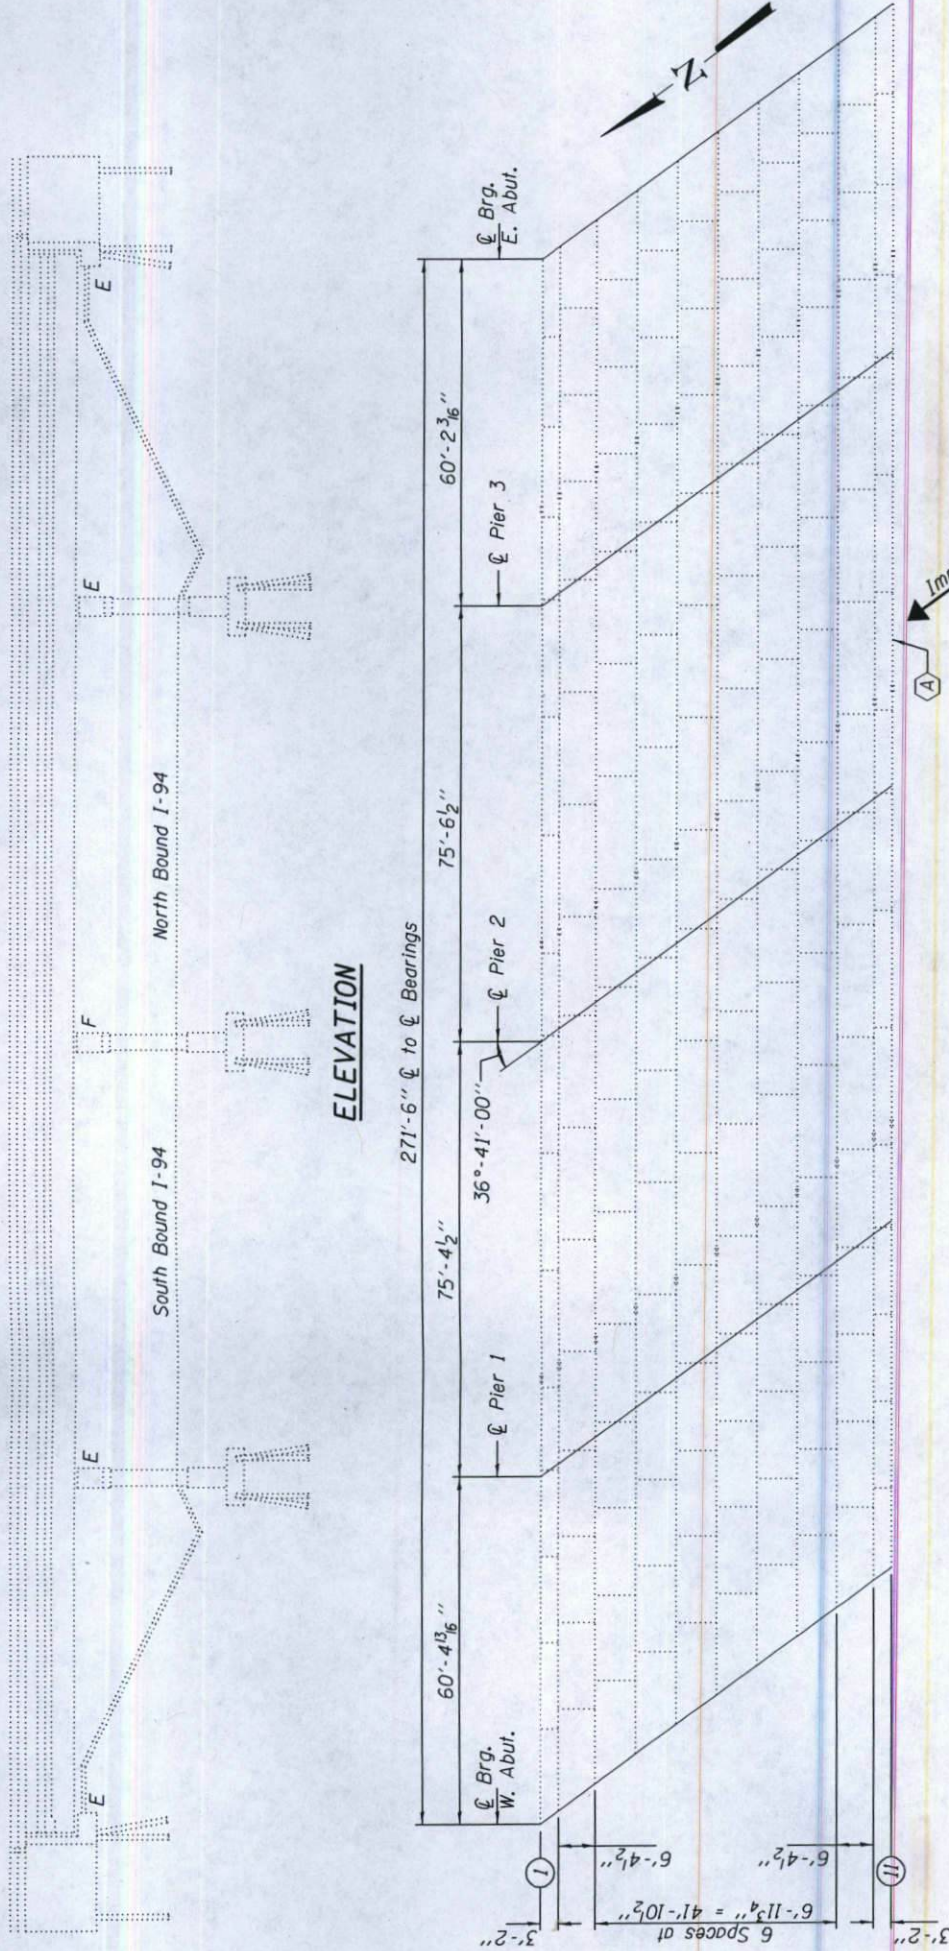
FRAMING PLAN

(A) - Existing Beam to be Straightened & Strengthened.
