**STRUCTURAL REPAIR OF CONCRETE**  
**SPAN 9**

**STRUCTURE REPAIR DETAILS**  
**SPAN 9**  
**VACHEL LINDSAY BRIDGE REHABILITATION**  
**LONG BAY DRIVE OVER LAKE SPRINGFIELD**  
**SPRINGFIELD, ILLINOIS**

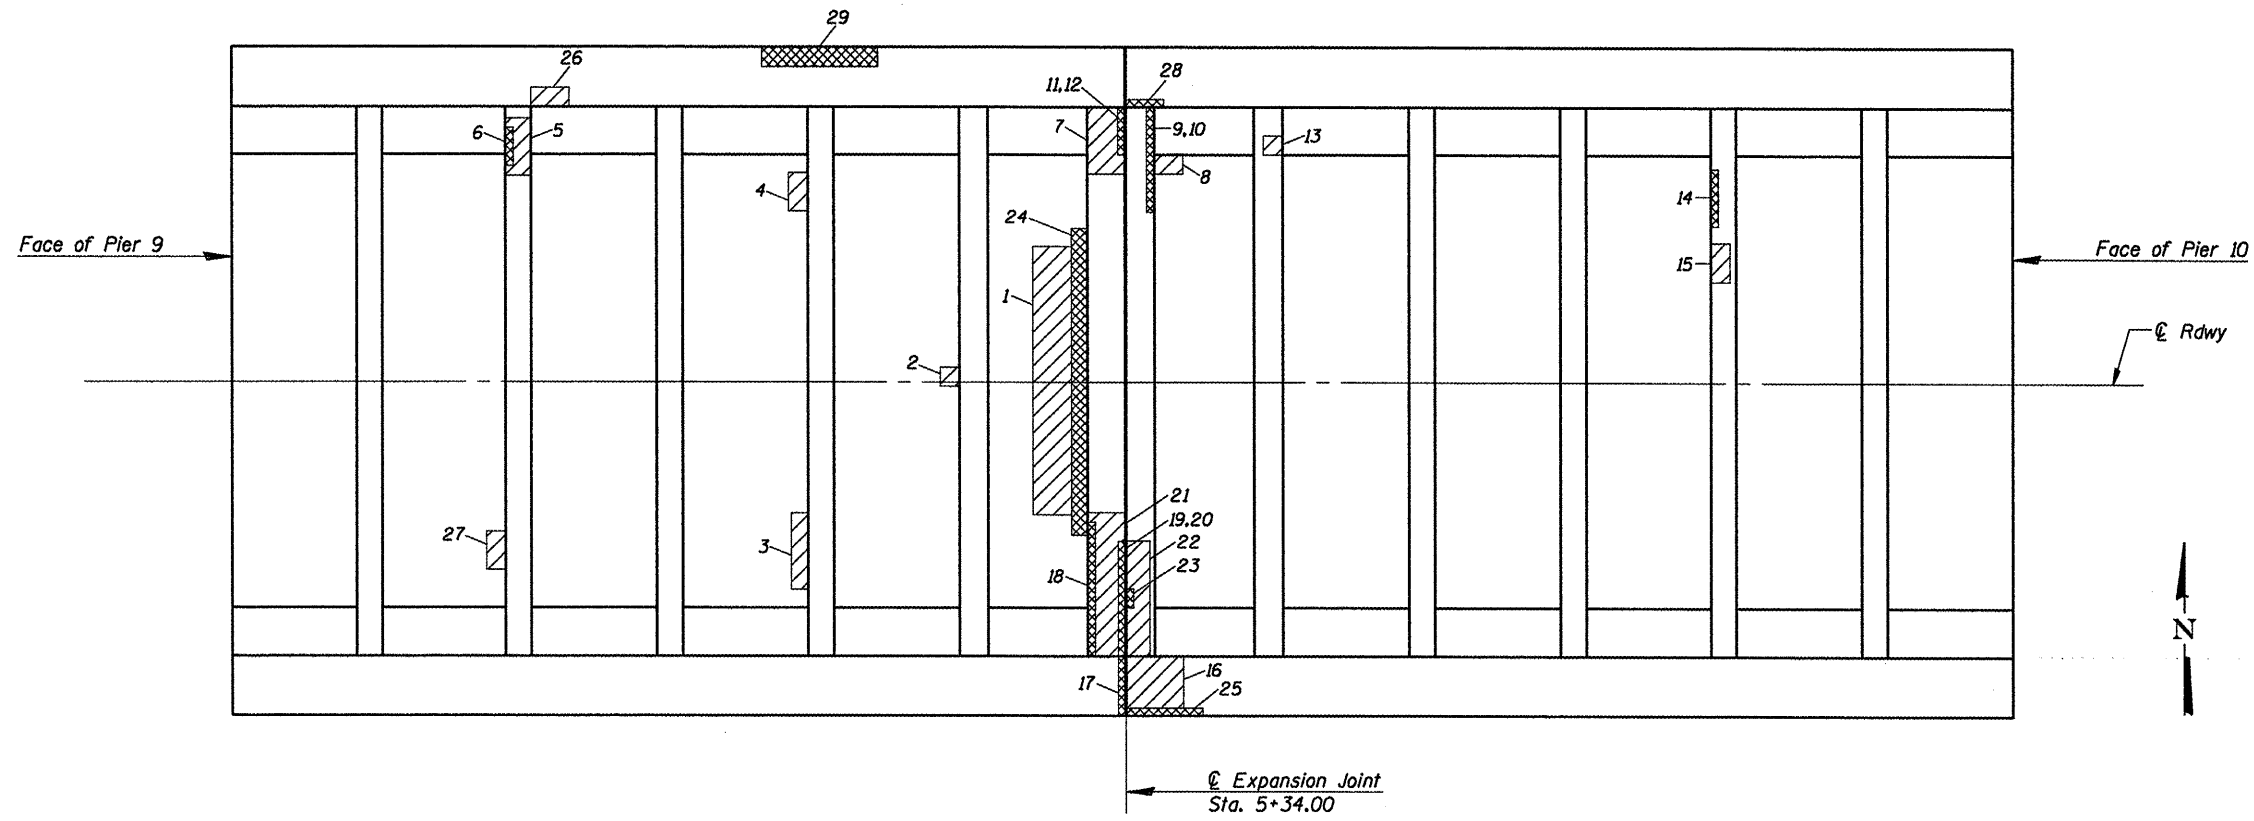
**STRUCTURE REPAIR PLAN AT FLOOR BEAMS**  
(Span 9)

Patch No.	Vert. or Horiz.	Dimensions	Area (SQ. FT.)
1	H	14.00'x2.00'	28.00
2	H	1.00'x1.00'	1.00
3	H	4.00'x0.83'	3.32
4	H	2.00'x1.00'	2.00
5	H	3.00'x1.33'	4.00
6	V	2.00'x0.67'	1.34
7	H	3.50'x2.00'	7.00
8	H	1.50'x1.00'	1.50
9	V	5.50'x1.25'	6.88
10	V	1.50'x2.50'	3.75
11	V	2.00'x0.83'	1.66
12	V	2.50'x0.83'	2.08
13	H	1.00'x1.00'	1.00
14	V	3.00'x1.00'	3.00
15	H	2.00'x1.00'	2.00
16	H	3.00'x4.33'	13.00
17	V	1.00'x4.33'	4.33
18	V	7.00'x1.00'	7.00
19	V	2.50'x1.00'	2.50
20	V	6.00'x1.25'	7.50
21	H	7.50'x2.00'	15.00
22	H	6.00'x1.25'	7.50
23	V	1.00'x1.00'	1.00
24	H	16.00'x0.83'	13.28
25	V	2.00'x4.00'	8.00
26	H	2.00'x1.00'	2.00
27	H	2.00'x1.00'	2.00
28	V	2.00'x2.00'	4.00
29	V	6.00'x1.00'	6.00
Subtotal of Vertical Repair Areas			69.04
Subtotal of Horizontal Repair Areas			102.60
Subtotal			161.64
