SUBSTRUCTURE REPAIR DETAIL SN 098-0052 SOUTH ABUTMENT (LOOKING SOUTH)

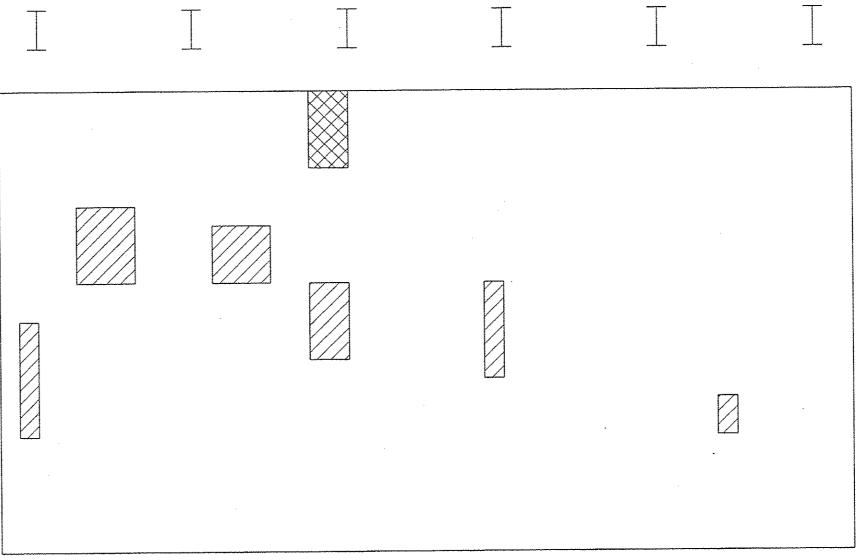
SN 098-0052 SOUTH ABUTMENT (LOOKING SOUTH)

ITEM	QUANTITY	
(*) STRUCTURAL REPAIR OF CONCRETE =< 5"	41.5 (SQ FT)	
(*) STRUCTURAL REPAIR OF CONCRETE > 5"	8.0 (SQ FT)	
TEMPORARY SHORING AND CRIBBING	1 (EACH)

(*) THIS IS AN ESTIMATED QUANTITY. THE ACTUAL LOCATION OF DELAMINATED AREAS AND QUANTITIES WILL BE DETERMINED BY THE RESIDENT ENGINEER IN THE FIELD.
