PIER 1 BILL OF MATERIAL

Inspection Date: 12/10/07

PIER 1 IL 34 OVER MIDDLE FORK SALINE RIVER FAP ROUTE 869 - SECTION 105BR-2 SALINE COUNTY STATION 1561+70.00 STRUCTURE NO. 083-0038

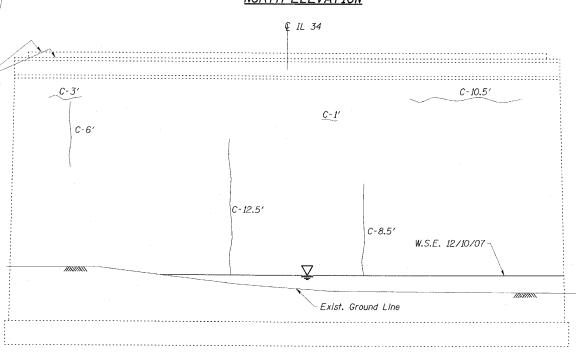
Crack to be epoxy injected

Delaminated or spalled area use Structural Repair of Concrete

C-9' W.S.E. 12/10/07-Exist. Ground Line NORTH ELEVATION

END VIEW

SOUTH ELEVATION

EXISTING BEARING SEAT TO BE INSPECTED BY THE ENGINEER AFTER DECK BEAM REMOVAL. DETERIORATED CONCRETE AREAS SHALL BE REPAIRED (ESTIMATED IS S.F. STRUCTURAL REPAIR OF CONCRETE DEPTH \(\lequid 5"\)) AND CRACKS SHALL BE SEALED (ESTIMATED 20' PEOXY CRACK INJECTION) IF FOUND. CONCRETE SEALER SHALL BE APPLIED TO CONCRETE REPAIR AREAS.

NOTE: PIER CRACK REPAIR LENGTHS AND STRUCTURAL
REPAIR OF CONCRETE AREAS ARE ESTIMATED FROM
12-10-07 SURVEY WORK, ACTUAL LOCATIONS AND
QUANTITIES OF REPAIRS SHALL BE SHOWN BY THE
ENGINEER ON THE AS-BUILT PLANS FOR THIS SECTION.
