STATE OF ILLINOIS DEPARTMENT OF TRANSPORTATION

SOUTH ABUTMENT
IL 34/145 OVER BRIER CREEK
FAP ROUTE 132 - SECTION 1BR-1
SALINE COUNTY
STATION 102+28.00
STRUCTURE NO. 083-0018

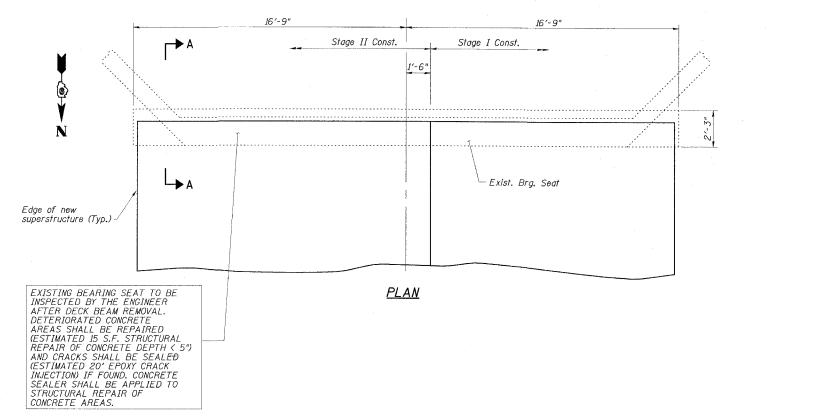
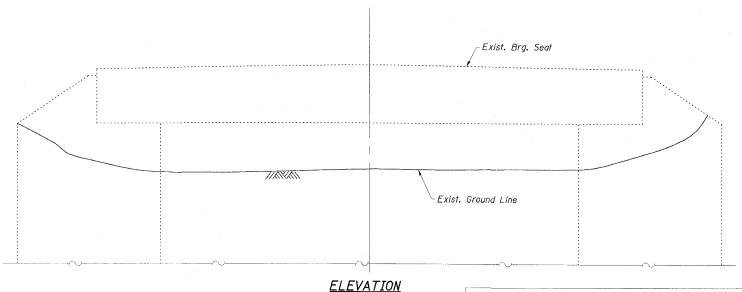
<u>SOUTH ABUTMENT</u> BILL OF MATERIAL

C.-6' Crack to be epoxy injected

Delaminated or Spalled Area -Use Structural Repair of Concrete

NOTE: ABUTMENT CRACK REPAIR LENGTHS AND STRUCTURAL
REPAIR OF CONCRETE REPAIR AREAS ARE ESTIMATED
FROM 02-01-07 SURVEY WORK. ACTUAL LOCATIONS AND
QUANTITIES OF REPAIRS SHALL BE SHOWN BY THE
ENGINEER ON THE AS-BUILT PLANS FOR THIS SECTION.
