STATE OF ILLINOIS
 DEPARTMENT OF TRANSPORTATION

STRUCTURAL REPAIR OF CONCRETE DETAILS
 SN 081-0124

SHEET NO. 4 OF 6 SHEETS

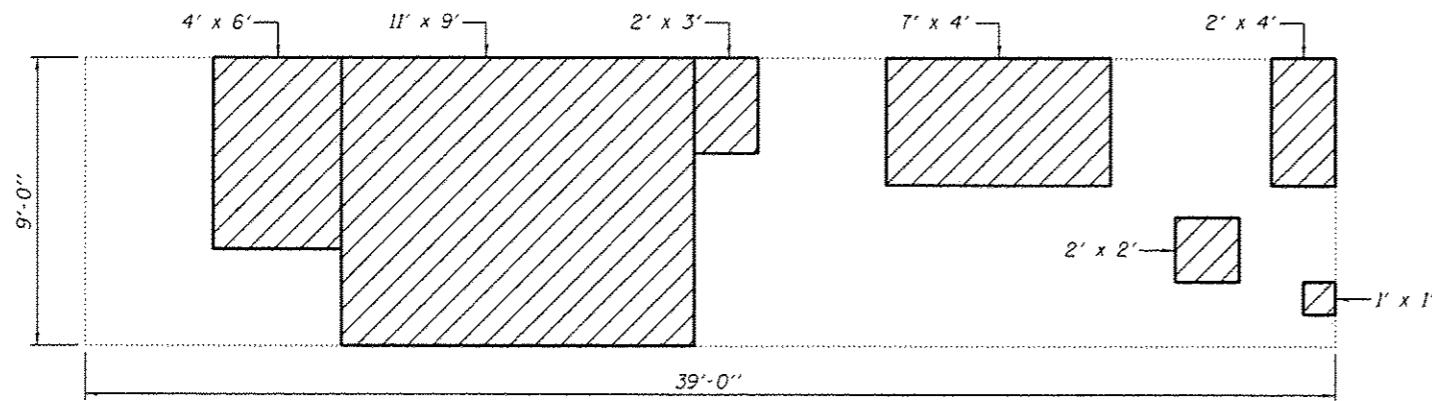
NORTH ABUTMENT

- Hatched areas indicate delaminated areas.
