June 9 Inspection Notes:

<b>ILLINOIS DEPARTMENT OF TRANSPORTATION</b>		
I-64 OVER WABASH RIVER STRUCTURE NUMBER: 097-0003 <b>EASTBOUND PIER 6</b>		
Drawn By: PRH/DR	<b>COLLINS ENGINEERS</b> <small>123 North Wacker Drive Suite 300 Chicago, IL 60606 (312) 764-9300 www.collinsengr.com ILLINOIS PROFESSIONAL DESIGN FIRM LICENSE NO. 184-000993</small>	Date: JULY, 2005
Checked By: JEO		Scale: 1"=20'
Code: 419503-04		Figure No.: 20

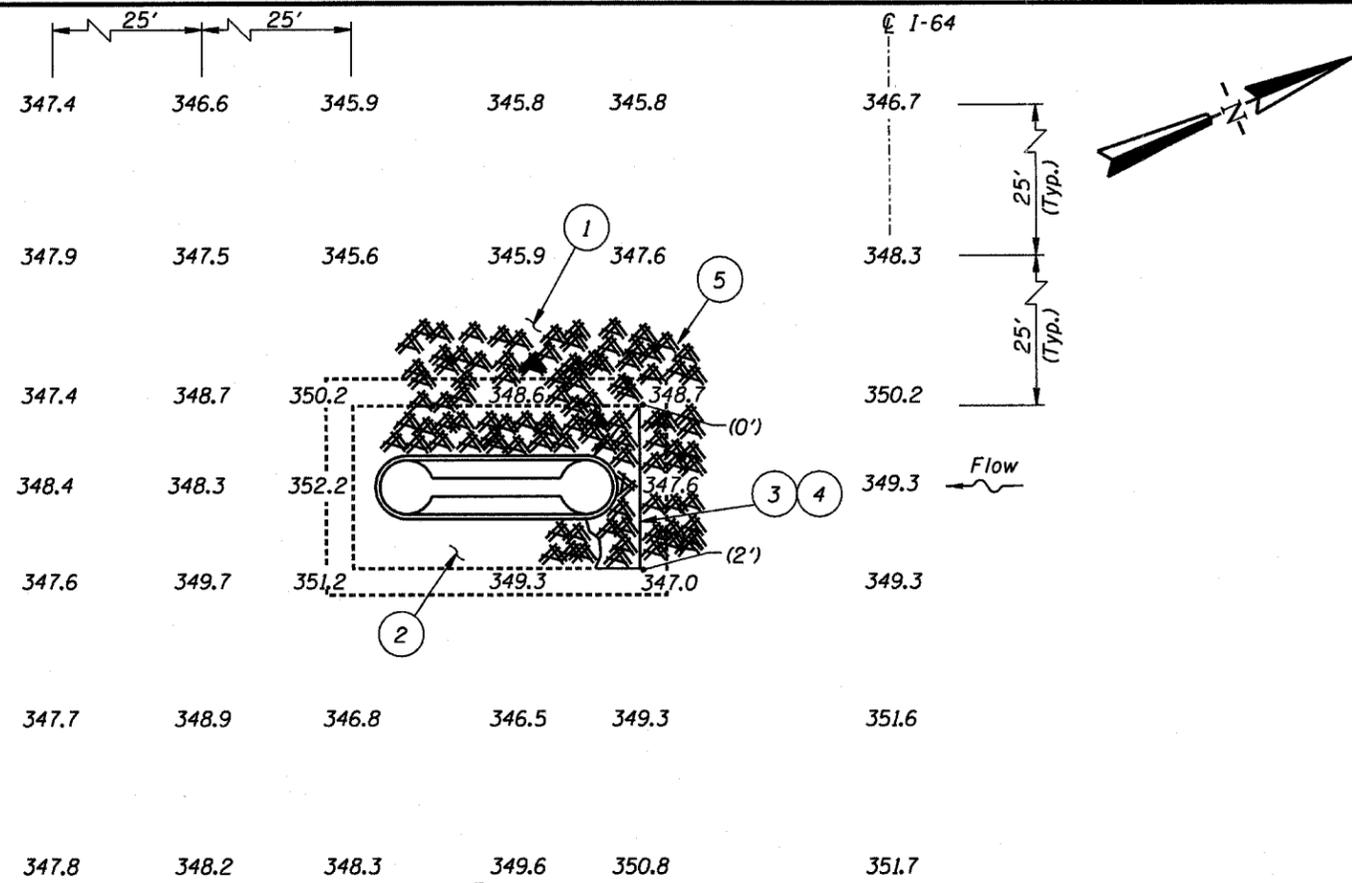
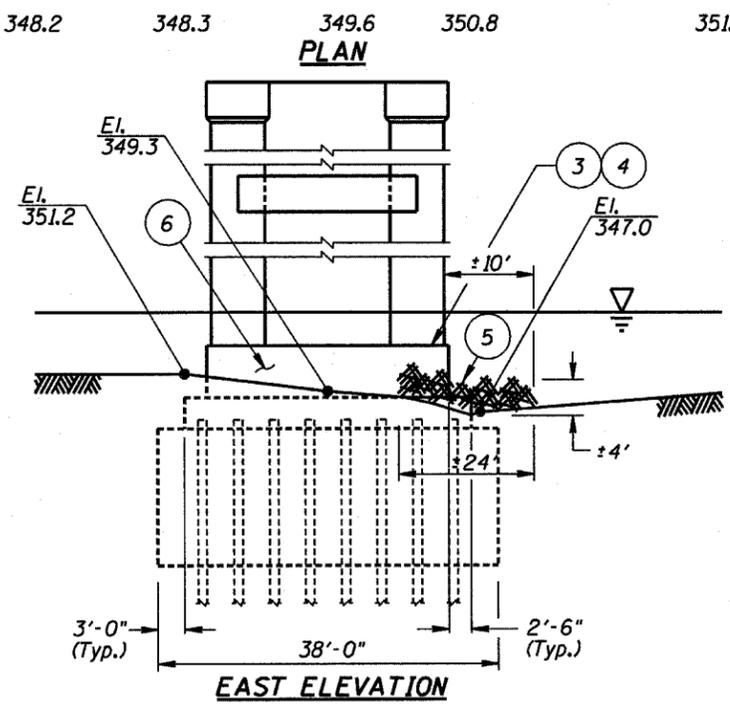
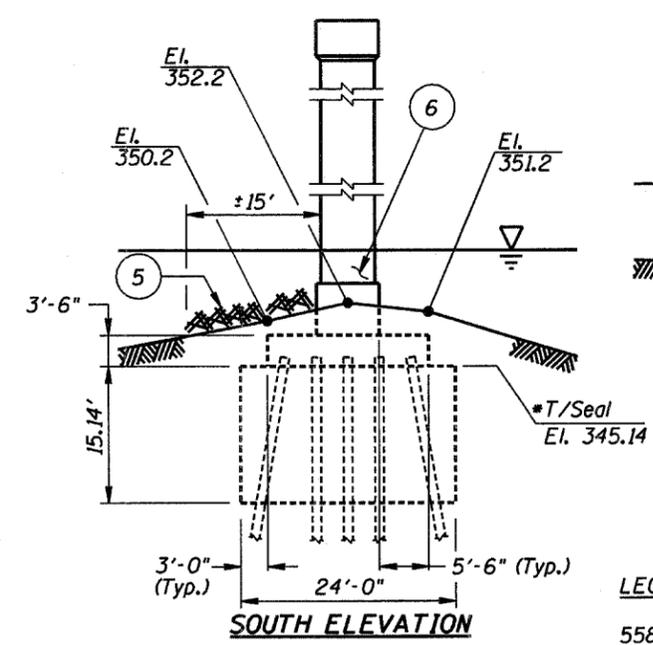
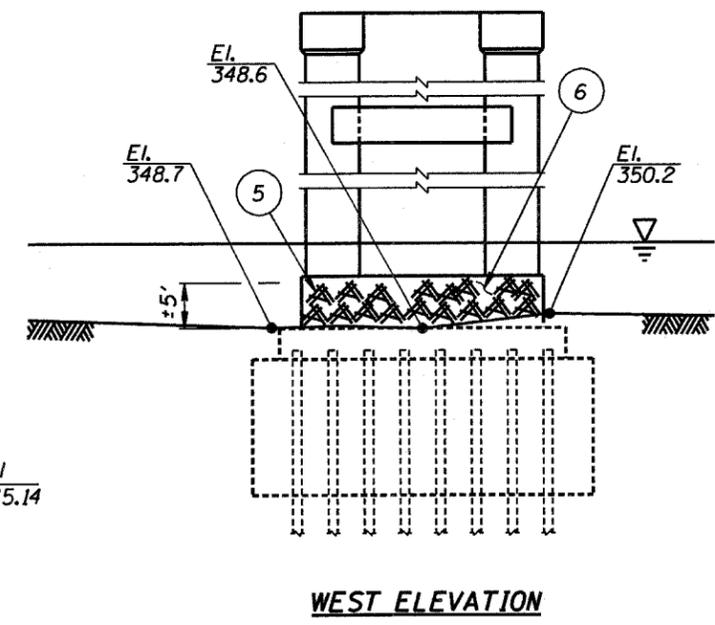
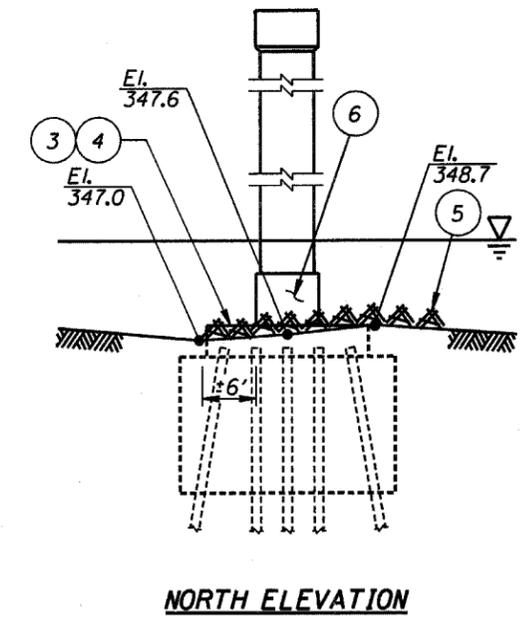
- ① The channel bottom material typically consisted of loose sandy silt, with up to 1 foot of probe rod penetration.
- ② The channel bottom material typically consisted of soft silt, with up to 3 feet of probe rod penetration.
- ③ Footing exposure, with vertical limits as shown. Due to heavy timber debris accumulations, the footing could not be detected along the west fascia. In the area where the footing was exposed, no undermining was detected.
- ④ Timber formwork covered approximately 90 percent of the vertical concrete footing surface.
- ⑤ Heavy accumulation of timber debris, consisting of trees measuring up to 3 feet in diameter with associated branches.
- ⑥ No damage below waterline.

1. At the time of the inspection, the waterline was located approximately 14.4 feet below the bottom of the pier beam at Eastbound Pier 3. This corresponds to a waterline elevation of 358.1 feet, based on the 1966 design plans.
2. Soundings indicate the channel bottom elevation at the time of inspection and are measured in feet.
