**Table 1. Asbestos Homogeneous Areas Summary**  
**IDOT - Asbestos Abatement Survey**  
**WO # 38**  
**202 W. Main Street, Benton, Illinois**

IDOT / Asbestos Surveys WO #38  
Job No. R-99-009-15  
Route IL 14 Parcel 9033515  
202 W. Main Street  
Benton, Franklin County, Illinois  
**ASBESTOS ABATEMENT SURVEY**

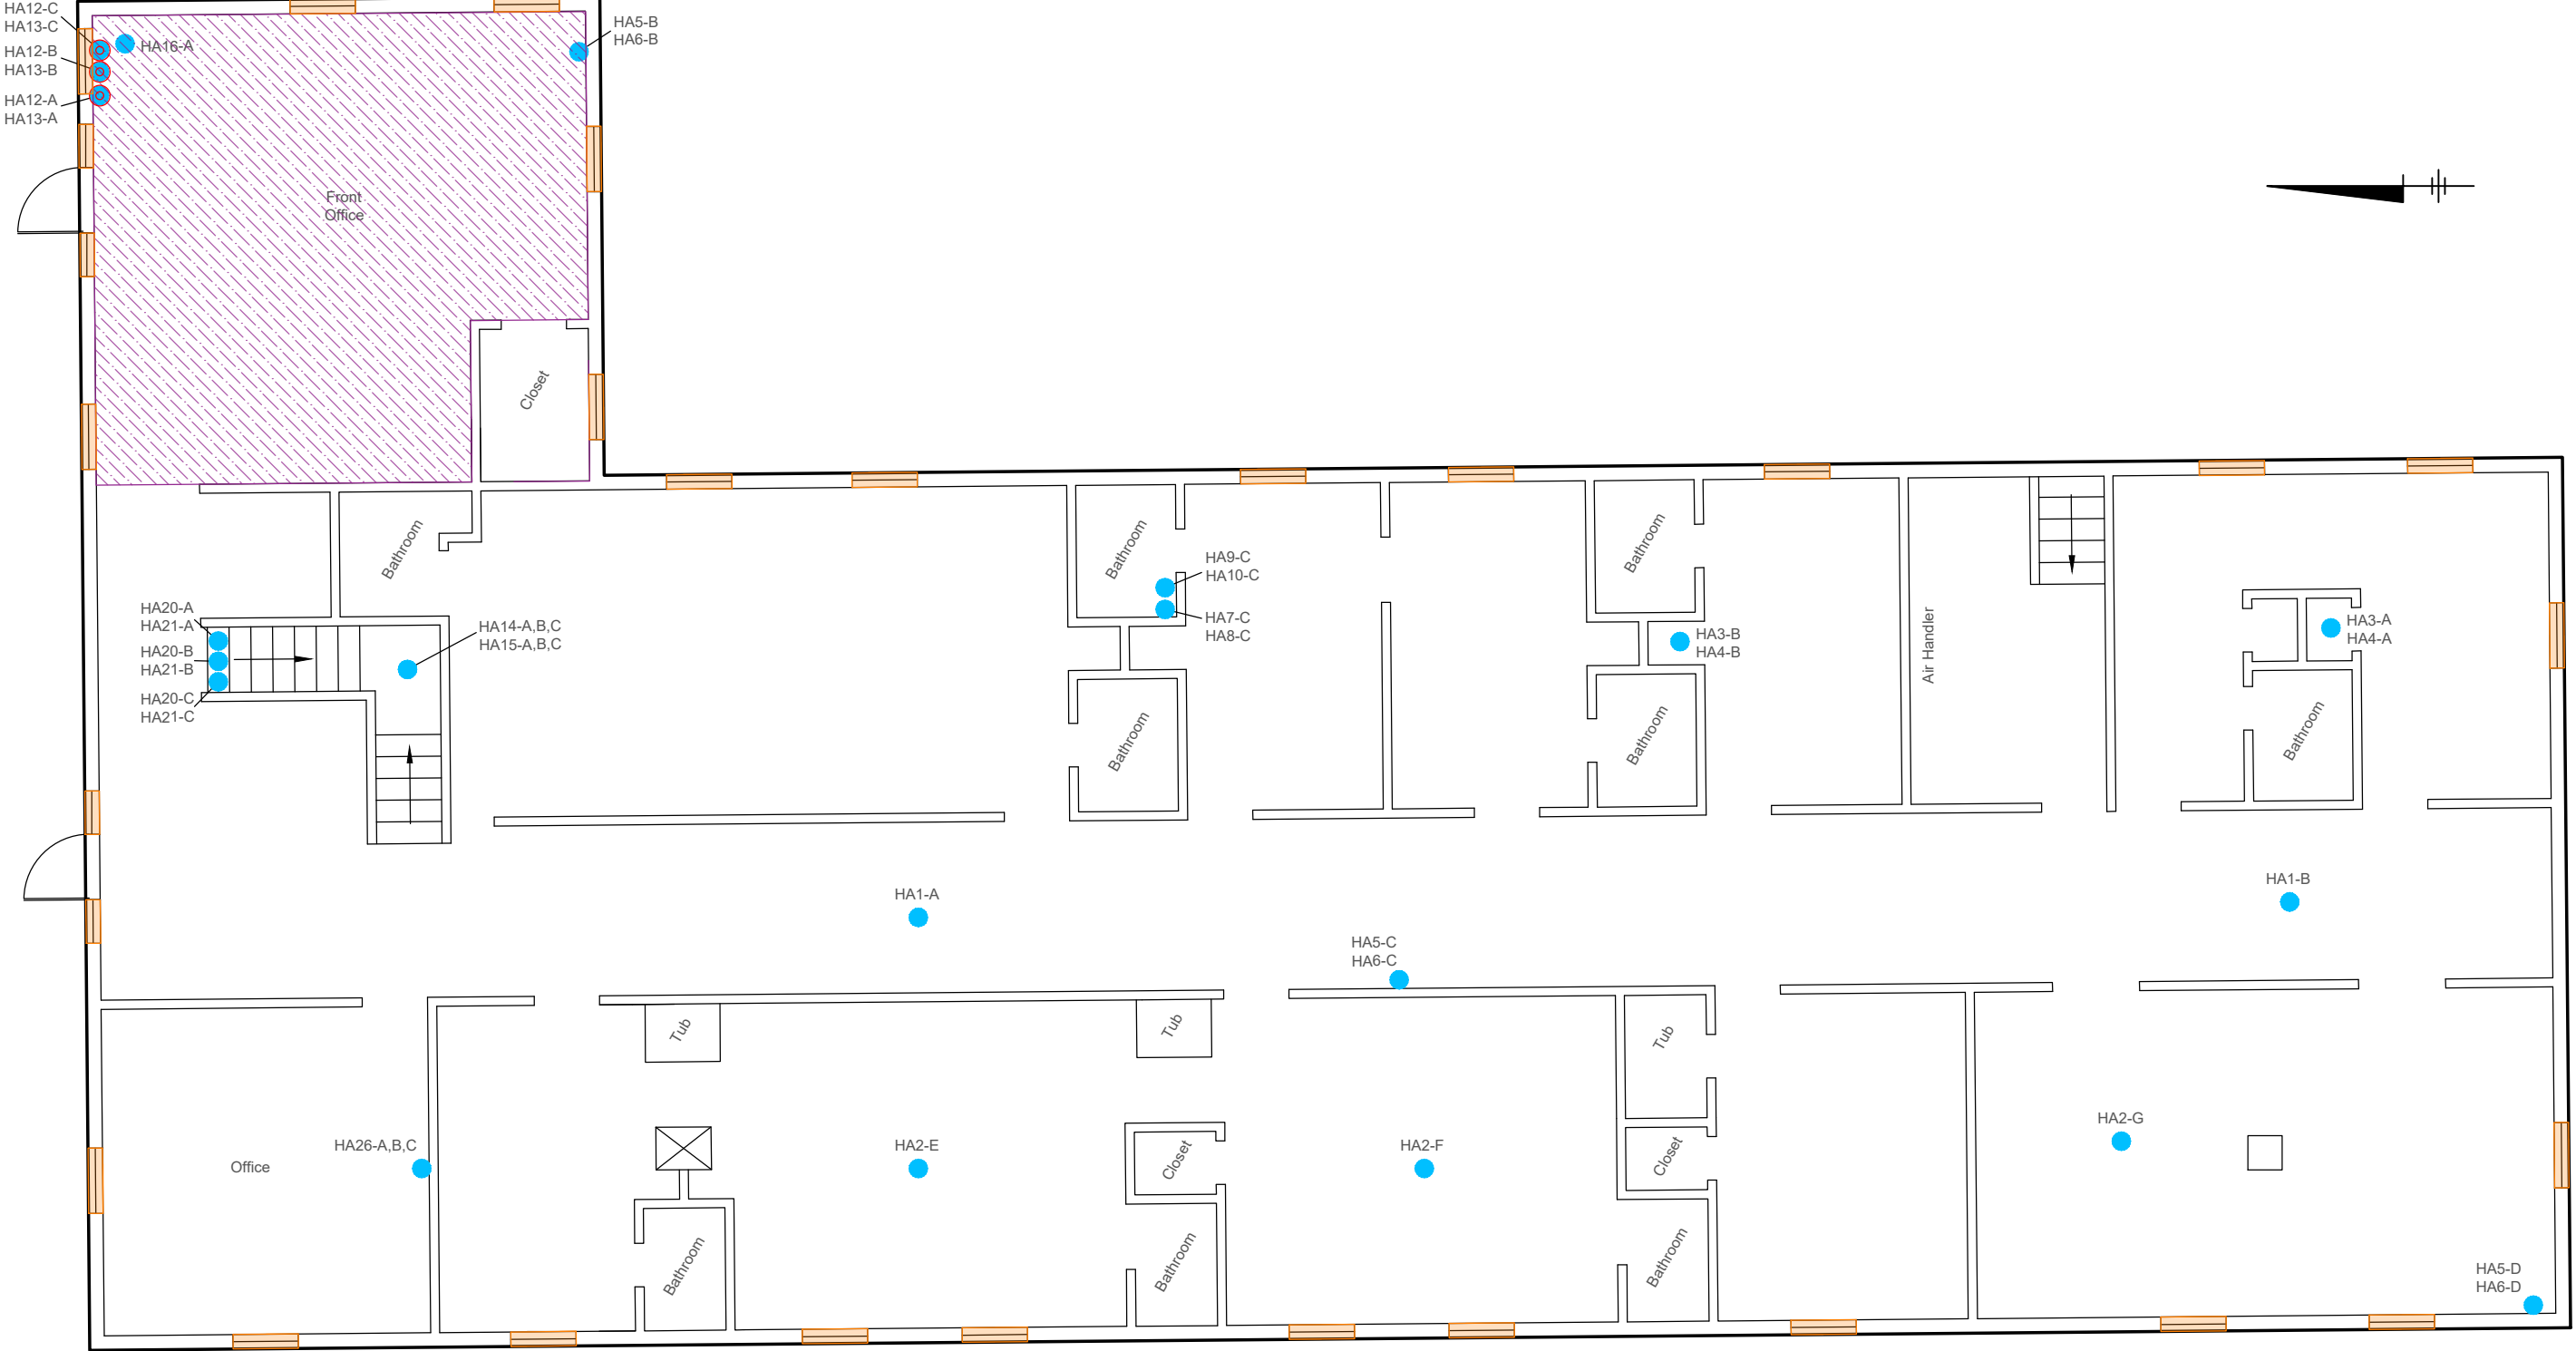
**ASBESTOS CONTAINING MATERIAL  
LOCATIONS - FIRST FLOOR**

- LEGEND**
- ASBESTOS SAMPLE
  - POSITIVE SAMPLE
  - HA-12: 12 x 12 Smooth Brown Floor Tile  
HA-13: Black Mastic associated with HA-12
  - HA-17: White Window Caulking  
HA-18: White Window Glazing

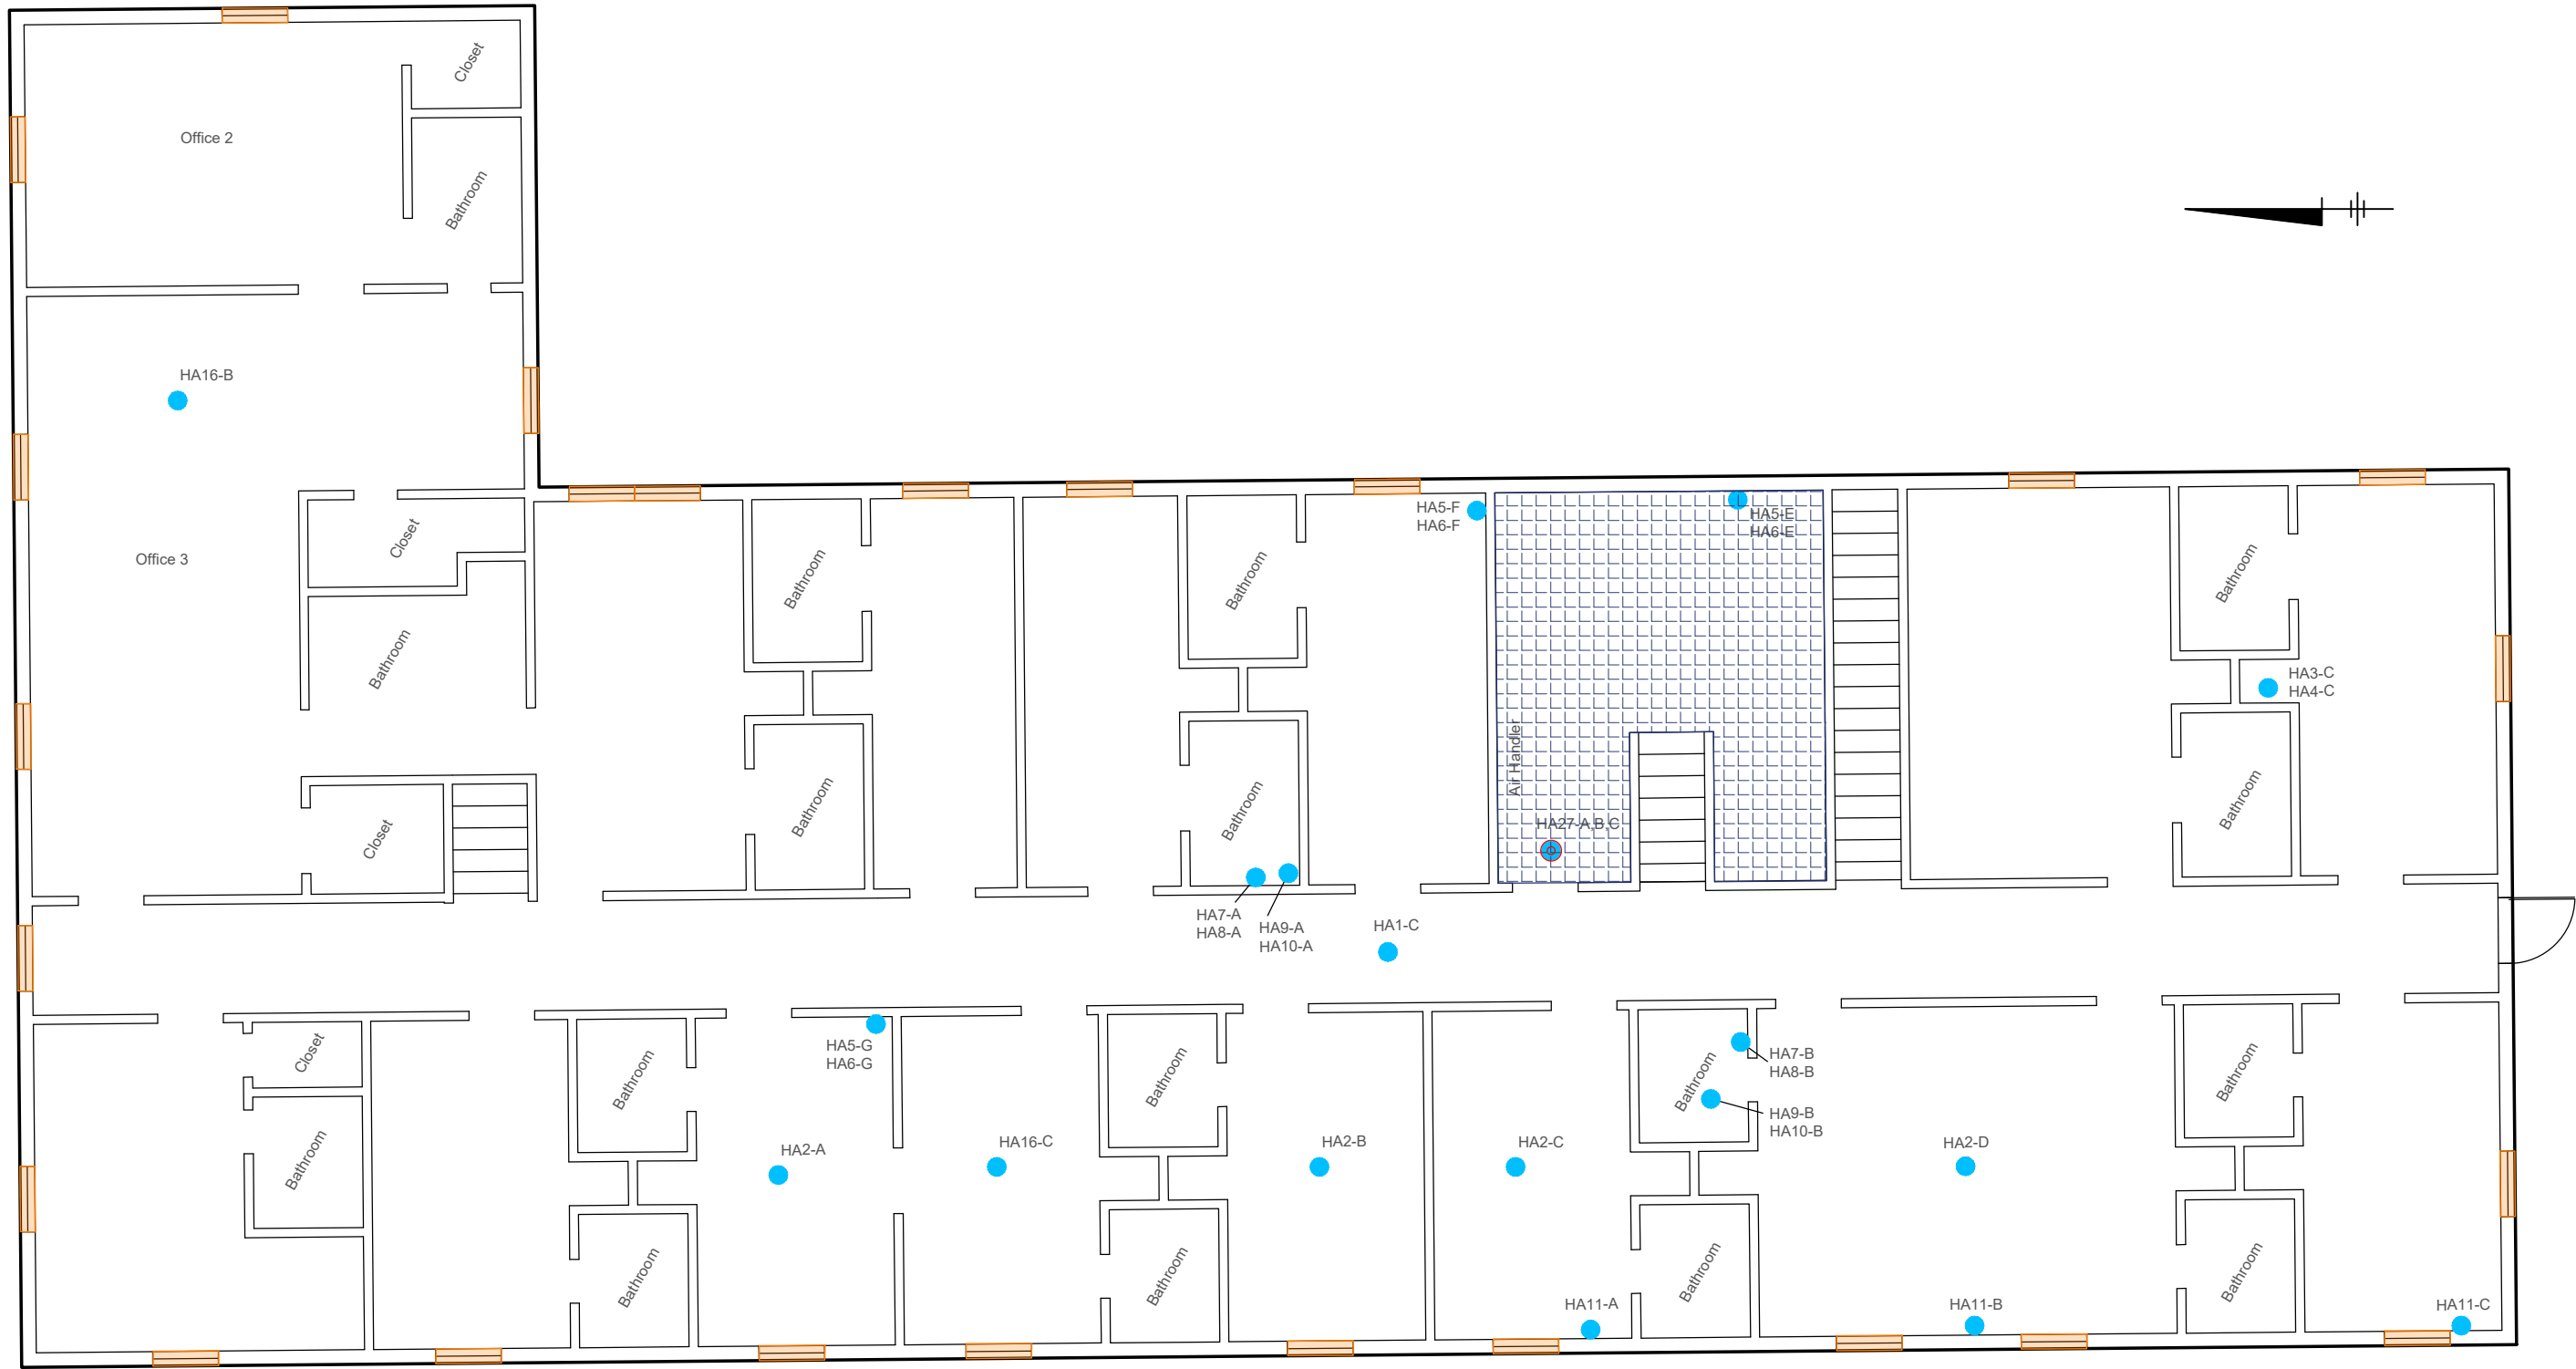
**ASBESTOS CONTAINING MATERIAL  
LOCATIONS - SECOND FLOOR**

- LEGEND**
- ASBESTOS SAMPLE
  - ⊙ POSITIVE SAMPLE
  - HA-17: White Window Caulking  
HA-18: White Window Glazing
  - HA-27: Beige Vibration Dampener
