STATE OF ILLINOIS
DEPARTMENT OF TRANSPORTATION

ABUTMENT REPAIRS
STRUCTURE NO. 016-2034

SHEET NO. S-21	F.A.I. RTE.	SECTION	COUNTY	TOTAL SHEETS	SHEET NO.
S-26 SHEETS	57	1818.3B-R	COOK	58	45
FED. ROAD DIST. NO.			ILLINOIS FED. AID PROJECT		
CONTRACT NO. 60862

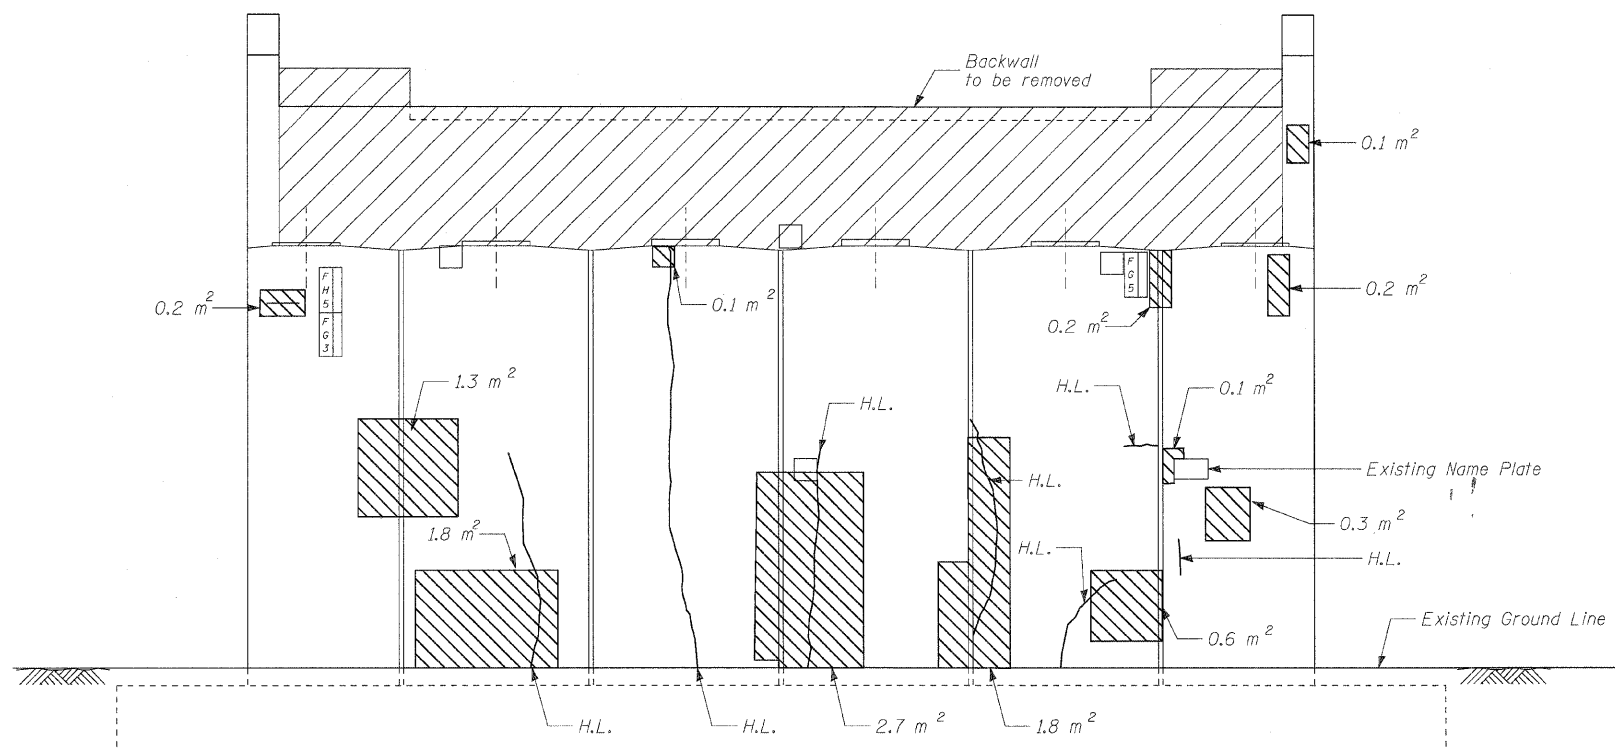
EAST ABUTMENT
(Looking East)

Note:
Crack widths are 3 mm ± 1 mm unless otherwise noted.
H.L. denotes Hairline Crack - Not to be sealed

- Repairs shall include but not be limited to the areas shown. The actual areas to be determined by the Engineer at the time of construction.
- Removal and attachment of plates embedded in Abutment stem is included with Structural Repair of Concrete.
- Repairs indicated on plans are based on in-depth inspection performed on April 2002. Total quantity reported in Bill of material has been increased by 15% from the original to take into account deterioration that may have occurred after inspection.
