STRUCTURAL REPAIR OF CONCRETE *TABLE*

1							
DESIGNED - <u>Jos</u> ue Ortiz-Varela	EXAMINED	Jayme F. J. J.M.	DATE - MARCH 24, 2014		STRUCTURAL REPAIR OF CONCRETE	F.A.P.	SECTION	COUNTY SHE	TOTAL SHEET
CHECKED - <u>Mes</u> eret Sima		ACTING ENGINEER OF BRIDGE DESIGN		STATE OF ILLINOIS		322	54B-3, 54B-2	DEWITT 8	89 54
DRAWN - h.t. duong	PASSED	& Carl Princer	REVISED	DEPARTMENT OF TRANSPORTATION	STRUCTURE NO. 020-0046	_		CONTRACT NO	NO. 70606
CHECKED - <u>JOV</u> /MS/GRA	A	ACTING ENGINEER OF BRIDGES AND STRUCTURES	REVISED		SHEET NO. 10 OF 10 SHEETS		ILLINOIS FED.	AID PROJECT

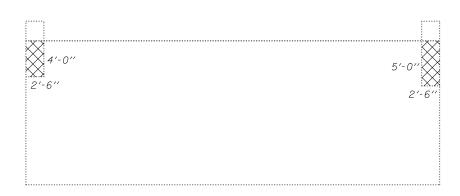
ELEVATION - NORTH ABUTMENT
(North Abut. - Looking North)

Abutment Corner	Repo	Repair			
	Wingwall		Abutment		Area
	Α	В	С	D	Sq. Ft.
Northeast	1'-0''	6'-0''	2'-6"	4'-0''	16.0
Northwest	4'-0''	3'-0''	2'-6"	6'-0''	27.0
Southeast	1'-0''	3'-0''	2'-6''	4'-0''	13.0
Southwest	1'-0''	3'-0''	2'-6"	5'-0''	<i>1</i> 5.5

Structural Repair of Concrete (Depth $\leq 5''$)
