BEAM STRAIGHTENING DETAILS

MERIDIAN ROAD

MADISON COUNTY

SN 060-0185

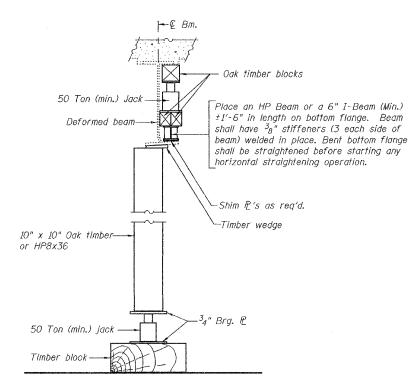
SUGGESTED VERTICAL STRAIGHTENING DETAIL

(To correct flange rotation.)

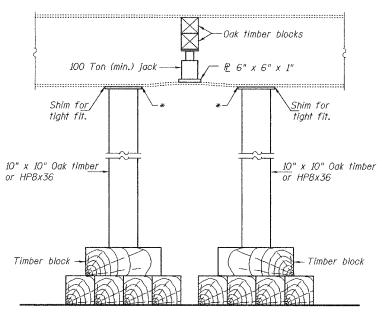
SUGGESTED VERTICAL STRAIGHTENING DETAIL

(To correct localized vertical flange deformations.)

* Edge of plate shall line up with edge of deformation.

Braces and Jack assembly shall be placed on same side of web. Bent bottom flange shall be straightened before starting any horizontal straightening operations.
