STA, 23+51 TO STA, 35+09

REVISIONS		ILLINOIS DEPARTMENT (OF TOANCOODTATION
NAME	DATE		
·····		DECK PATCHIN	
		APPROACH SPANS	
		EXISTING S.N.	
		IL 178 OVER ILLII	NOIS RIVER
		STATION 29+30	
······································		SCALE: HORIZ.	DRAWN BY RLW
		DATE 12/08/04	CHECKED BY

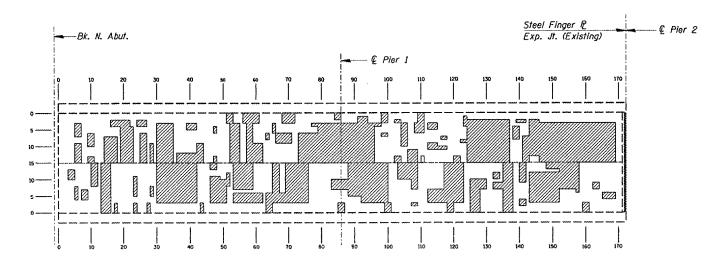
NORTH APPROACH PLAN

Hatched areas represent delaminated areas.

Deck Slab Repair (Partial) has been estimated at 19% of total deck area = 635 square yards.

Deck Slab Repair (Full Depth) has been estimated at 2% of total deck area = 70 square yards.

Date of Deck Survey: 12/28/04

The Engineer shall sound the entire deck surface to determine exact locations and quantities of "Deck Slab Repair".

The Engineer shall record the actual locations of the deck slab repair on the "As-Built" plans.
