ROADWAY GEOTECHNICAL REPORT

PAVEMENT RUBBLIZATION STUDY

INTERSTATE 55

**Illinois Department
of Transportation**

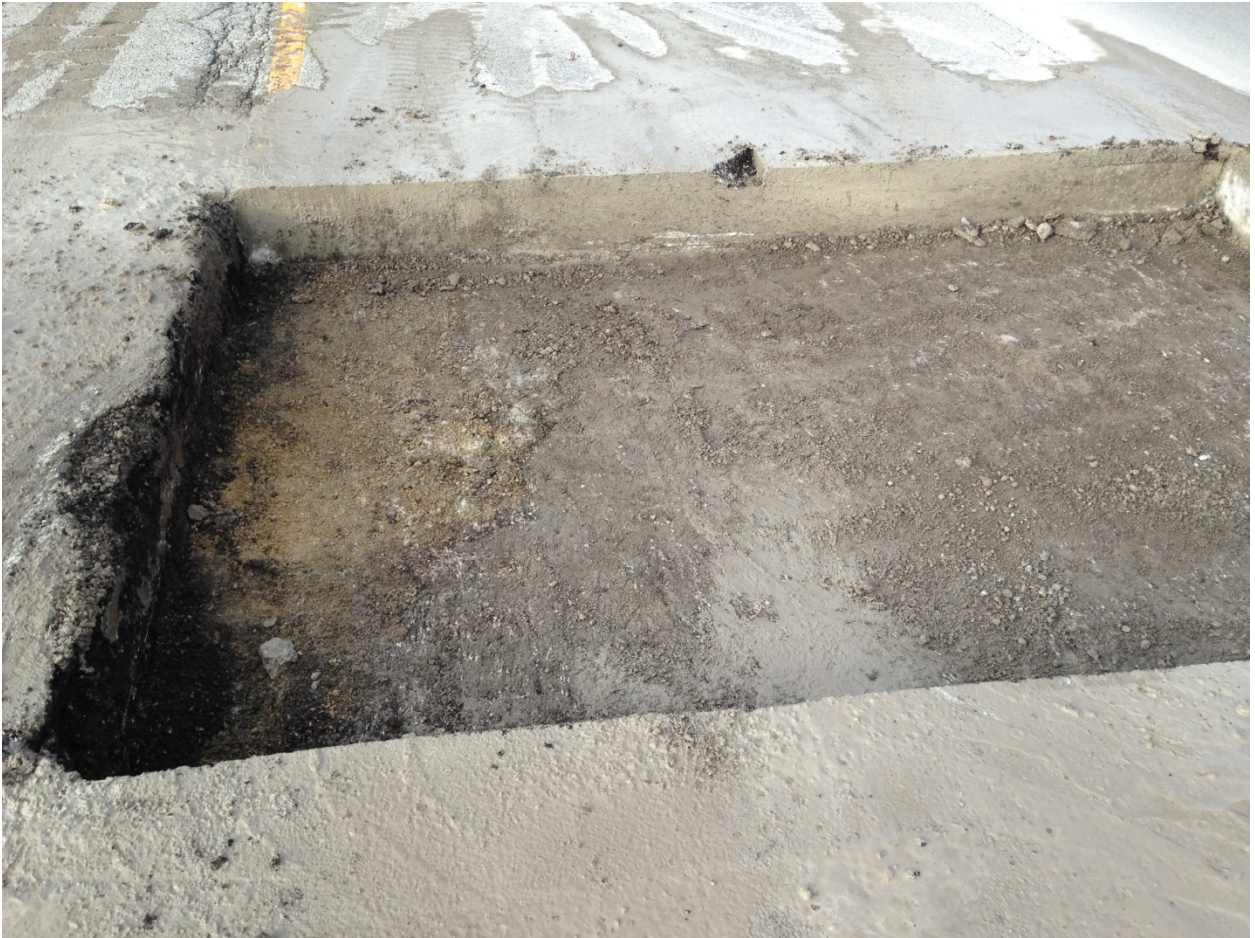
1. The stabilized subbase is in fair condition. All of the stabilized subbase was firm (Photo 1).
2. Subsurface drainage does not appear to be an issue. None of the patches held water or displayed other evidence of a subsurface drainage problem.
3. Rutting of the HMA overlay which was placed in 2012 is evident, with varying levels of severity.
4. Section 53-4 has significantly more pavement failures than Section 53-5 and the severity of the pavement failures is greater in Section 53-4 than in Section 53-5.
5. There are many more areas that need patching than can be patched on the current project. An additional patching contract will be necessary to complete all of the necessary pavement patching.

Photo 1: Example of a typical patch with a subbase in good condition.

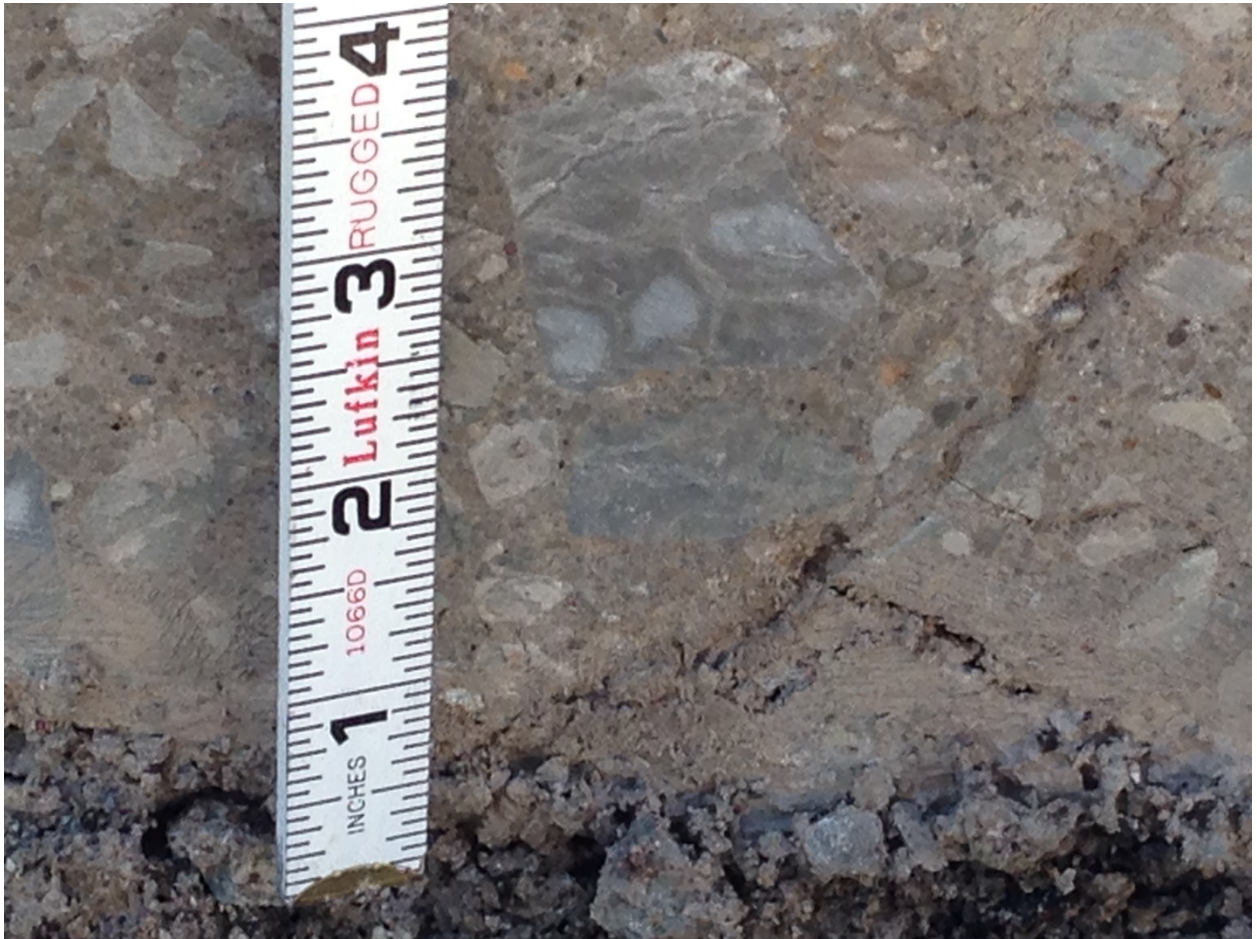
1. The CRPCC pavement has a thickness of 9 to 9.25 inches.
2. The CRPCC pavement is in poor condition.
 - o The aggregate has evidence of D cracking at all locations (Photo 2).

Photo 2: Example of typical cracking in the aggregate in Section 53-4.

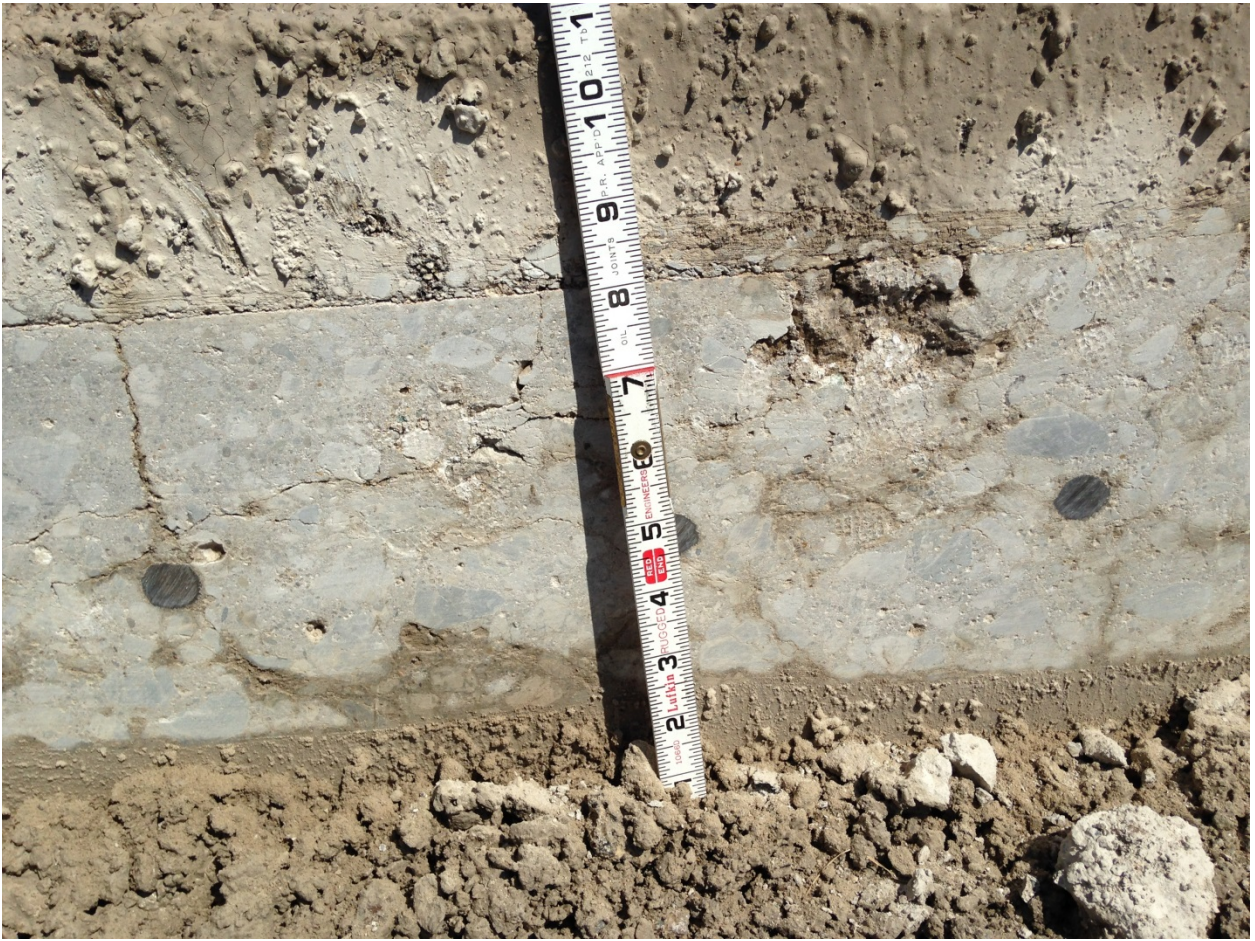
- o The CRPCC pavement has evidence of D cracking at many locations (Photo 3 & 4).
 - o The CRPCC pavement has vertical cracks in the center of the right wheel lane at some locations (Photo 5).

Photo 3: Example of typical D cracking of the PCC pavement in Section 53-4.

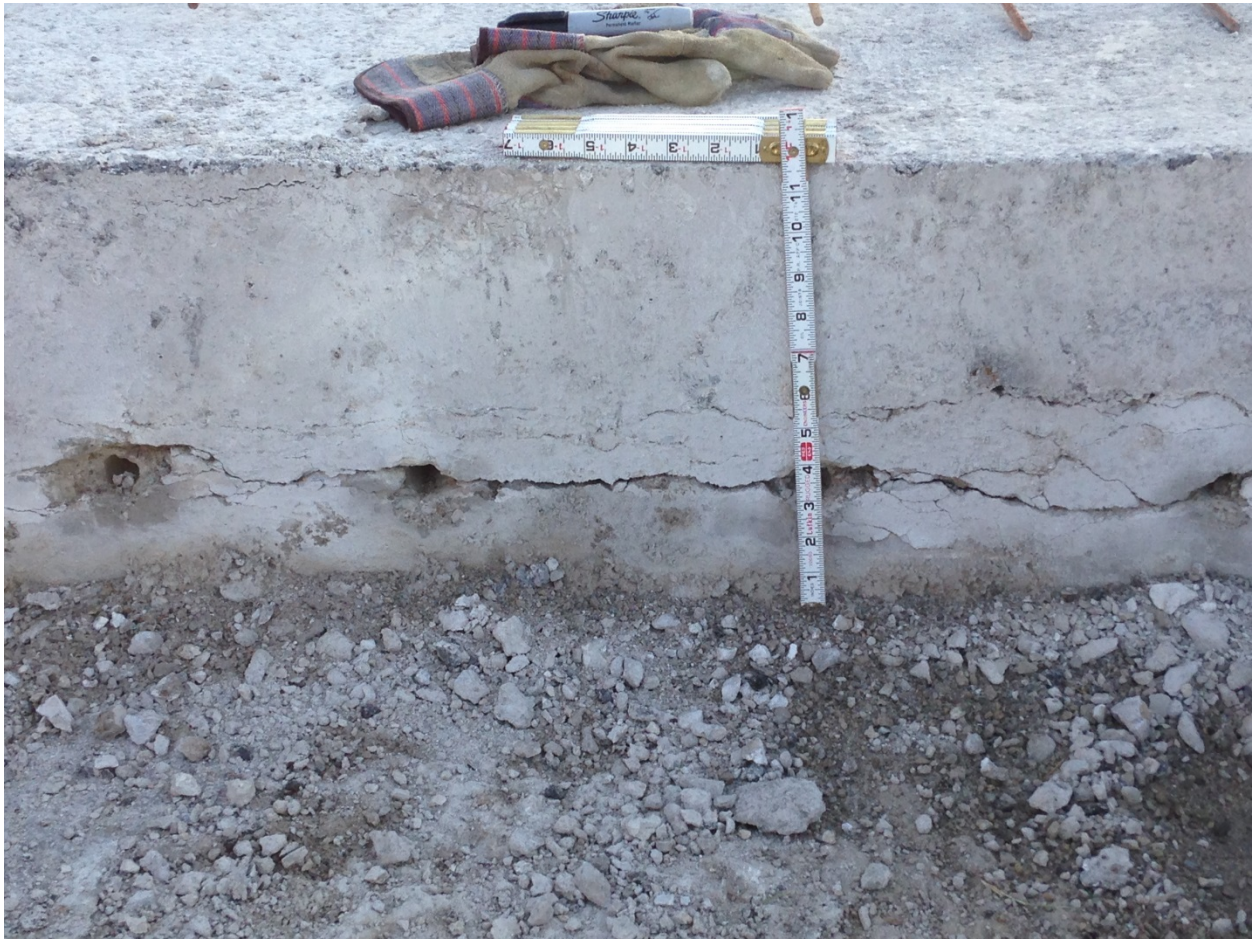
- o The CRPCC pavement has horizontal cracks at some locations (Photo 4).
 - o The sawed vertical face of the CRPCC sounds “hollow” as some locations.
3. The reinforcement bars are at varying positions within the pavement. Locations of the bars range from $t/3$ to $t/2$ below the top of the concrete pavement.

Photo 4: Example of typical D cracking with a horizontal crack in the PCC in Section 53-4.

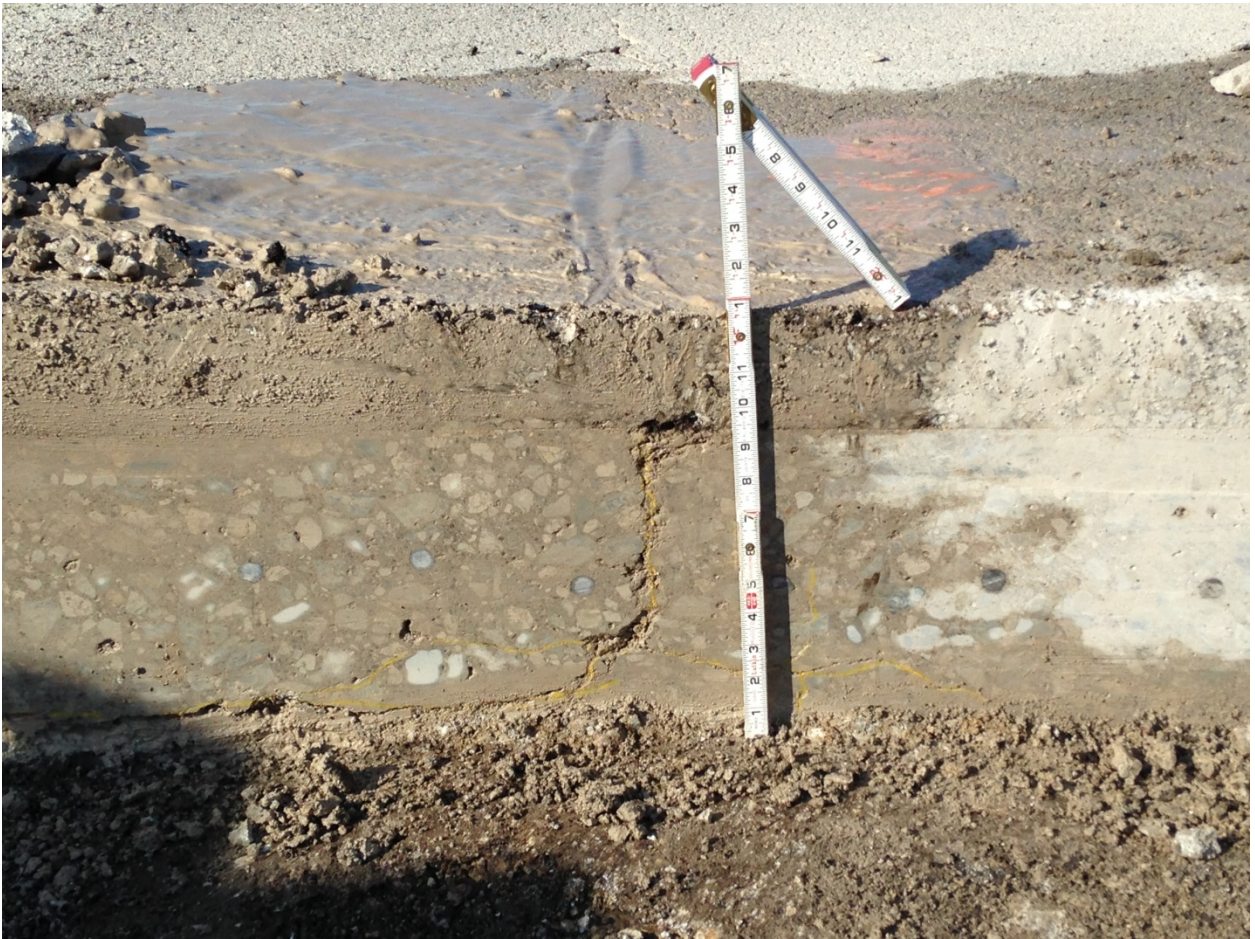
Photo 5: Example of a reflective longitudinal crack in the HMA overlay caused by an underlying longitudinal crack in the PCC pavement in Section 53-4.

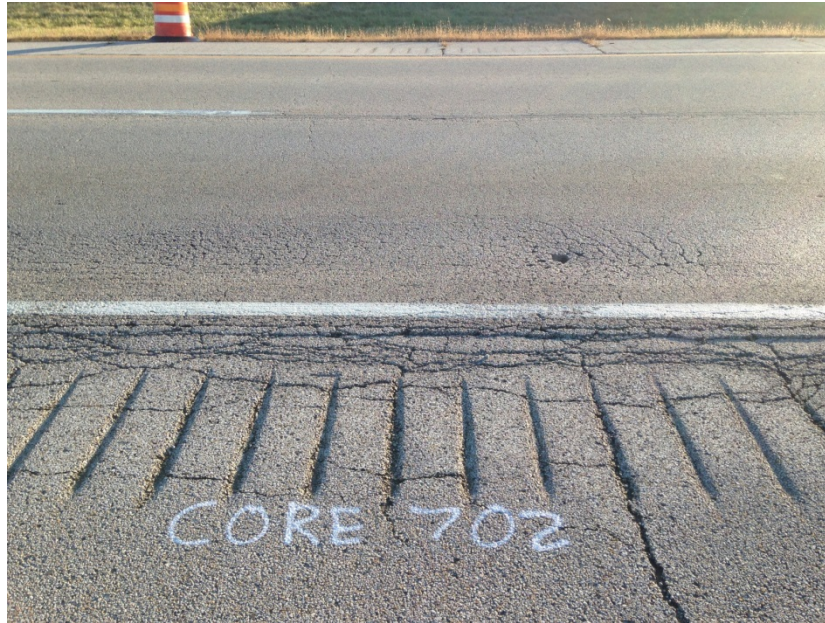
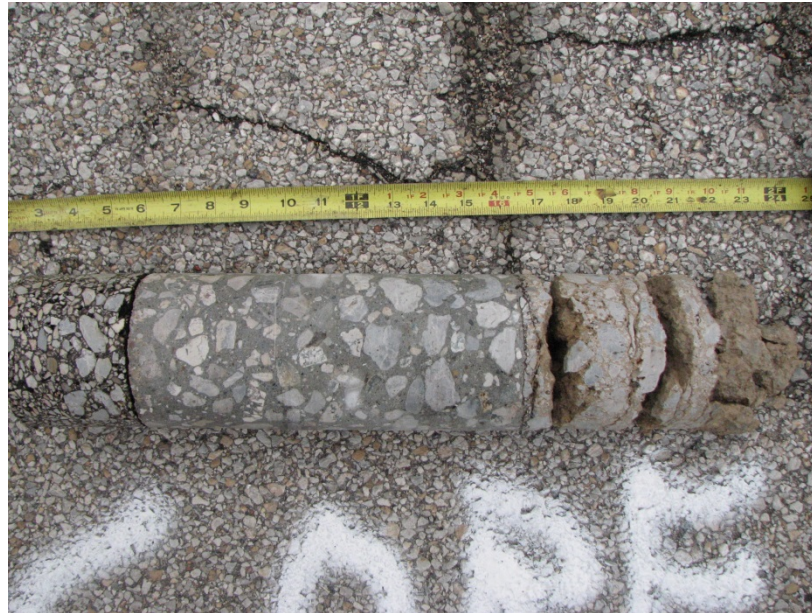
| Comments: | MM 197.16, Bad Pavement / Rutting | | | | | | |

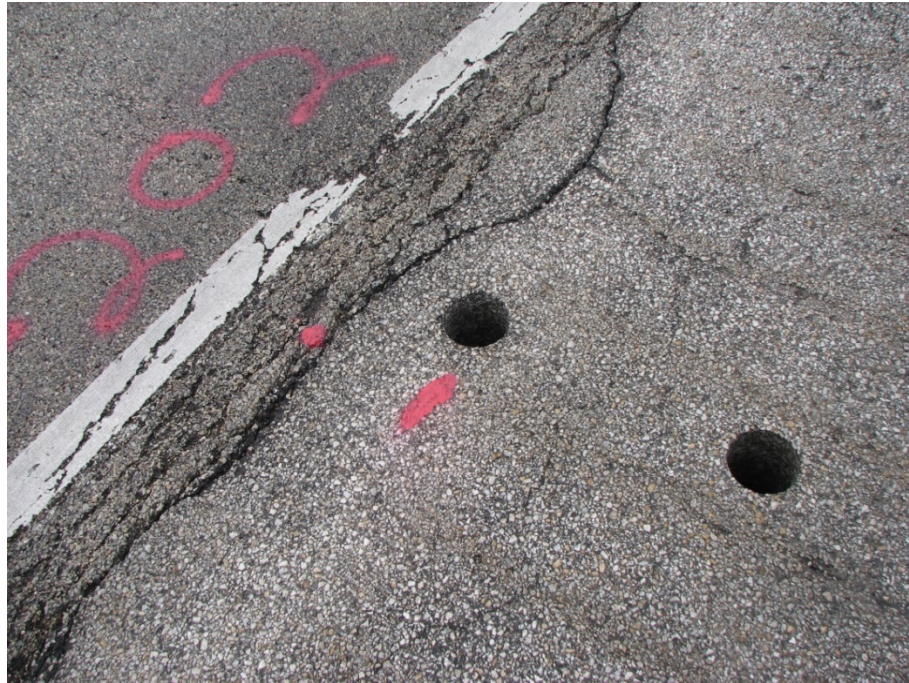
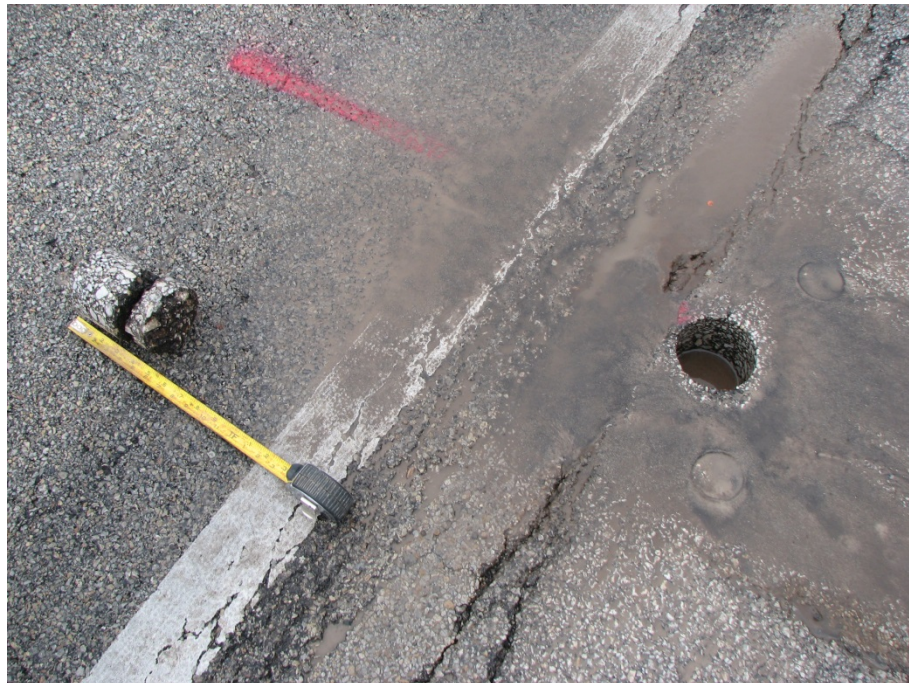
Core #1

1 ¾" HMA Surface Course – Fair Condition – No Cracks – Some Voids
2" HMA Binder Course – Poor Condition – Some Cracks – Some Voids
2 ¼" HMA Binder Course – Poor Condition – Some Cracks – Some Voids
6" recovery – the rest is rubble

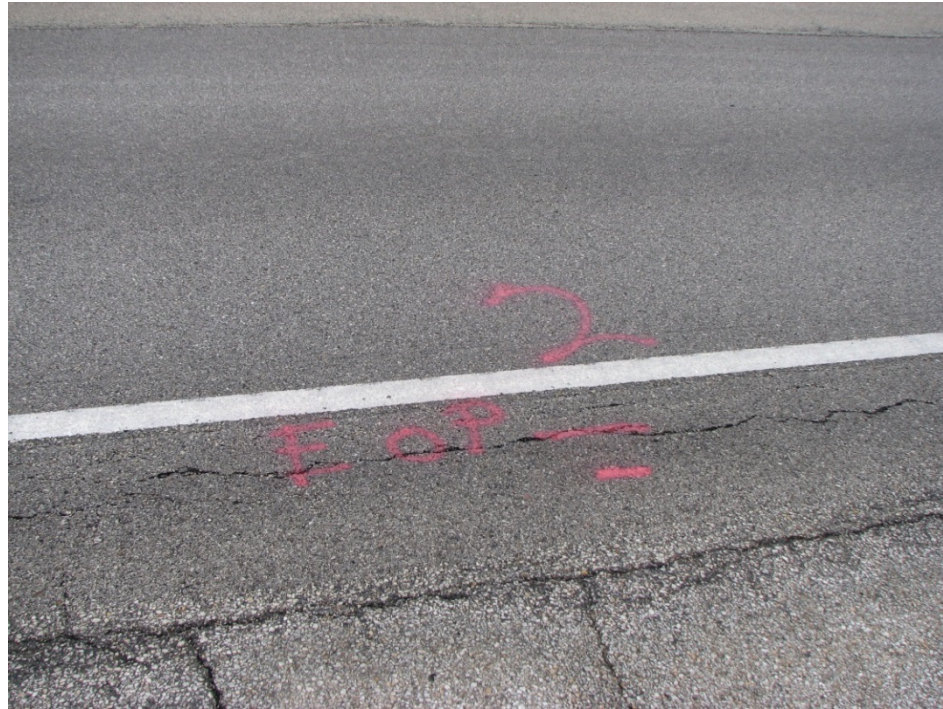
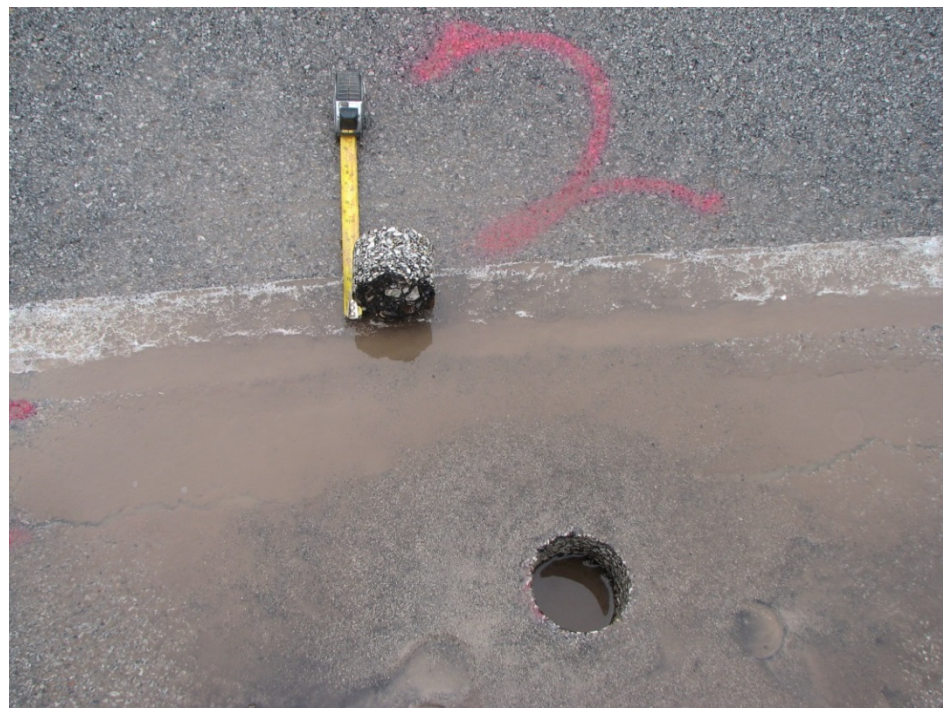
Core #2

3" HMA Surface Course – Poor Condition – Some Cracks – Many Voids
3" recovery – the rest is rubble

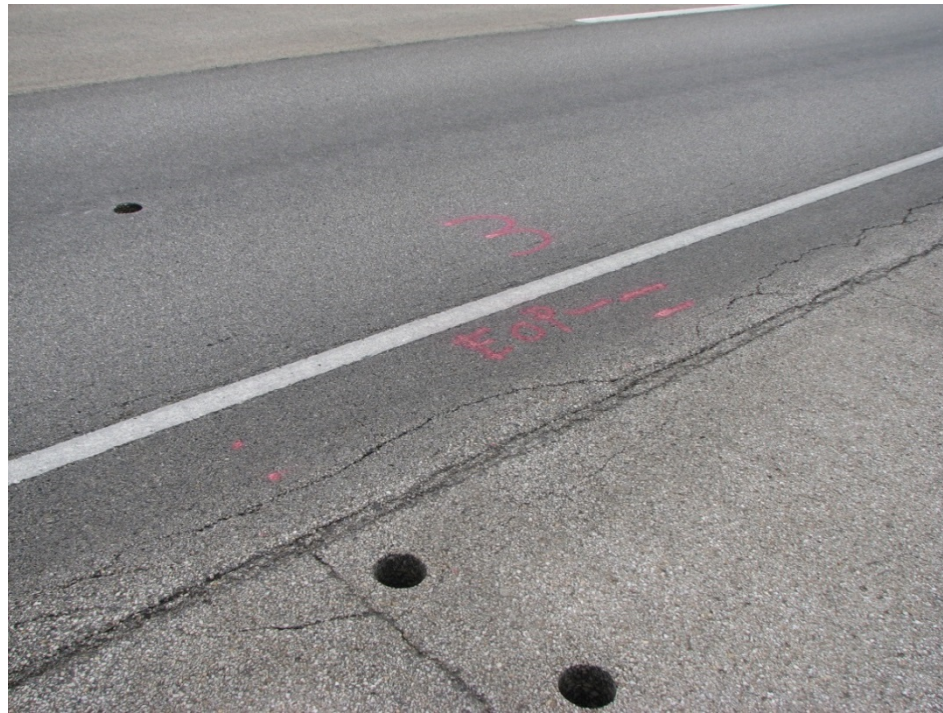
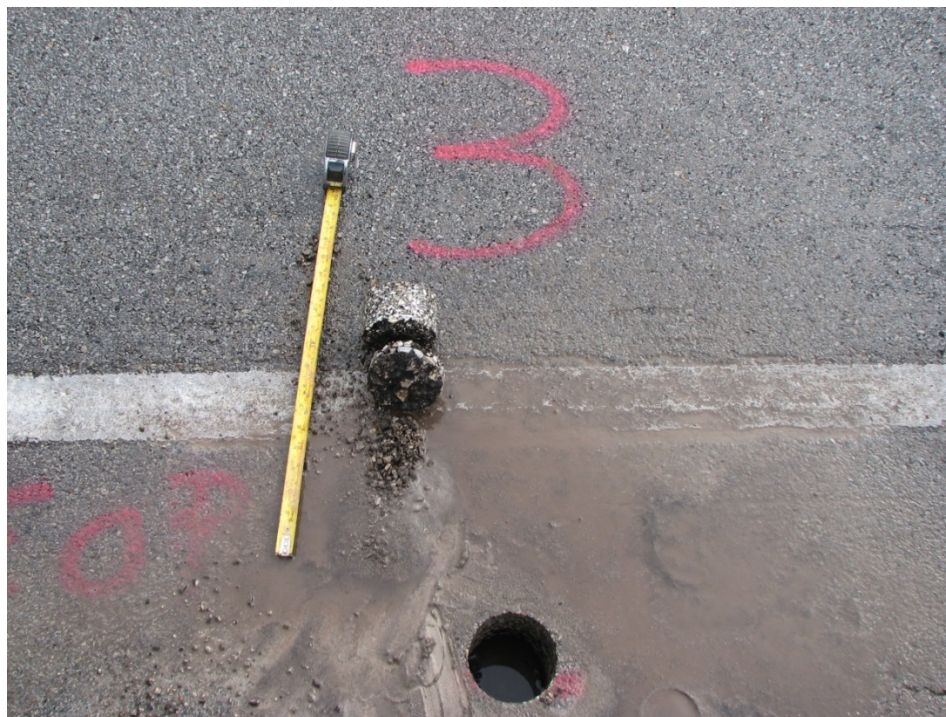
Core #3

2 ½" HMA Surface Course – Fair Condition – No Cracks – Some Voids
3" HMA Binder Course – Poor Condition – Some Cracks – Many Voids –
Very Poor
5" recovery – the rest is rubble

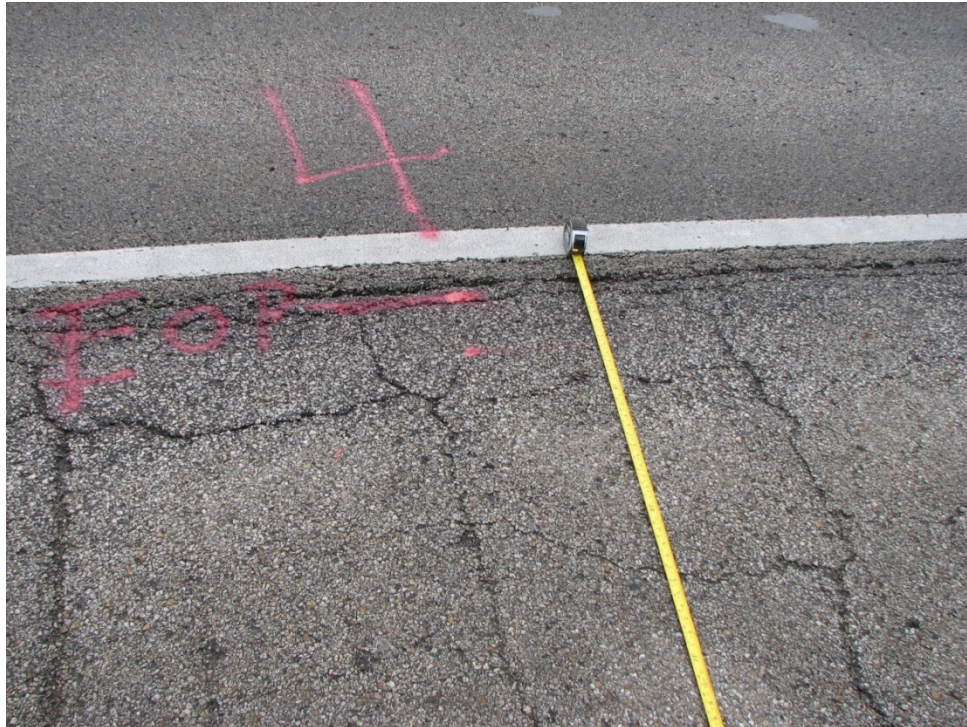
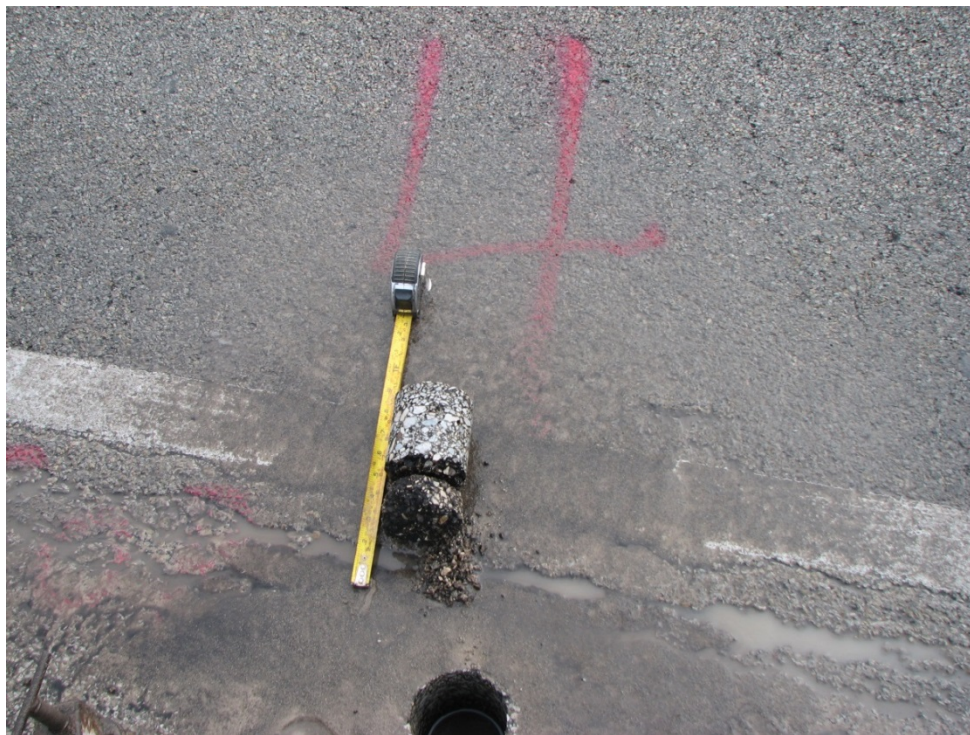
Core #4

1 ¼" HMA Surface Course – Poor Condition – No Cracks – Many Voids
3" HMA Binder Course – Poor Condition – Some Cracks – Many Voids
2 ½" HMA Surface Course – Poor Condition – Some Cracks – Many Voids –
Very Poor
7" recovery – the rest is rubble

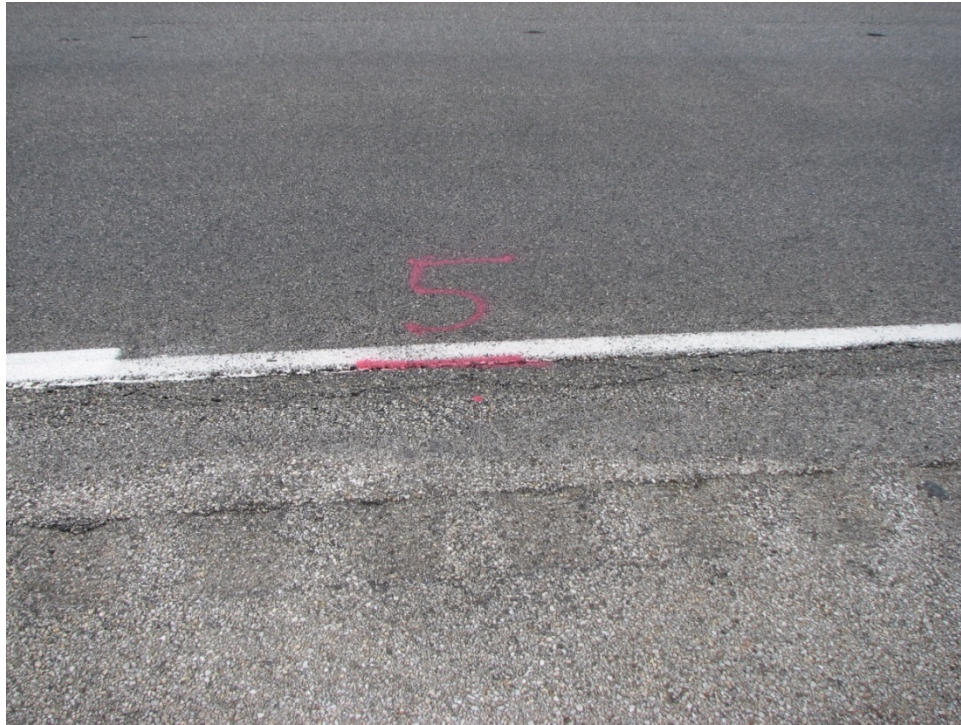
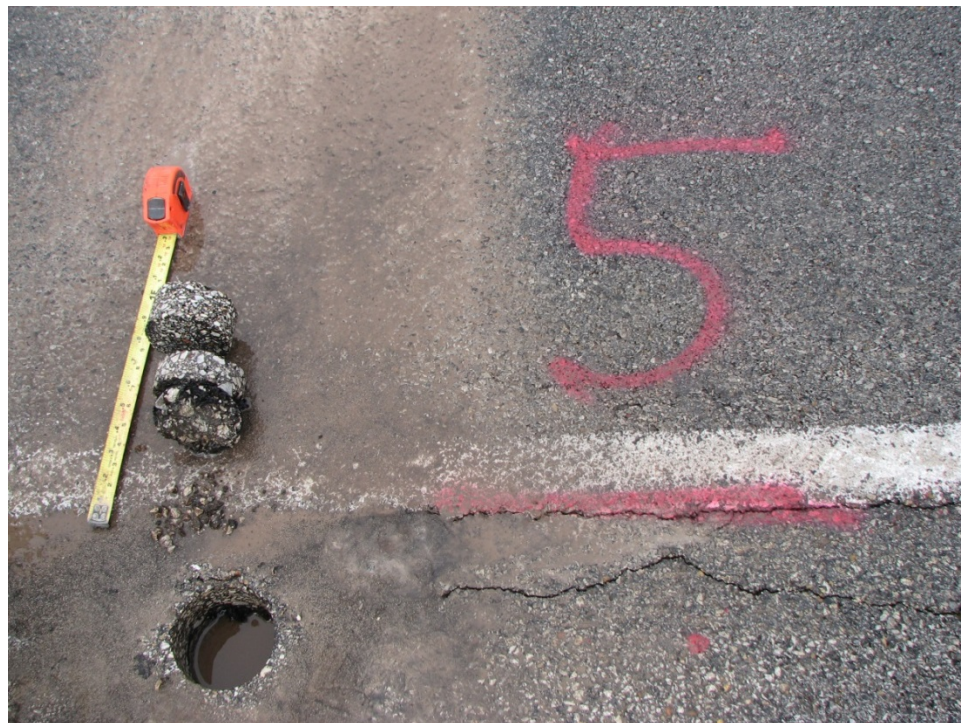
Core #5

- Lift #1 2" HMA Surface Course – Fair Condition – No Cracks – Some Voids
- Lift #2 ½" HMA Surface Course – Poor Condition – Some Cracks – Many Voids –
Very Poor
- Lift #3 1 ¾" HMA Surface Course – Poor Condition – Many Cracks – Many Voids –
Very Poor
- 4" recovery – the rest is rubble

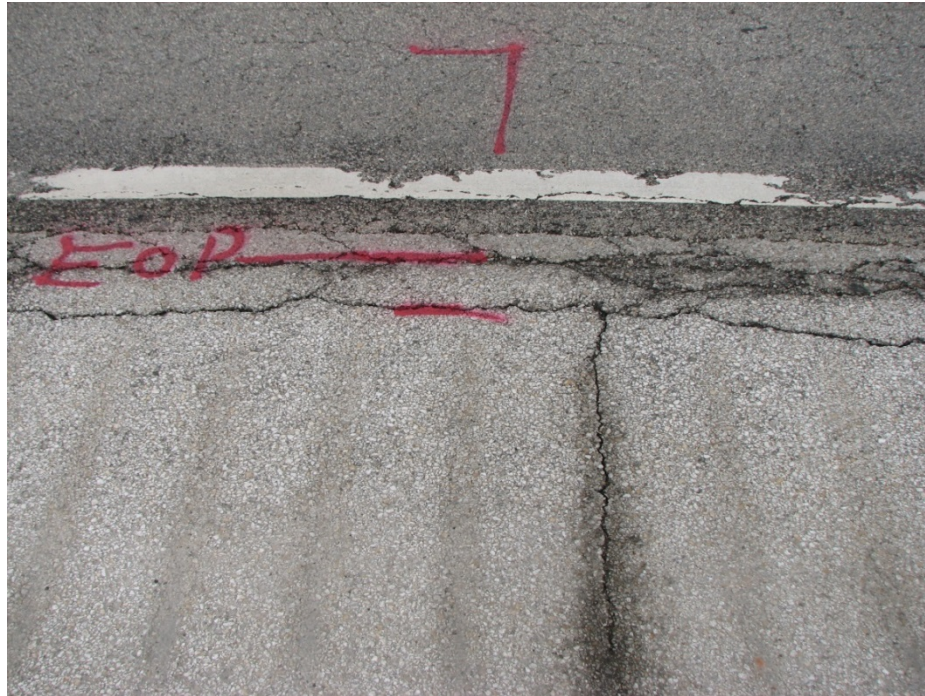
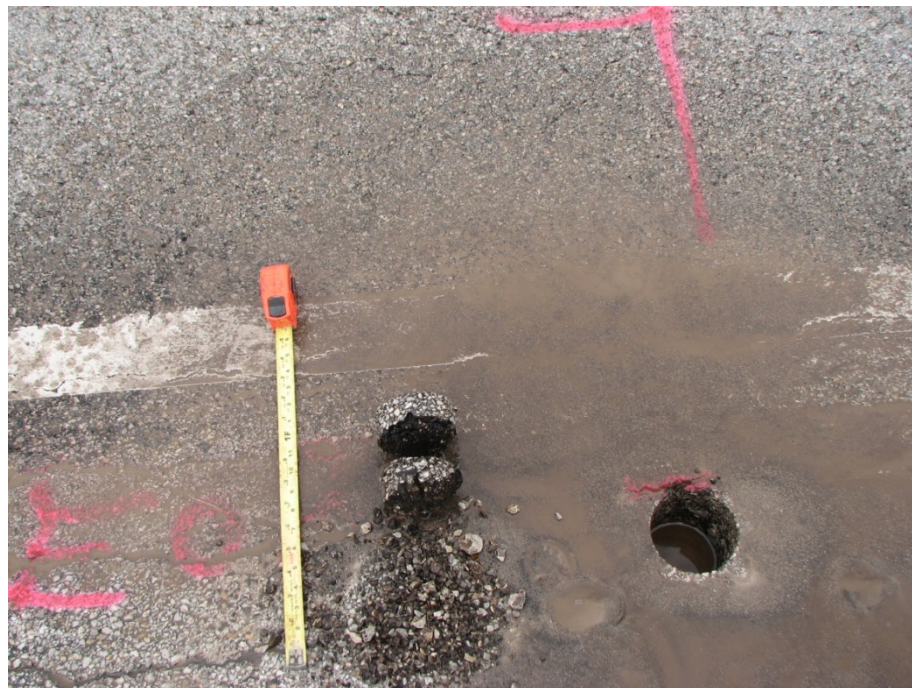
Core #7

1 ¾" HMA Surface Course – Fair Condition – No Cracks – Some Voids
2 ½" HMA Binder Course – Poor Condition – Many Cracks – Many Voids –
Rubble – Very Poor
4" recovery – the rest is rubble

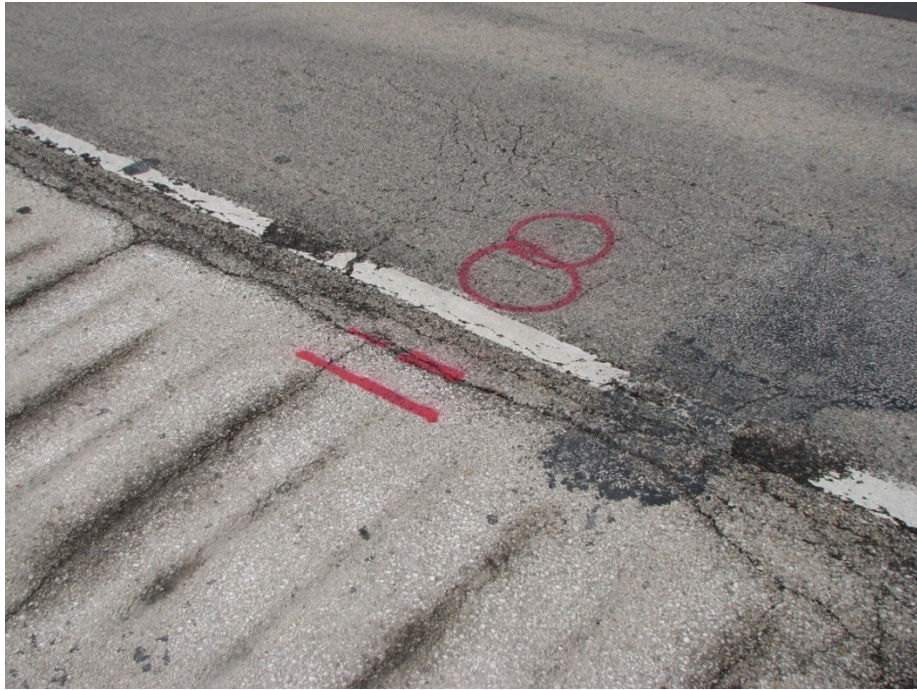
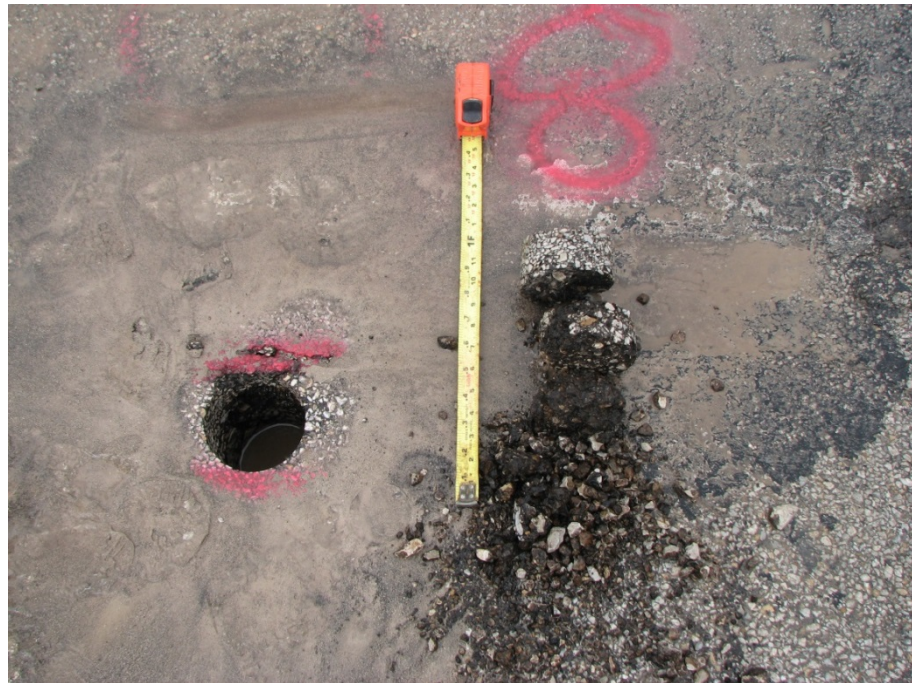
Core #8

1 ¾" HMA Surface Course – Fair Condition – No Cracks – Some Voids
5 ½" HMA Binder Course – Broken & Crumbled – Very Poor
7" recovery – the rest is rubble
