INFRARED THERMOGRAPHIC INSPECTION RESULTS

SHEET S-27 OF S-44

INFRARED INSPECTION DATE: 7/24/00-7/26/00 SURFACE TYPE: ASPHALT OVERLAY

1/1/	MAMED	I TERMOGRAPHIC INSPECTION RESULTS
		R 1				T E C		REVISIONS		STATE OF ILLINOIS
E	A I		т	Н	7		H	NAME	DATE	DEPARTMENT OF TRANSPORTATION REHABILITATION AND RETROFIT REPAIRS
L	^ I	¥.	•	11			10.0			FAI ROUTE 70
										POPLAR STREET BRIDGE APPROACHES
									l	ST. CLAIR COUNTY
INSPEC	TED: TC					CADD:	MAZMD DSZEG	and the state of t		STRUCTURE NO. 082-0142 (RAMP S)
ANALYS	SIS: TC					CHECKED:	ĐU			SCALE:
										DATE: 02/28/2006

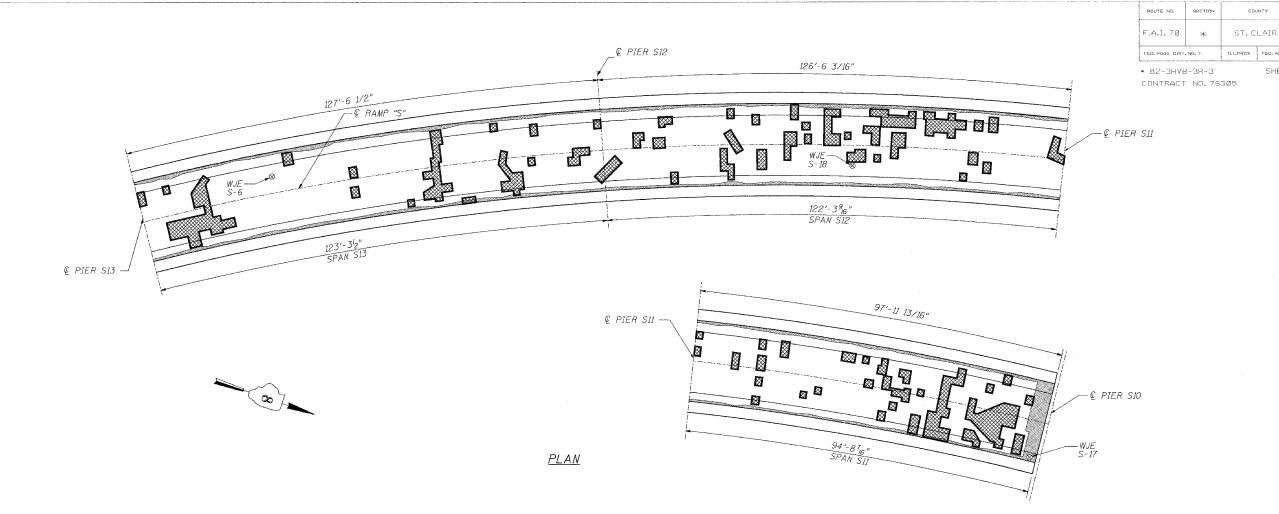
INFRARED THERMOGRAPHIC INSPECTION RESULTS

FIELD OBSERVATIONS SUMMARY		TOPS	IDE	LEGEND		
ITEM	UNIT	QUANT.	%	DELAMINATION		
TOTAL AREA	f+2	7633		SPALI		
SHADE/DEBRIS	f †2 f †2	0		DEBOND		
DELAMINATION		246	3.2			
SPALL	Ft2	0	0	ASPHALT PATCH		
DEBOND	f†²	590	7.7	SUBSURFACE PATCH		
ASPHALT PATCH	f+²	0	0	SHADE/DEBRIS	TITTO	
SUBSURFACE PATCH	f+2	0	0	SHADE/ DEDING	alle

SPAN	2000 SURV RESULTS		2005 ANTICIPATED PARTIAL DEPTH REPAIRS					
SII	410				520			
SI2	530				670			
SI3	250				320			
OLIANTIT	IES IN THIS	TABLE	ARE	FOR	INFORMATIONAL

AREAS OF DECK DELAMINATIONS AND SPALLS SHOWN REQUIRING REPAIR ARE ESTIMATED. ACTUAL REPAIR LOCATIONS SHOULD BE SHOWN ON AS-BUILT DRAWINGS.
