## EAST ABUTMENT BILL OF MATERIAL

EAST ABUTMENT IL 149 OVER TILLEY CREEK FAP ROUTE 873 - SECTION 107BR-1 FRANKLIN COUNTY STATION 1060+46.00 STRUCTURE NO. 028-0040

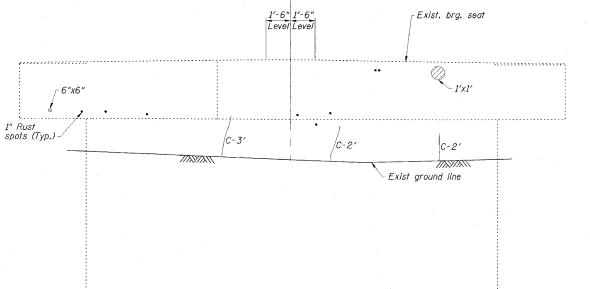
**ELEVATION** (Looking East)

Inspection Date: 12/18/07

EXISTING BEARING SEAT TO BE INSPECTED BY THE ENGINEER

AFTER DECK BEAM REMOVAL. DETERIORATED CONCRETE PLAN AREAS SHALL BE REPAIRED (ESTIMATED 15 S.F. STRUCTURAL REPAIR OF CONCRETE DEPTH ( 5") AND CRACKS SHALL BE SEALED (ESTIMATED 20' EPOXY CRACK INJECTION) IF FOUND. CONCRETE SEALER SHALL BE APPLIED TO STRUCTURAL REPAIR OF CONCRETE AREAS. ℚ Roadway 1'-6" 1'-6" Level Level <sub>F</sub> Exist. brg. seat

NOTE: ABUTMENT CRACK REPAIR LENGTHS AND STRUCTURAL REPAIR OF CONCRETE AREAS ARE ESTIMATED FROM 12-18-07 SURVEY WORK. ACTUAL LOCATIONS AND QUANTITIES OF REPAIRS SHALL BE SHOWN BY THE ENGINEER ON THE AS-BUILT PLANS FOR THIS SECTION.
