Asbestos Abatement Survey

Job Order No.: R-90-001-21

Parcel No.: 0N30006

6435 S. Old Harlem Avenue

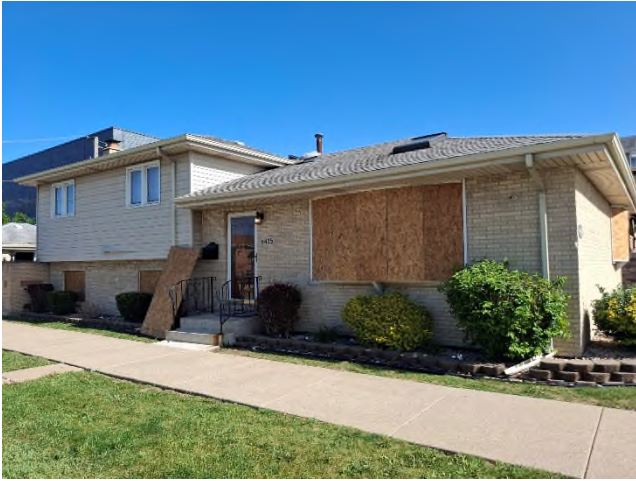
Exterior of Building – Front

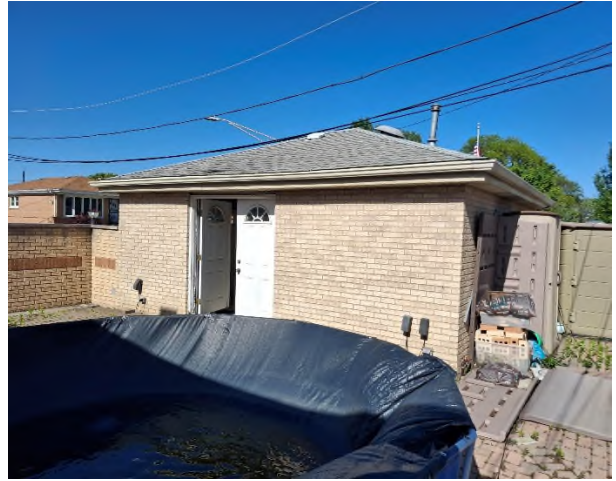
Exterior of Garage

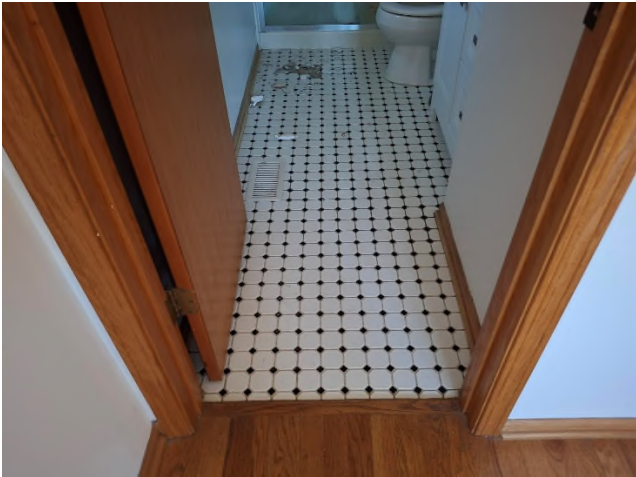
HA-1: 2" x 2" White and Black Ceramic Floor Tile

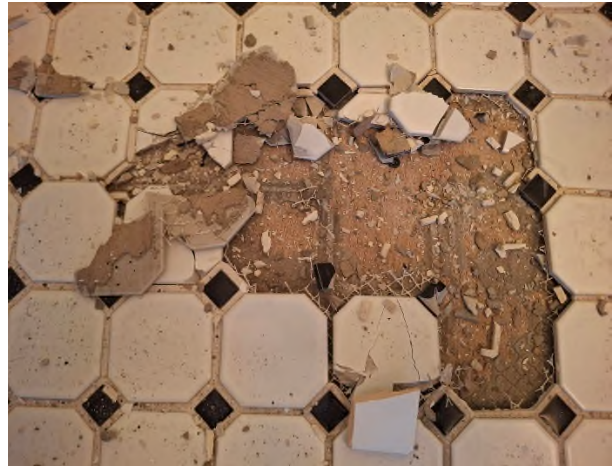
**HA-2: White Grout for HA-1
HA-3: Gray Adhesive for HA-1**

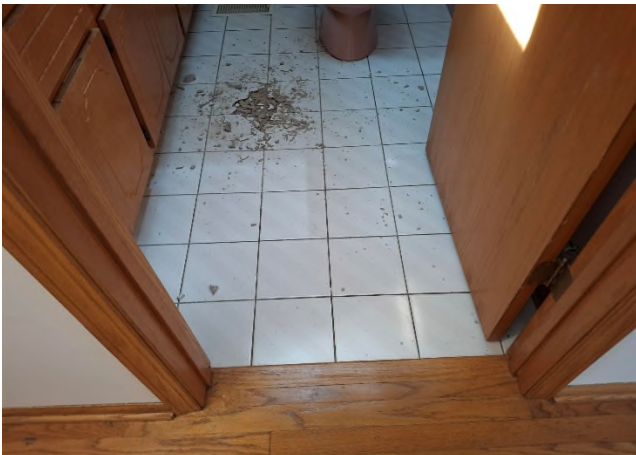
HA-4: White 9" x 9" Ceramic Floor Tile

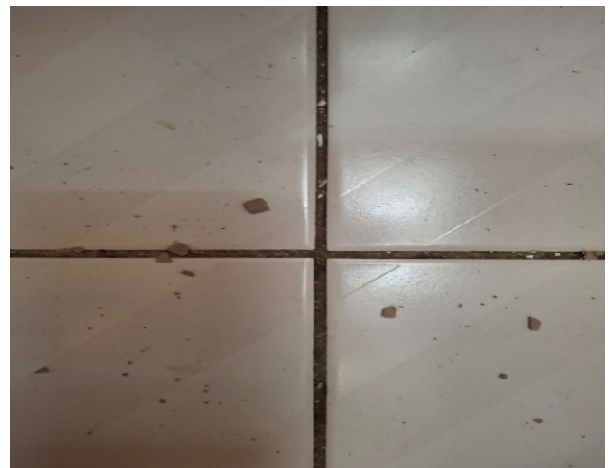
HA-5: Gray Grout for HA-4

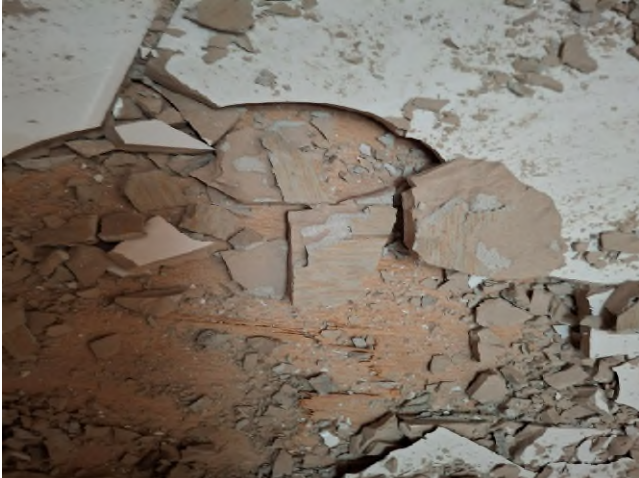
HA-6: Gray Adhesive for HA-4

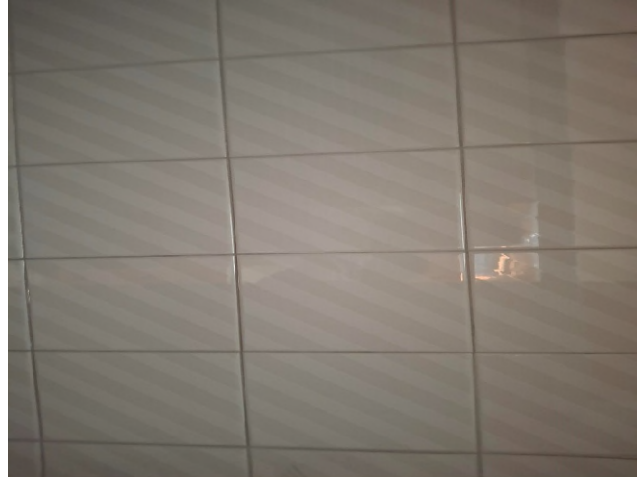
HA-7: Gray 6" x 9" Ceramic Wall Tile

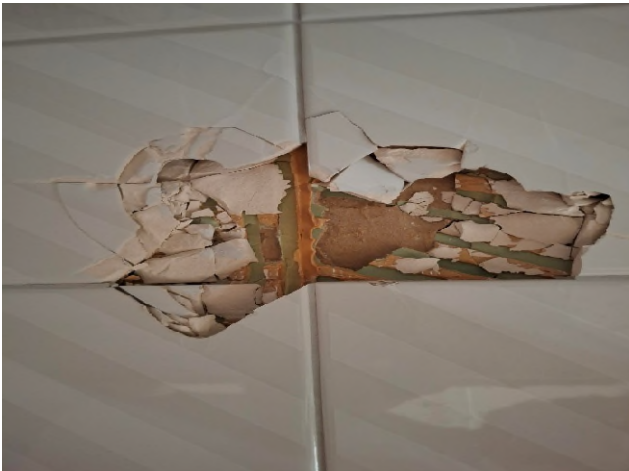
**HA-8: Gray Grout for HA-7
HA-9: Gold Adhesive for HA-7**

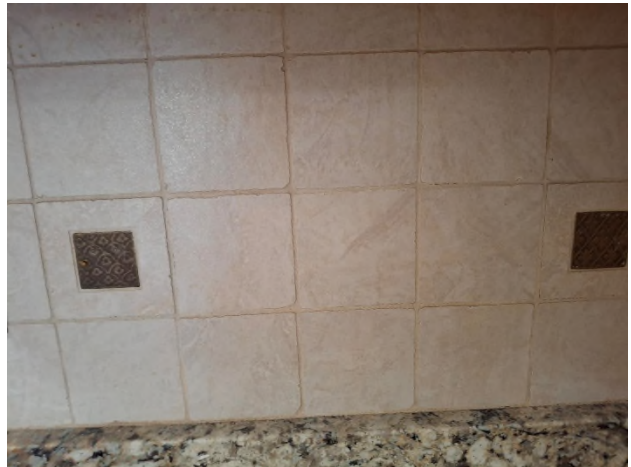
HA-10: 3" x 3" Ceramic Wall Tile

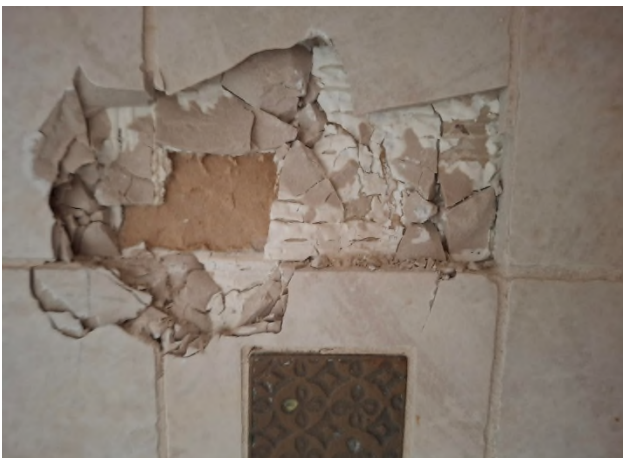
**HA-11: Beige Grout for HA-10
HA-12: White Adhesive for HA-10**

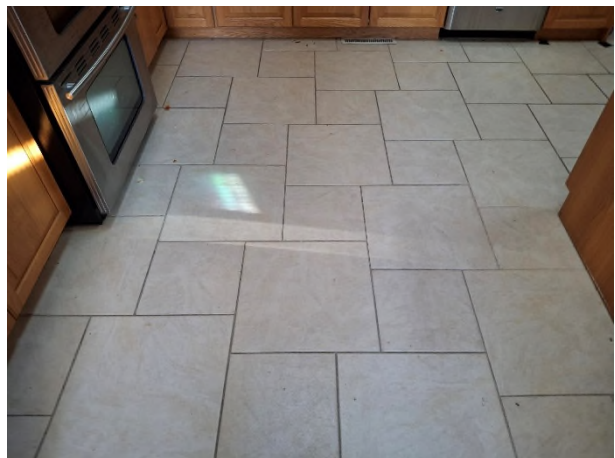
HA-13: White 12" x 12" and 16" x 16" Ceramic Floor Tile

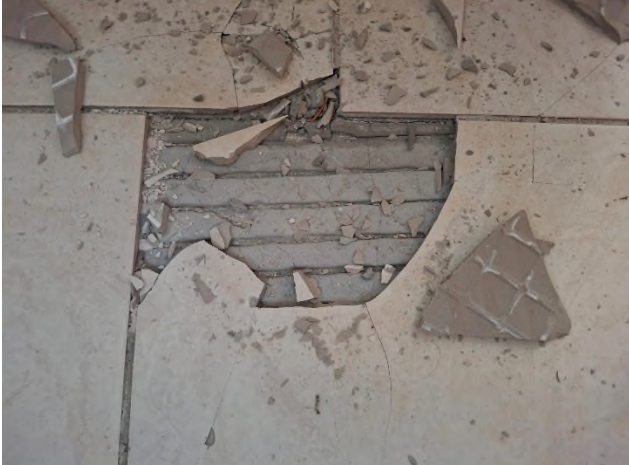
**HA-14: Gray Grout for HA-13
HA-15: Gray Adhesive for HA-13**

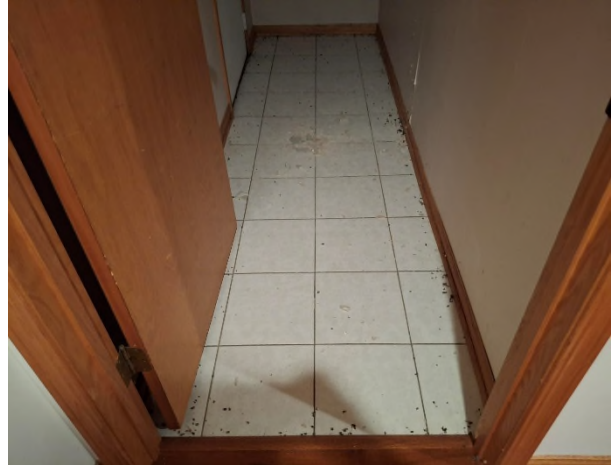
HA-16: White 12" x 12" Ceramic Floor Tile

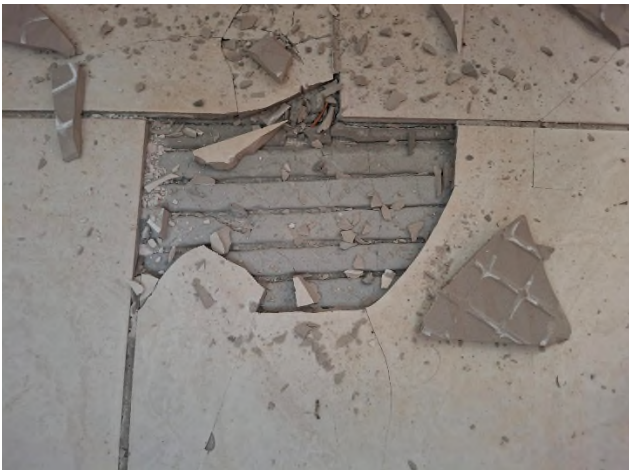
**HA-14: Gray Grout for HA-13
HA-15: Gray Adhesive for HA-13**

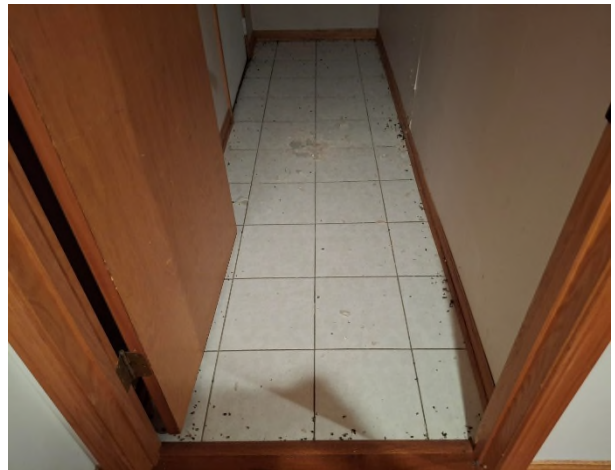
HA-16: White 12" x 12" Ceramic Floor Tile

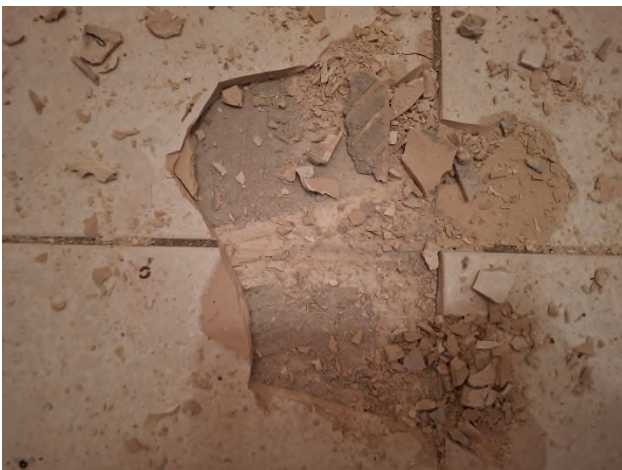
**HA-17: Gray Grout for HA-16
HA-18: White Adhesive for HA-16**

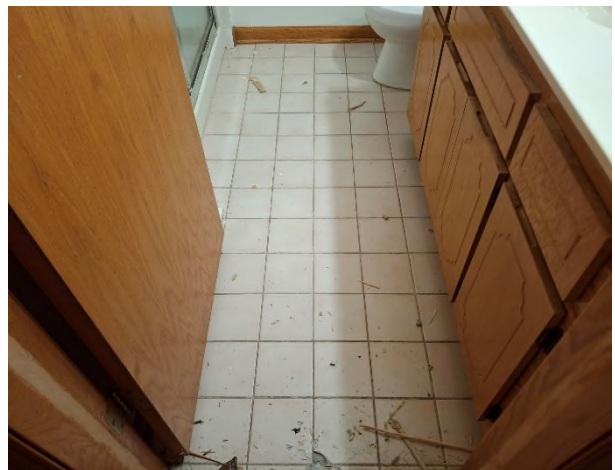
HA-19: Beige 6" x 6" Ceramic Floor Tile

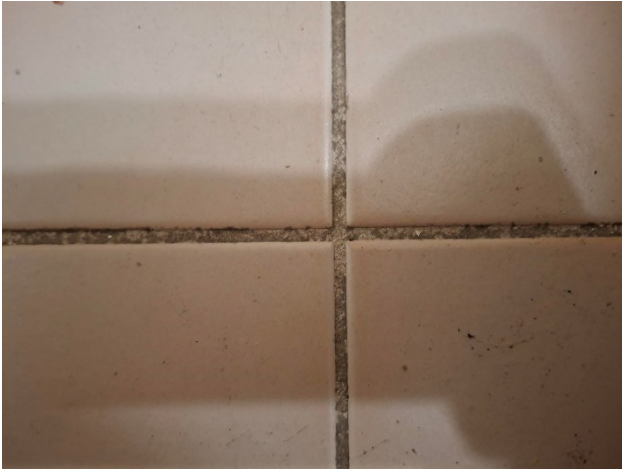
HA-20: Gray Grout for HA-19

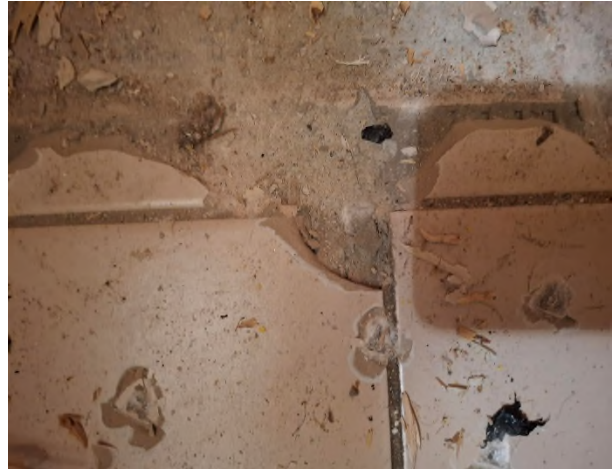
HA-21: Gray Adhesive for HA-19

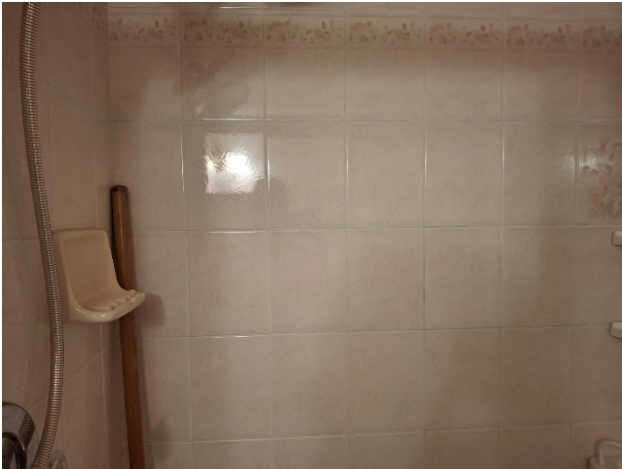
HA-22: 6" x 9" Ceramic Wall Tile

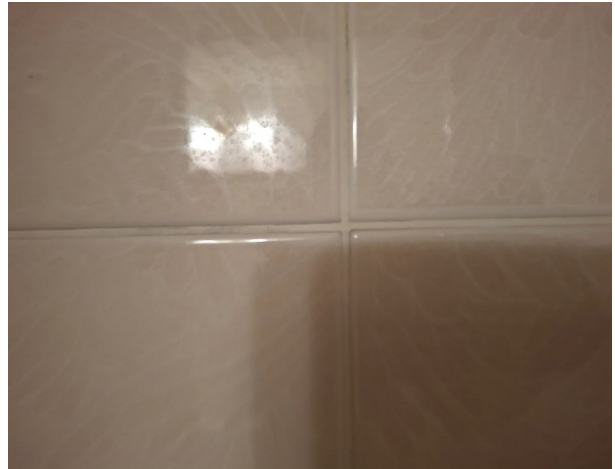
HA-23: White Grout for HA-22

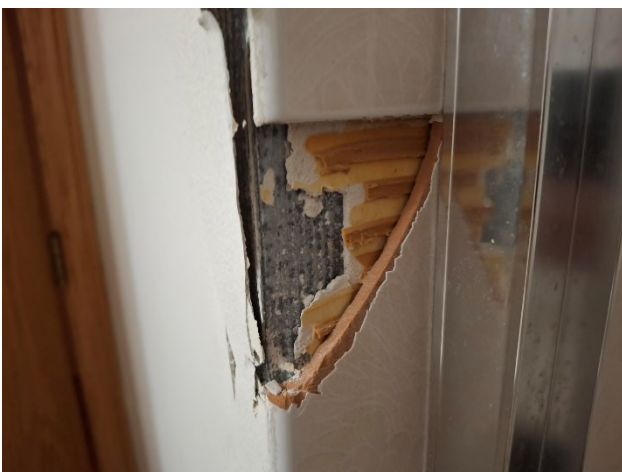
HA-24: Gold Adhesive for HA-22

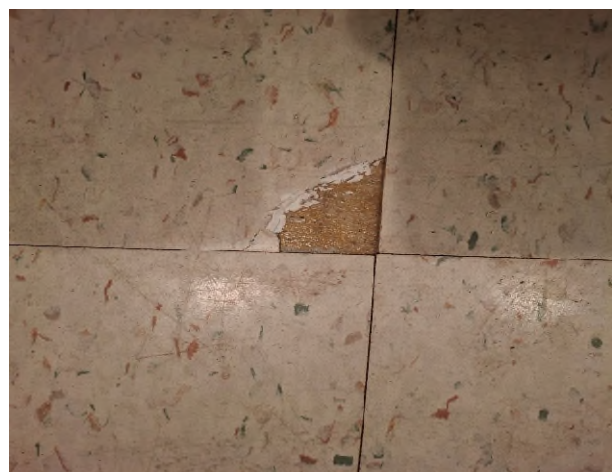
HA-25: White 12" x 12" Vinyl Floor Tile
HA-26: Gold Adhesive for HA-25

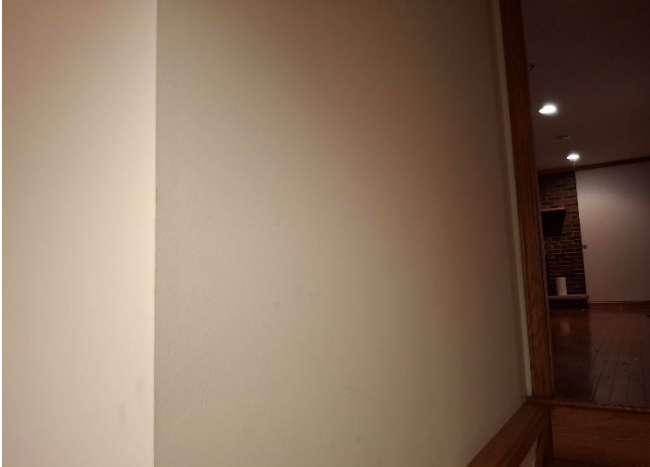
HA-27: Gypsum Board

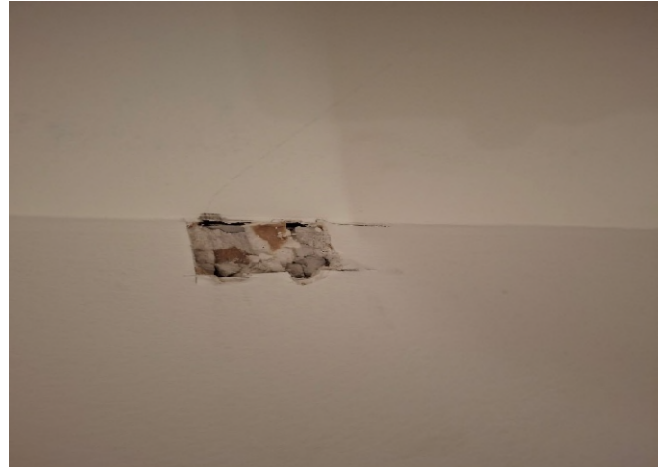
HA-28: Joint Compound

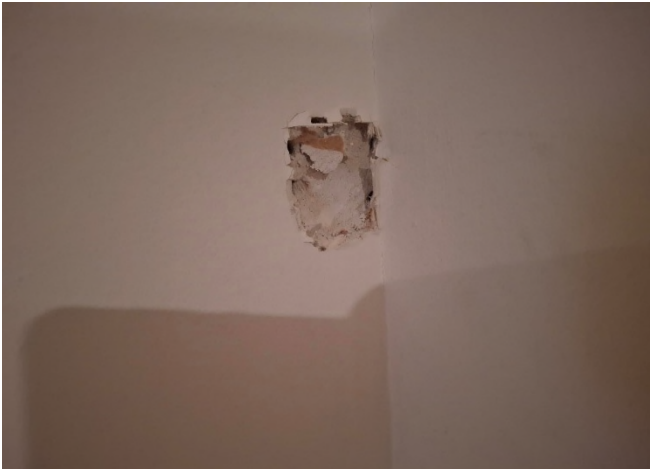
HA-29: Tape associated with HA-27

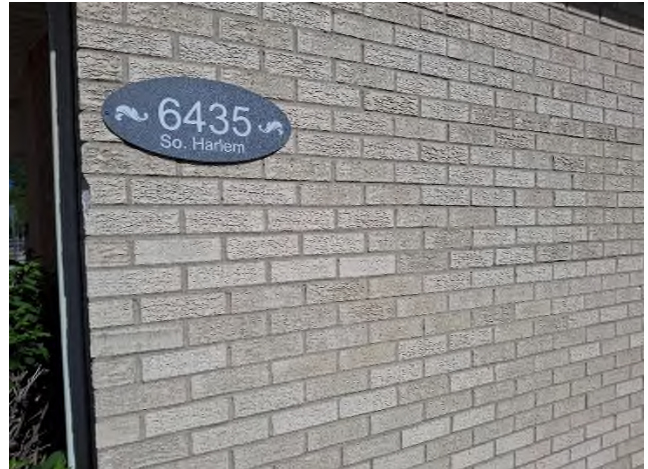
HA-30: Beige Brick
HA-31: Gray Brick Mortar

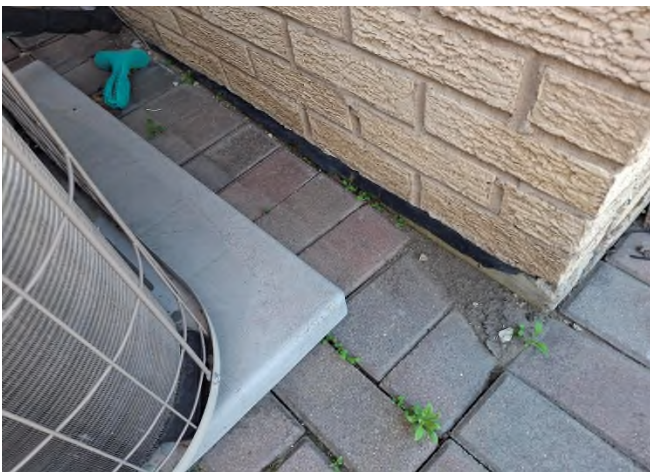
HA-32: Black Vapor Barrier

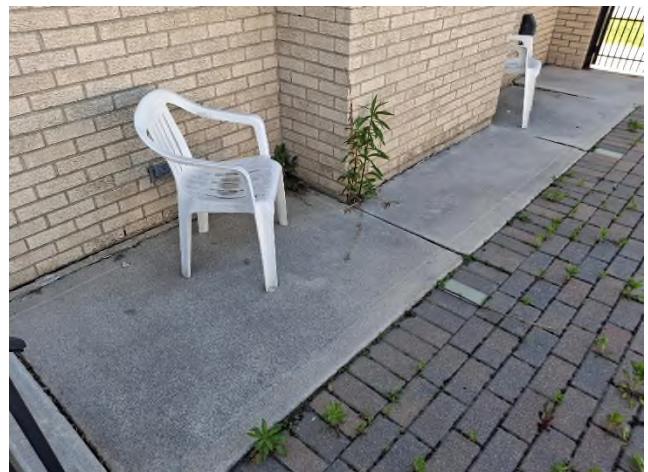
HA-33: Gray Concrete Foundation

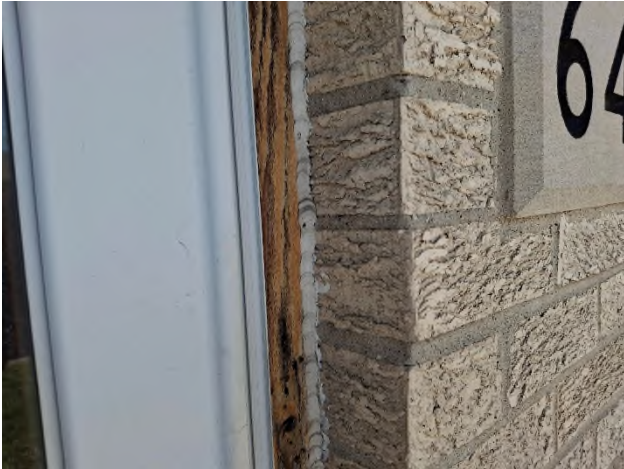
HA-34: White Door and Window Frame Caulk

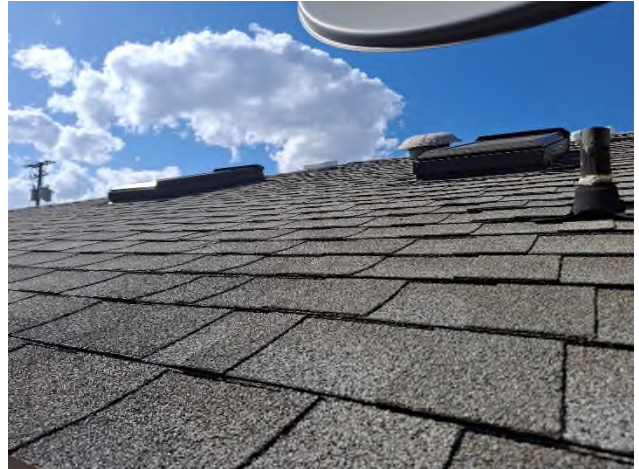
HA-35: Black Asphalt Shingle

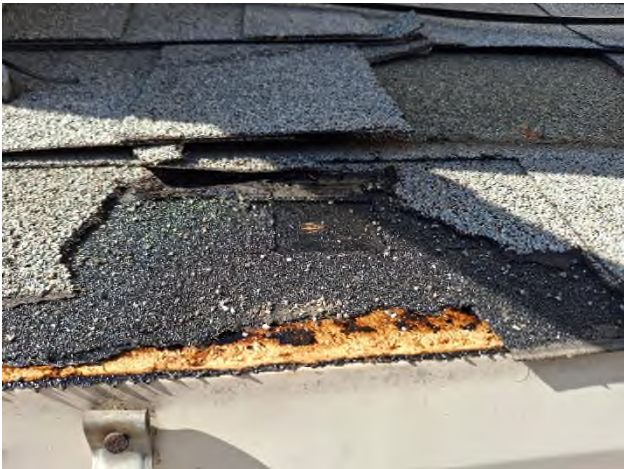
HA-36: Tar Paper Layer under HA-35

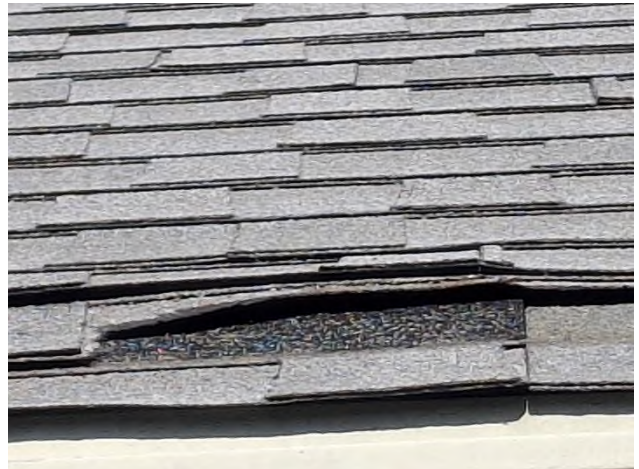
HA-37: Black Asphalt Shingle (Garage)
HA-38: Tar Paper Layer under HA-37 (Garage)

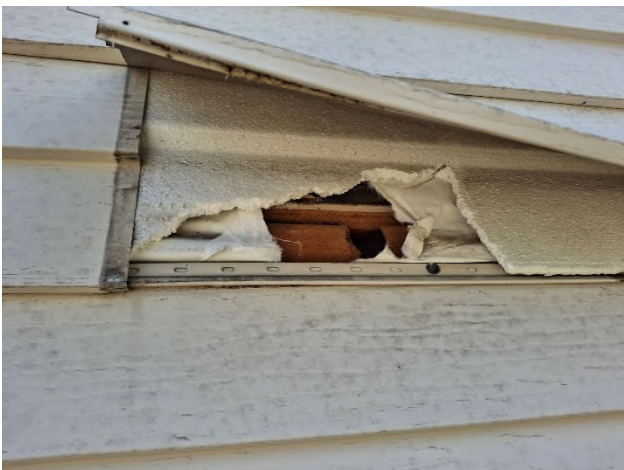
HA-39: White Vapor Barrier beneath Vinyl Siding

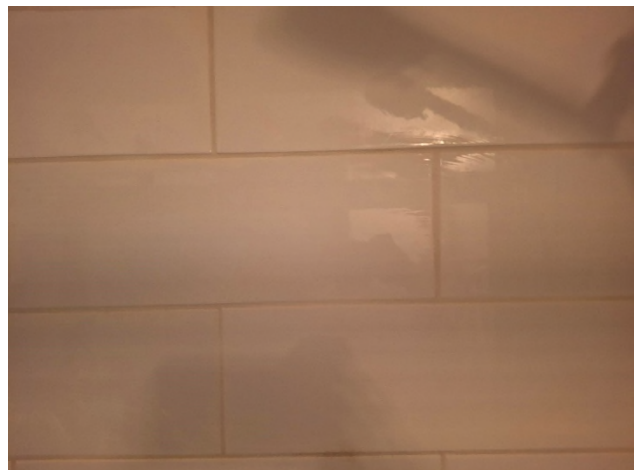
HA-40: 16" x 4" Ceramic Wall Tile

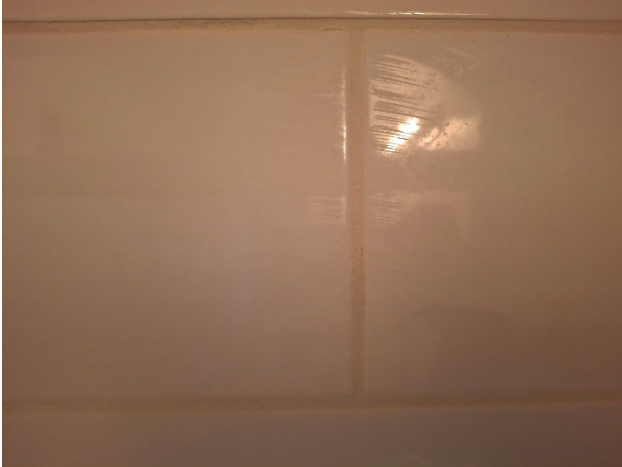
HA-41: White Grout for HA-40

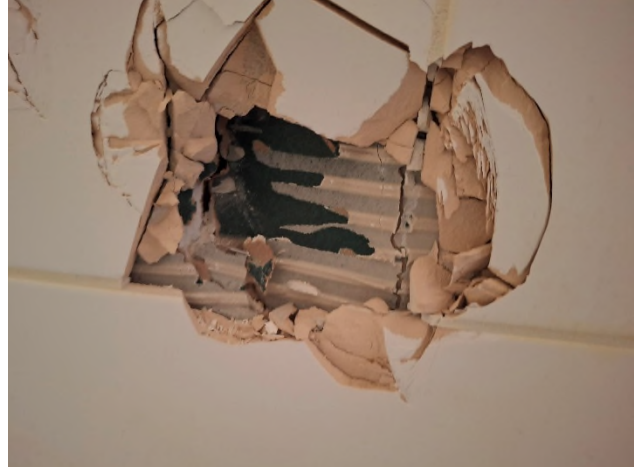
HA-42: Gray Adhesive for HA-40

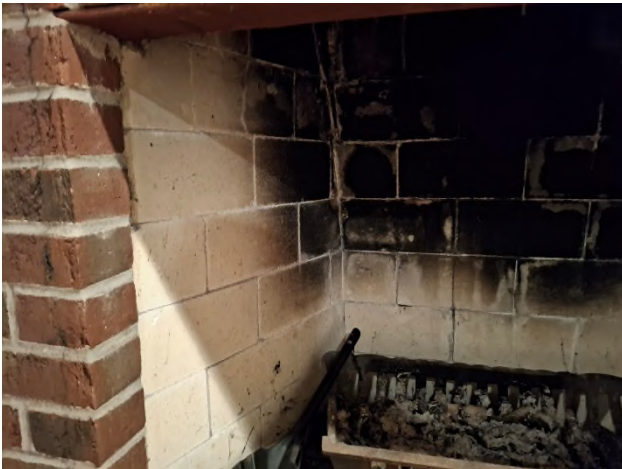
HA-43: Beige Fire Brick

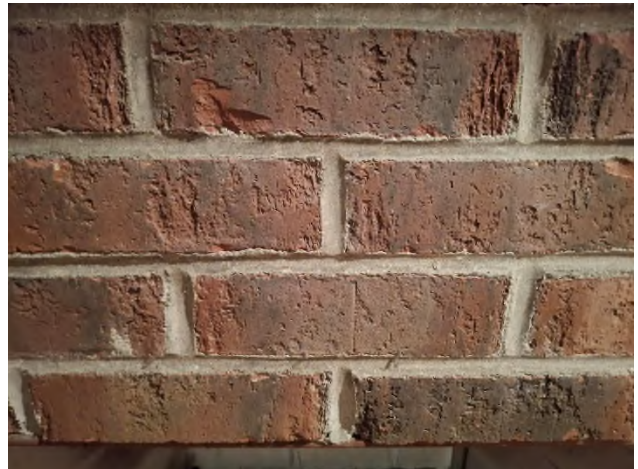
**HA-44: Red Fireplace Brick
HA-45: Gray Mortar for HA-44**

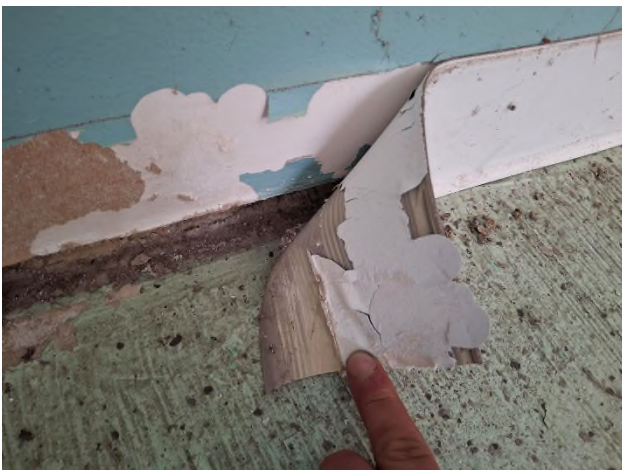
**HA-46: White Vinyl Base Board
HA-47: Beige Mastic for HA-46**

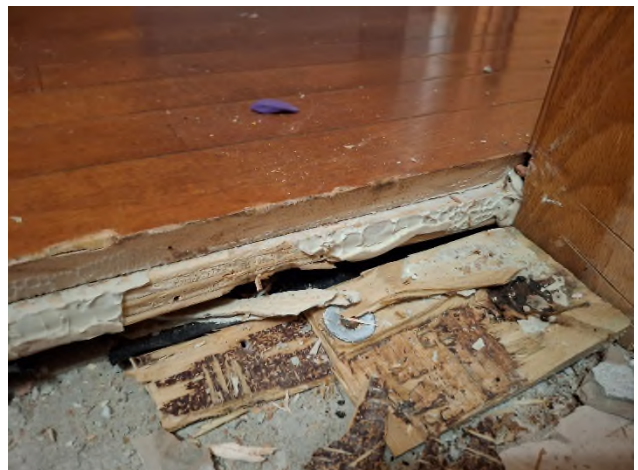
HA-48: Beige Sealant under Hardwood Floor

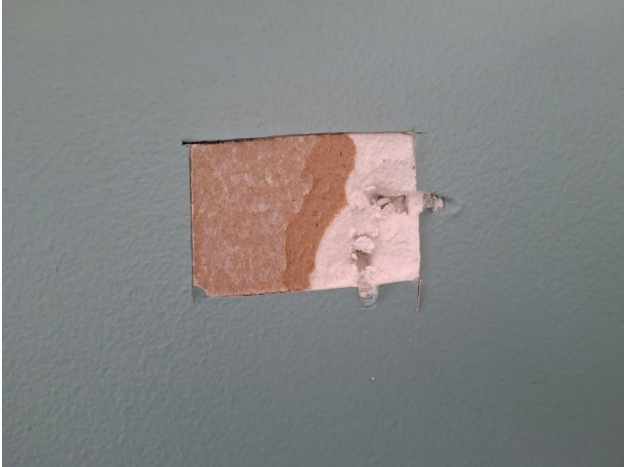
HA-49: White Gypsum Board (Garage)
