Illinois Department of Transportation

Asbestos Abatement Survey

Parcel No.: 0N30007

6449 S. Old Harlem Avenue

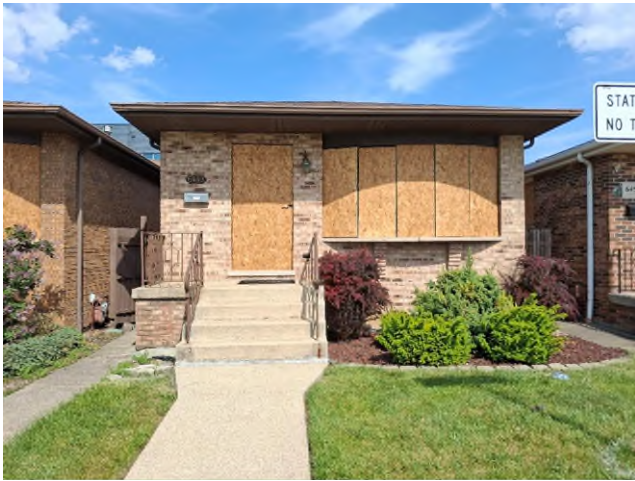
Exterior of Building – Front

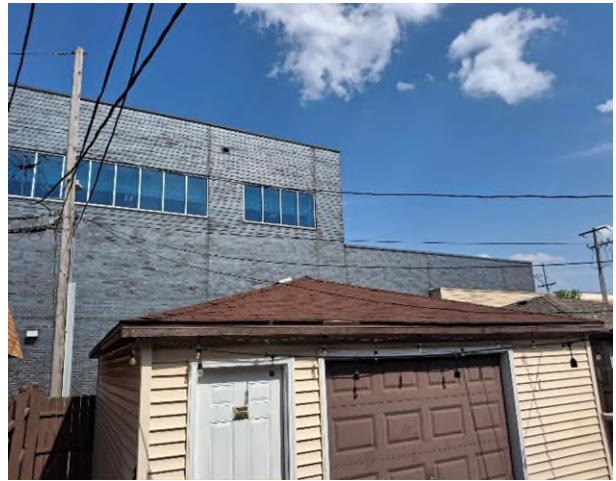
Exterior of Garage

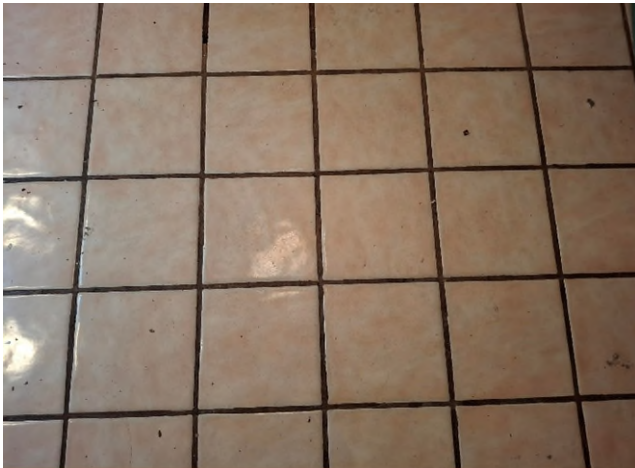
HA-1: 12" x 12" Beige Ceramic Floor Tile

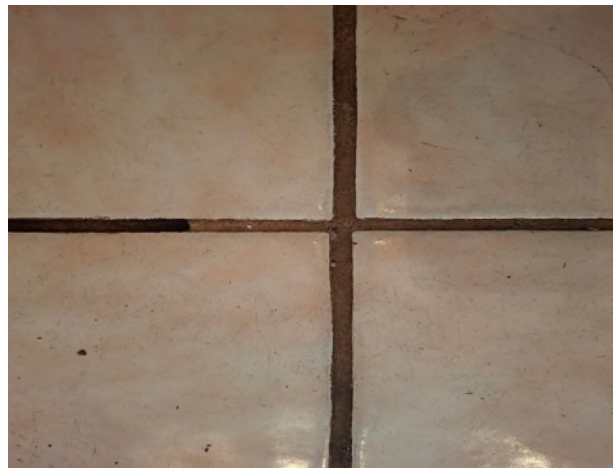
HA-2: Gray Grout associated with HA-1

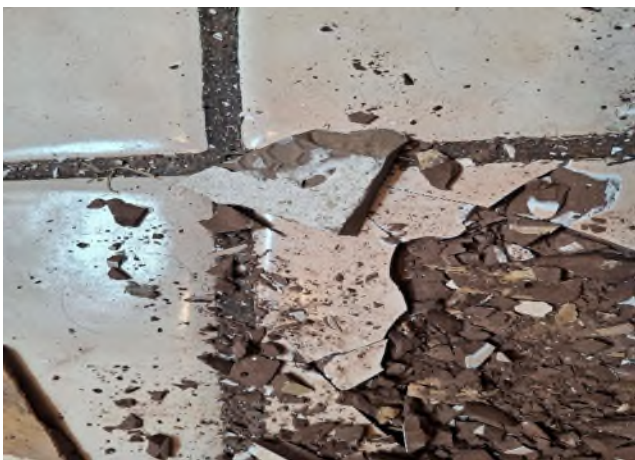
HA-3: Gray Adhesive associated with HA-1

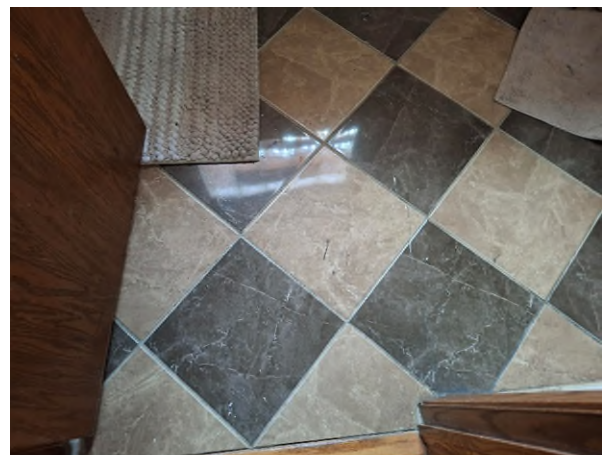
HA-4: Beige and Brown 12" x 12" Ceramic Floor Tile

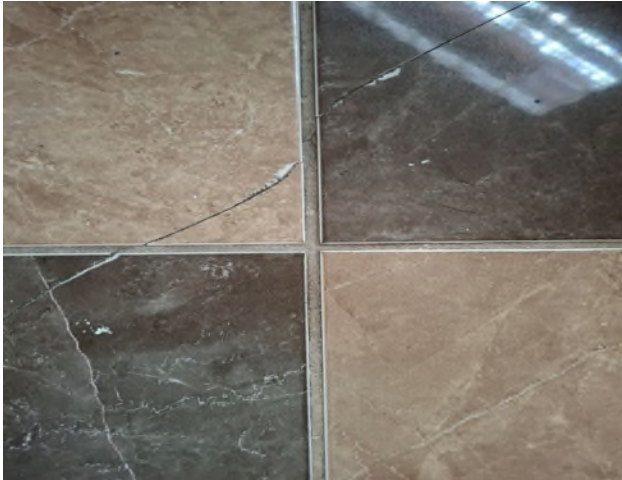
HA-5: Gray Grout associated with HA-4

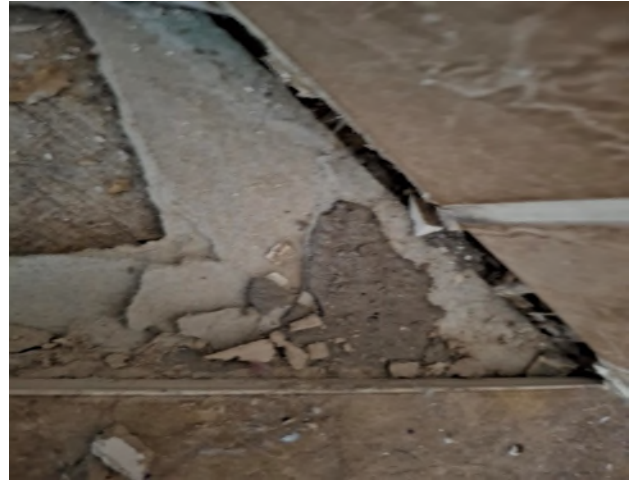
HA-6: Dark Gray Adhesive associated with HA-4

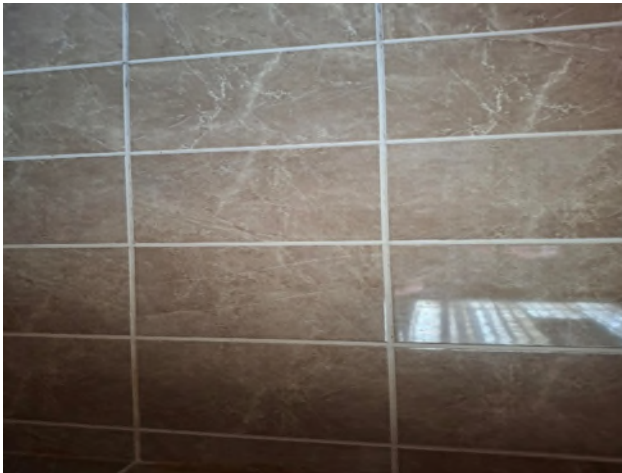
HA-7: Beige 12" x 6" Ceramic Wall Tile

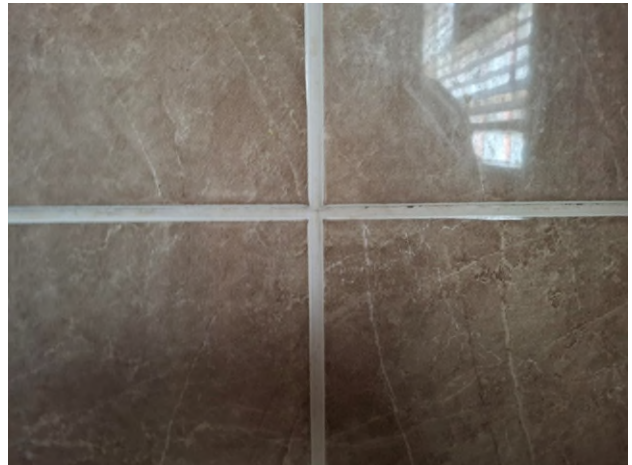
HA-8: White Grout associated with HA-7

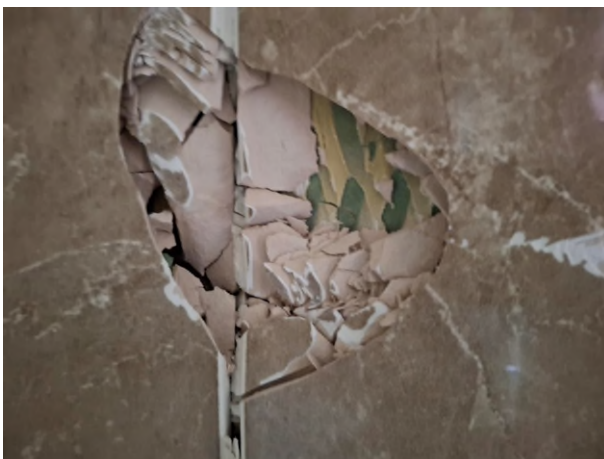
HA-9: Beige Adhesive associated with HA-7

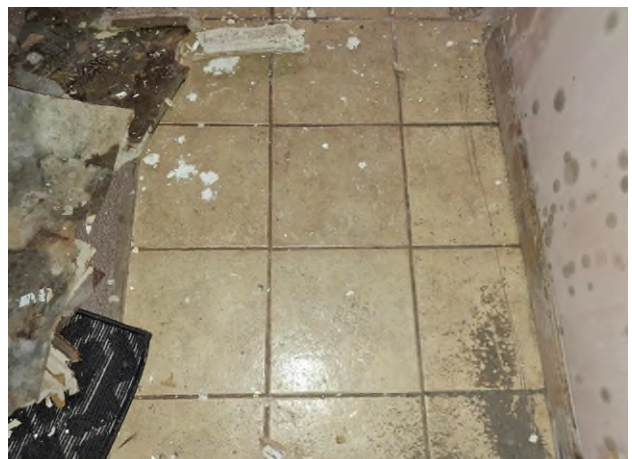
HA-10: Brown 12" x 12" Ceramic Floor Tile

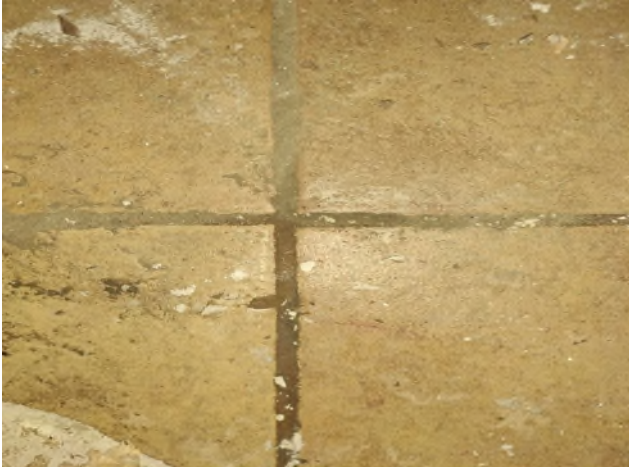
HA-11: Brown Grout associated with HA-10

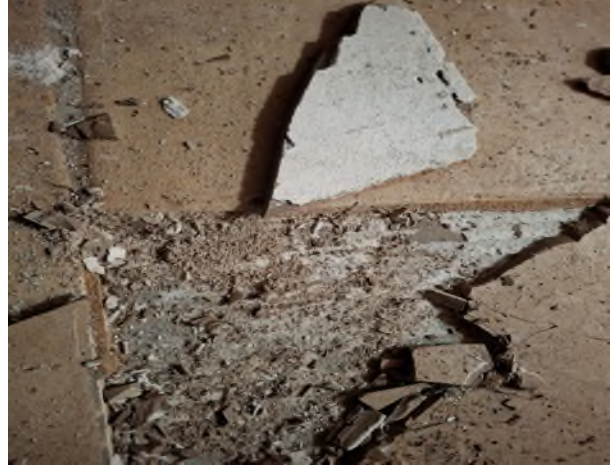
HA-12: Gray Adhesive associated with HA-10

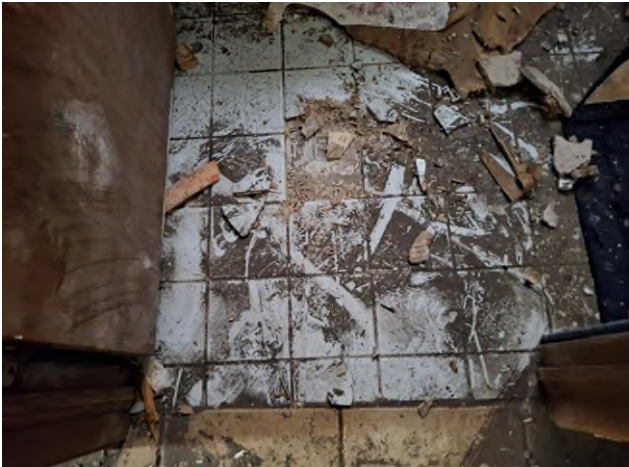
HA-13: White 6" x 6" Ceramic Floor Tile

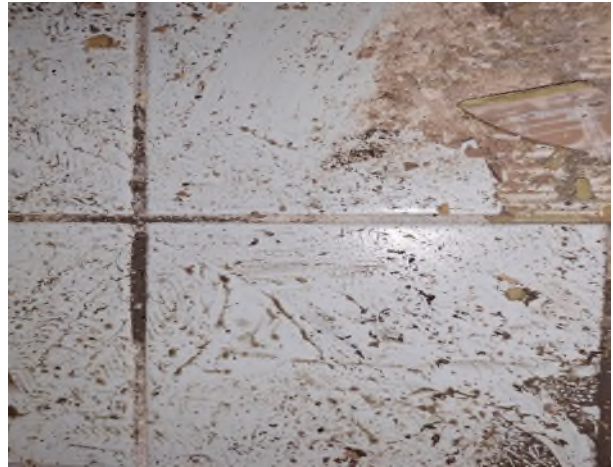
HA-14: Gray Grout associated with HA-13

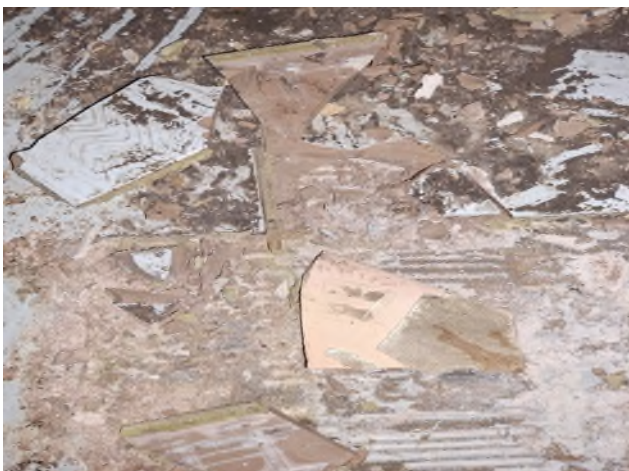
HA-15: White Adhesive associated with HA-16

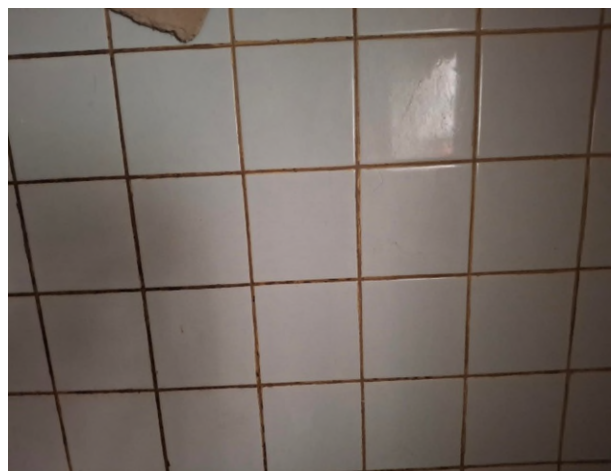
HA-16: White 6" x 6" Ceramic Wall Tile

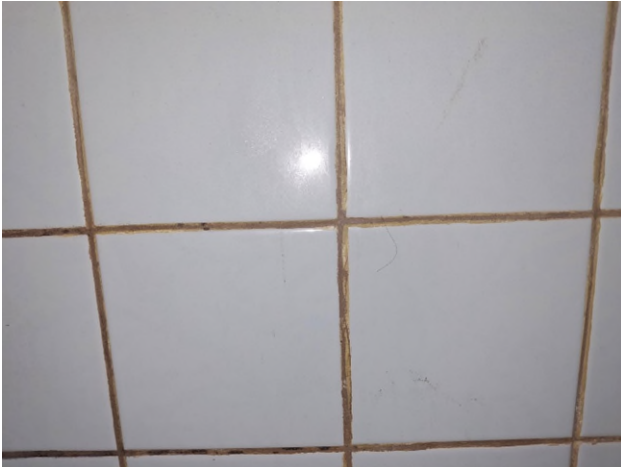
HA-17: Gray Grout associated with HA-16

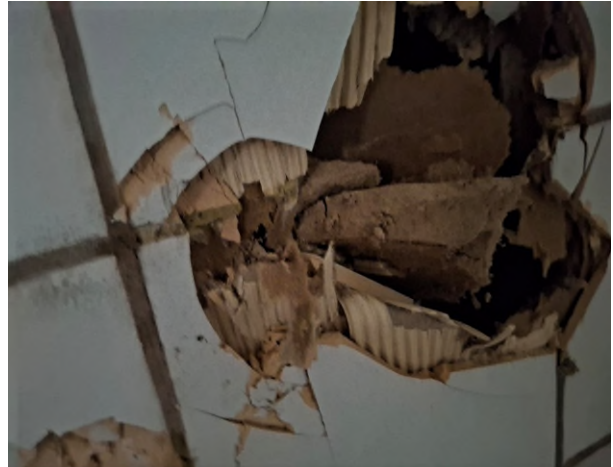
HA-18: Beige Adhesive associated with HA-16

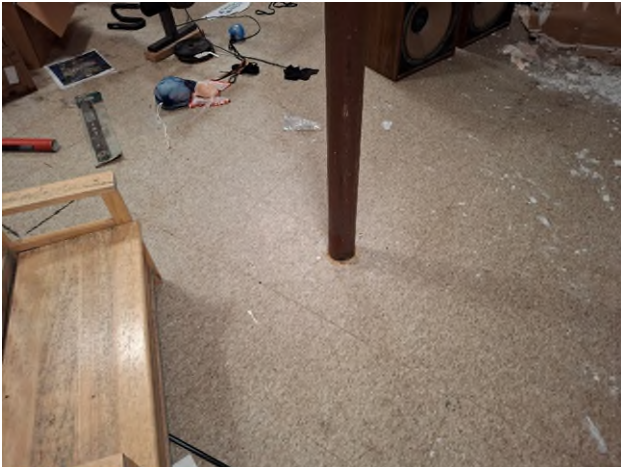
HA-19: Beige 12" x 12" Vinyl Floor Tile

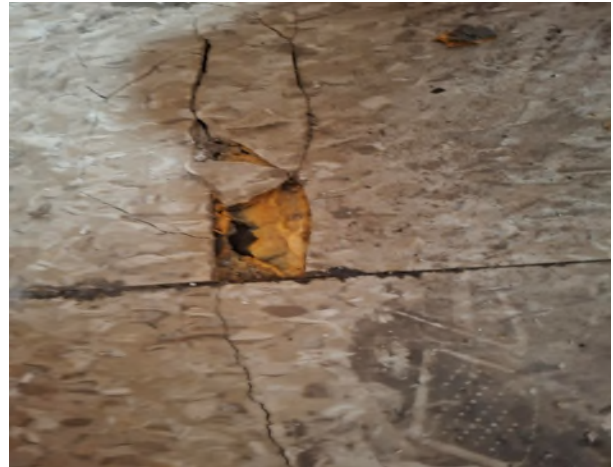
HA-20: Gold Adhesive associated with HA-19

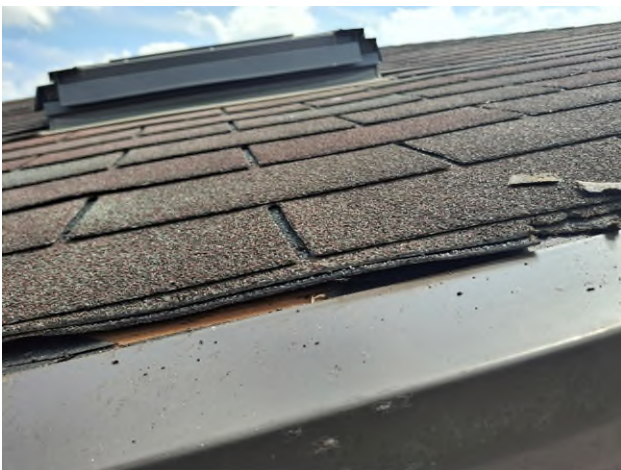
HA-21: Brown and Black Asphalt Shingles

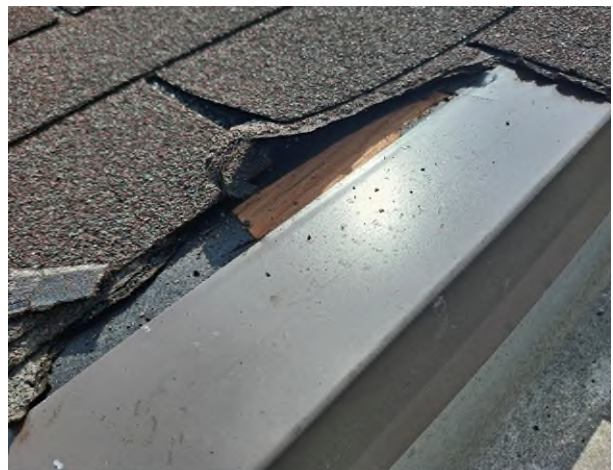
HA-22: Black Tar Paper associated with HA-21

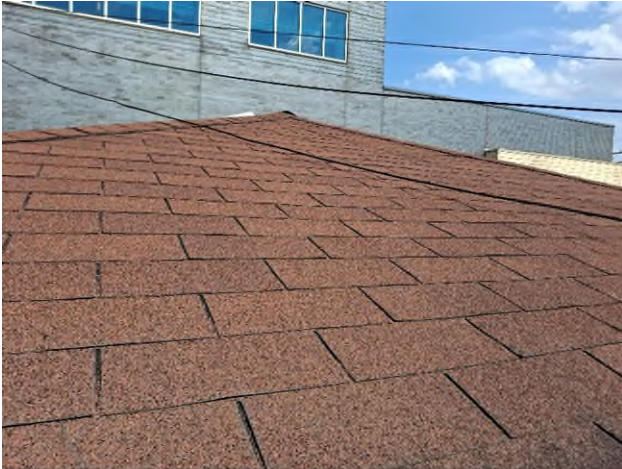
HA-23: Red and Black Asphalt Shingles

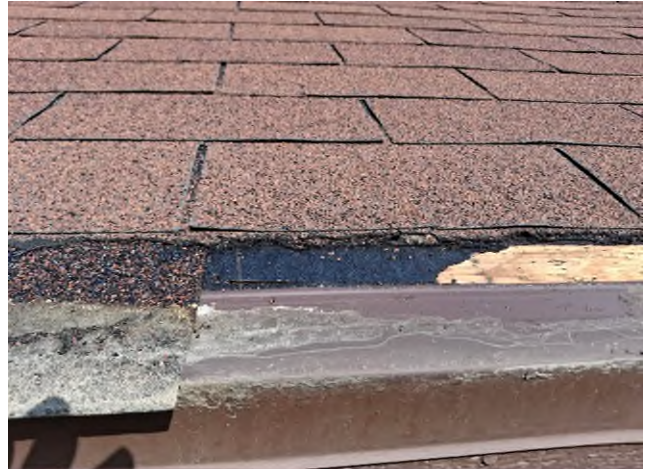
HA-24: Black Tar Paper associated with HA-23

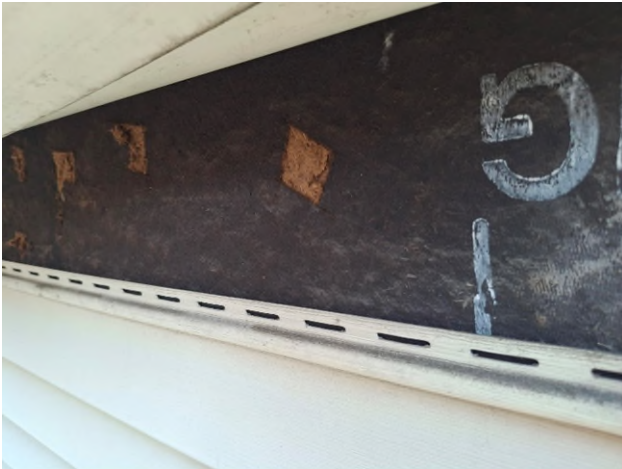
HA-25: Brown Fiberboard under Vinyl Siding

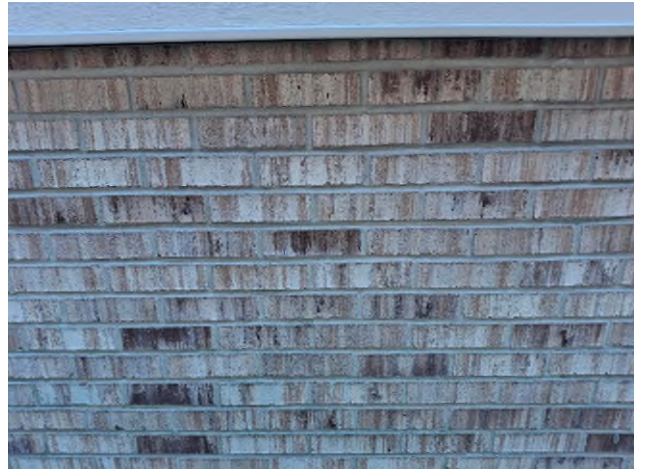
HA-26: Red Brick

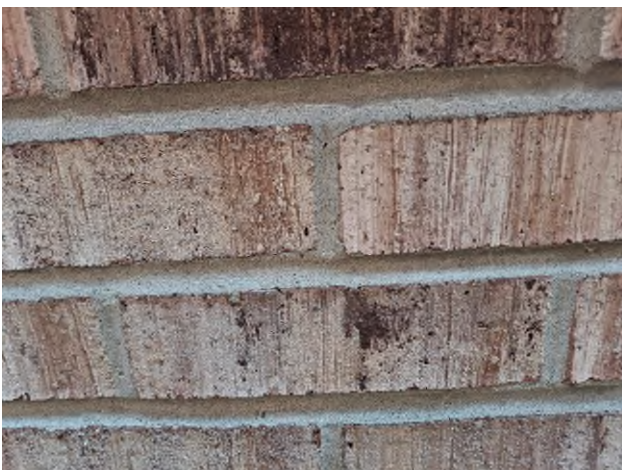
HA-27: Gray Mortar associated with HA-26

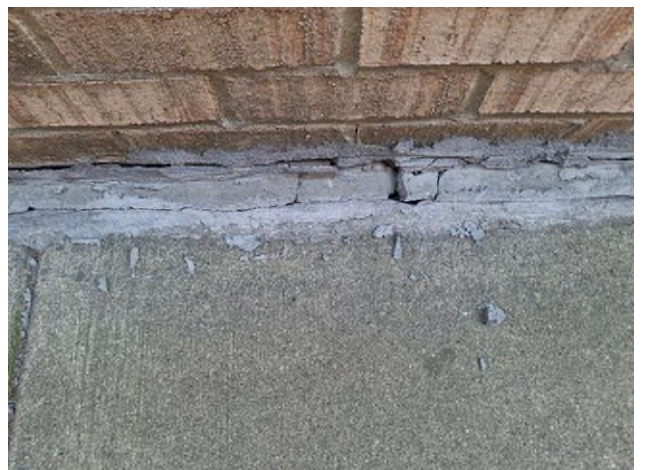
HA-28: Gray Cement Sealant at Base of House

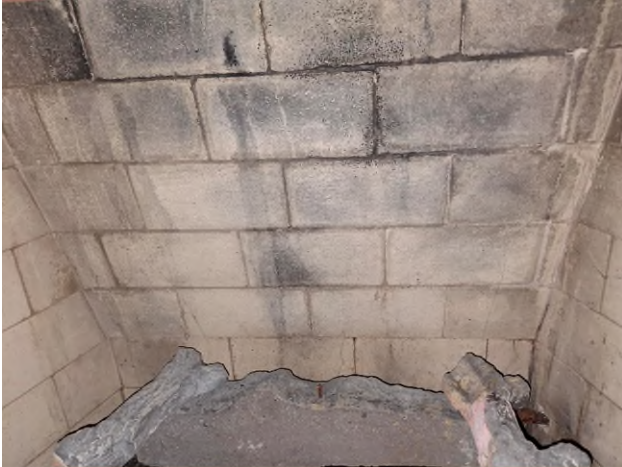
HA-29: Beige Fire Brick

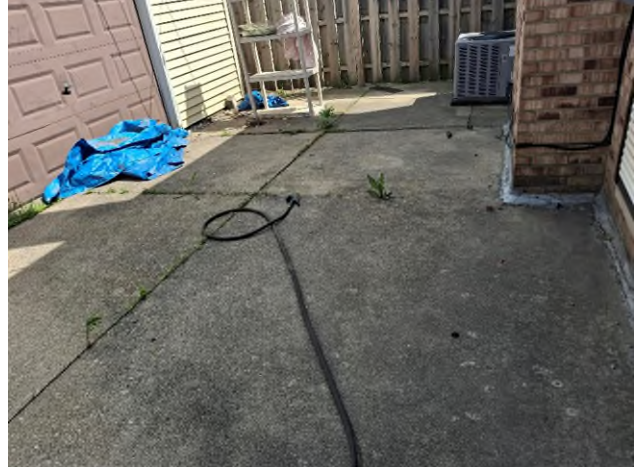
HA-30: Gray Concrete Foundation

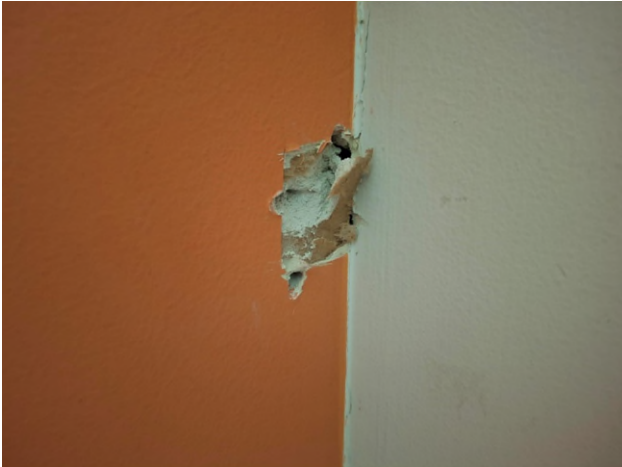
HA-31: Gypsum Board

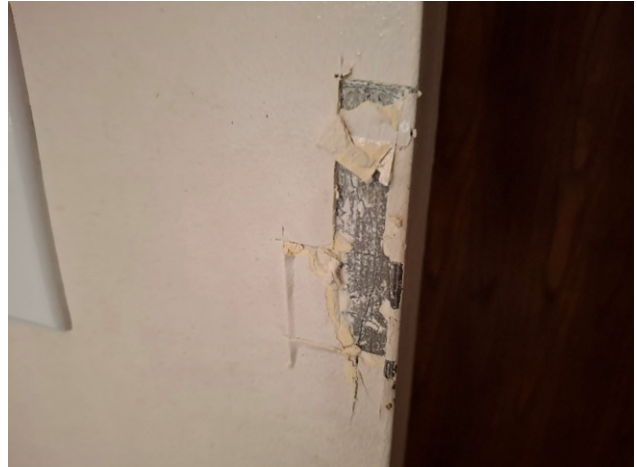
HA-32: Joint Compound

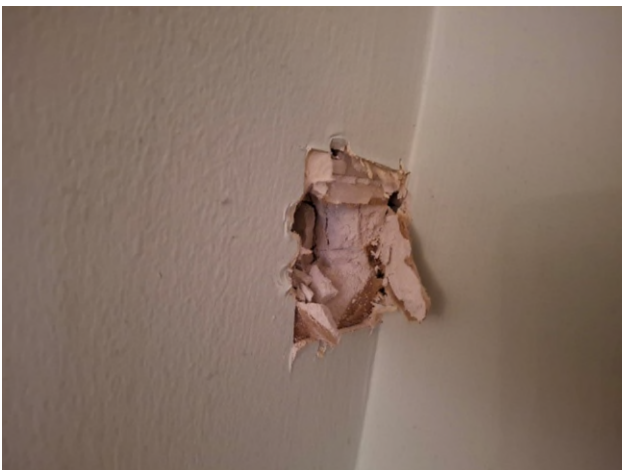
HA-33: Tape associated with HA-31

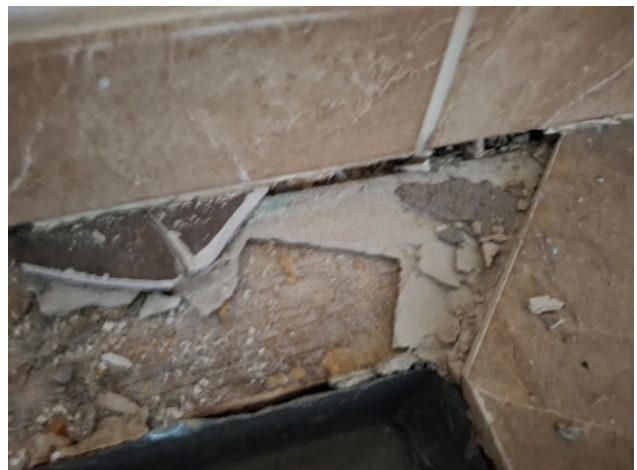
HA-34: Gray Floor Leveler beneath HA-4
