**SN 064-0035
I-24 BRIDGE
Over Ohio River
Metropolis, IL**

2023 Bridge Inspection Report

Bridge Inspection By: Collins Engineers, Inc. and WHKS & Co.

Bridge Inspection Report By: WHKS & Co.

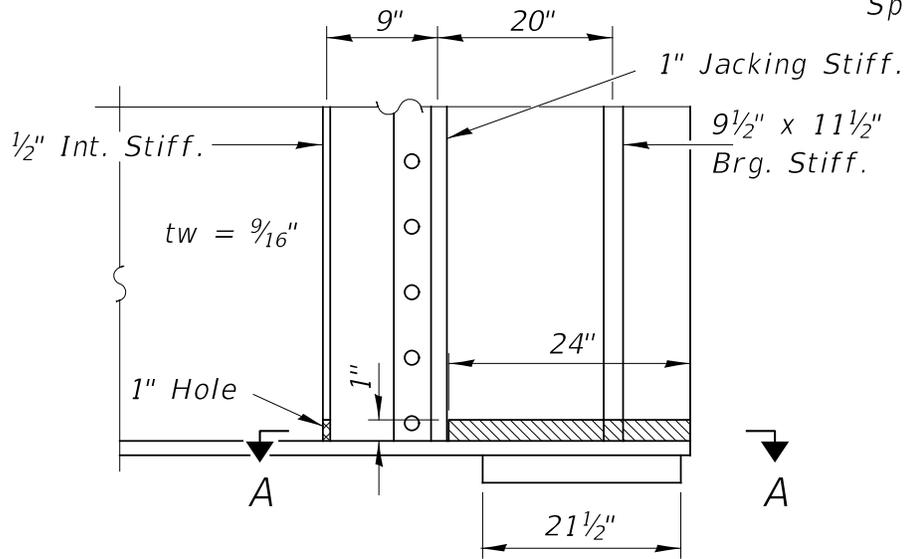
SN 064-0035
 District 9
 Insp Date: 3/6/2023
 Item #125
 Detail 1
 Span 1, W Girder

93A2-Remarks: Hoan repairs were finished in 2004. 13% Section Loss (Web Bearing - Item 125) IRF = 1.43.

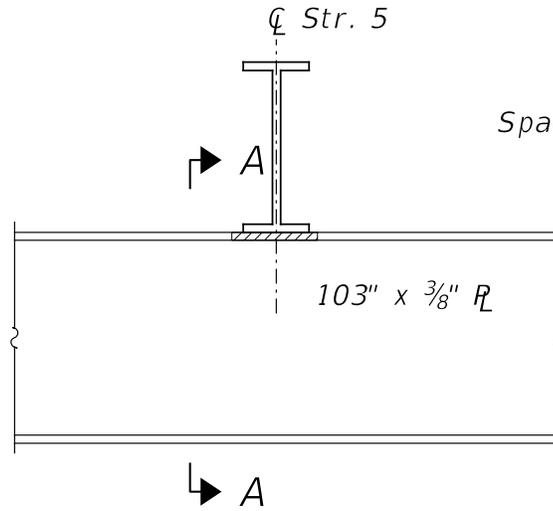
SN 064-0035
 District 9
 Insp Date: 3/6/2023
 Item #223
 Detail 11
 Span 13, Floorbeam 146
 at Stringer 5

223	13	Floorbeam 146	East of Stringer 5, under bearing plate	140 LSW	17% SL in Top Flange, (See Detail 11)	Repair 17% SL, Top Flange IRF=0.50	2019	
188	13	Stringer 5	@ Floorbeam 146, Panel 146	140 LSW	Bearing plate offset 3/4" due to pack rust	N/A	2017	
264	13	Stringer 6	@ Floorbeam 146, Panel 146	141 LSW	1 bolt w/ missing nut in Stringer to Floorbeam connection	Repair	2021	
303	13	East Arch	@ R4, Lower Chamber	238 LSW?	Full-length crack in weld between longitudinal stiffener and diaphragm plate.	N/A	2023	
304	13	East Arch	First stiffener from R4, Lower Chamber	239 LNE	Full-length crack in weld between longitudinal stiffener and vertical stiffener.	N/A	2023	
305	13	Stringer 6	@ Floorbeam 146, Panel 146	240 LN	1 broken bolt in Stringer to floorbeam connection	Repair	2023	
306	13	Stringer 4	@ Floorbeam 146, Panel 146	241 LNW	1 broken bolt in Stringer to floorbeam connection	Repair	2023

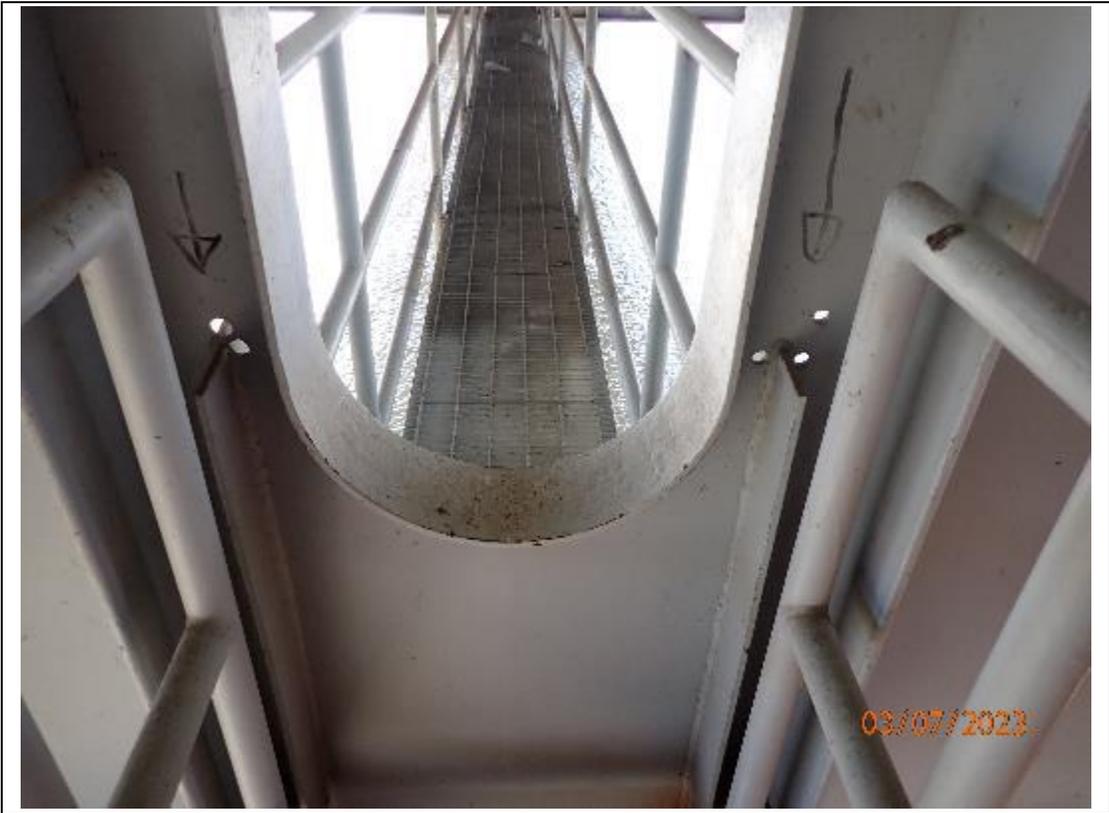
PHOTO 61

93A2-Remarks: Isolated areas with 26% section loss top flange, 22% section loss bottom flange at midspan (Item 208). 1" crack in Floorbeam 32 web near top flange at Stringer 4 (Item 179) has been arrested with 12-month Special Inspection implemented in 2021.

2 - 1" Crack arrestor holes drilled in web. No further crack propagation observed.

147	4	Floorbeam 31	@ midspan	59 LNW	1% SL, 2-5/8" misdrilled holes in Web, 1 in section	N/A	2015	
179	4	Floorbeam 32	@ midspan, East & West sides of catwalk & top. Flange	60 LS 61 LS	2 – 1" holes in web near top flange – crack arrestor holes, 3 – 1/2" holes (West side) & 2 – 1" holes (East side) in Web – all misdrilled holes	Monitor (2 Crack Arrestor Holes – 2023)	2017	
288	4	East Tie	3' south of T6 at splice	223 LNW	Missing lower cover plate	Repair	2023	
289	4	East Arch	4' North of R6, Lower Chamber, Inside Web	224 LNW	1 loose bolt/nut in horizontal splice plate	Repair	2023	
12	4	West Arch	@ R6, lower chamber, outside Web @ bottom plate	62 LS	1 1/2" crack in Web to hanger plate	N/A	1995

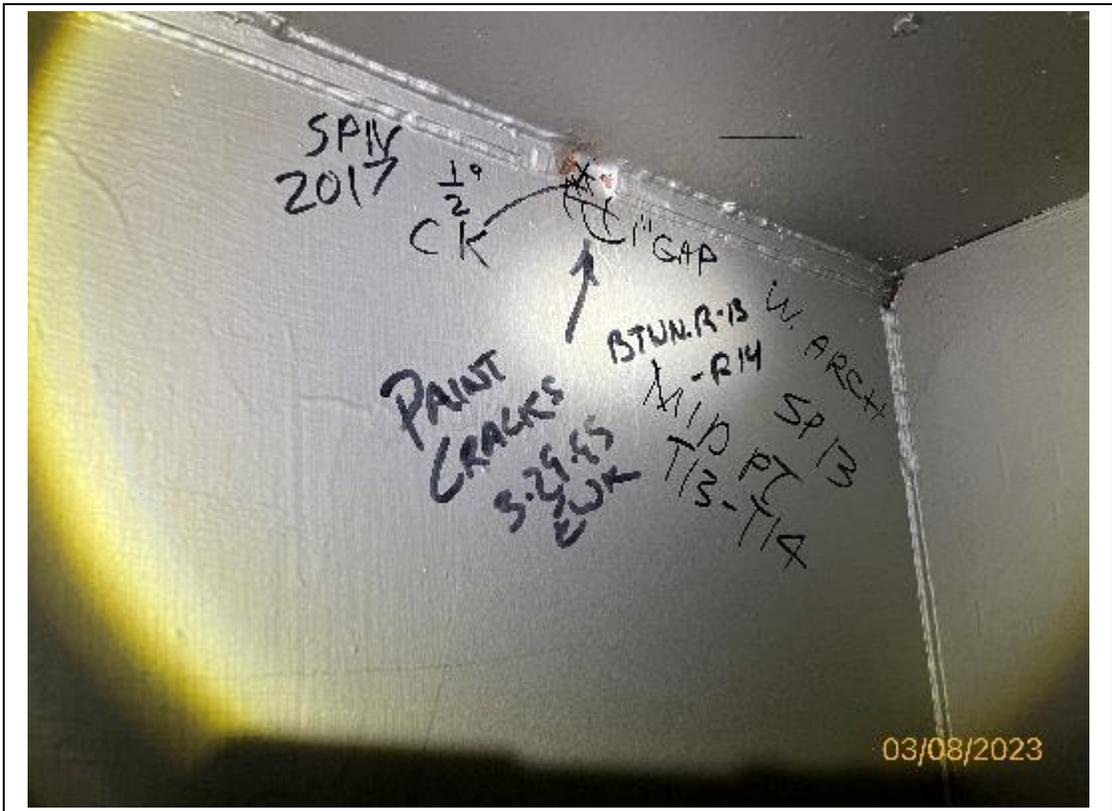
192	13	West Arch	Between R13 & R14 @ midpoint, upper chamber	177 LE	1" gap w/ 1/2" crack in weld between top plate & outside Web	N/A	2017	
311	13	West Arch	Between R13 and R14, Upper Chamber	246 LW	1 1/2" gap in weld between top plate and outside plate	N/A	2023	
312	13	East Arch	South of R13, past first vertical stiffener, Upper Chamber	247 LW	2" gap in weld between west web and top plate	N/A	2023	
47	13	East Arch	Between R13 & R14, 8' from R14, upper chamber	178 LNW	Broken weld between transverse stiffener & long. stiffener @ inside plate	N/A	1987	
48	13	East Arch	North Side of R14, upper chamber	179 LS	4" crack in weld between long. stiffener & diaphragm plate @ outside Web plate	N/A	1987	
271	13	West Tie	5' North of T15	180 LS	1/2" – 1" of water, bolts rusted	Repair (Water in 2023)	2021	
272	13	East Tie	@ T15	181 LSE	1" gap in weld between top plate & outside Web plate	Repair	2021	
313	13	East Tie	1' north of T15	248 LSE	4" gap in weld between east web & top plate	N/A	2023

PHOTO 176 (Photo mislabeled, weld is not repaired.)

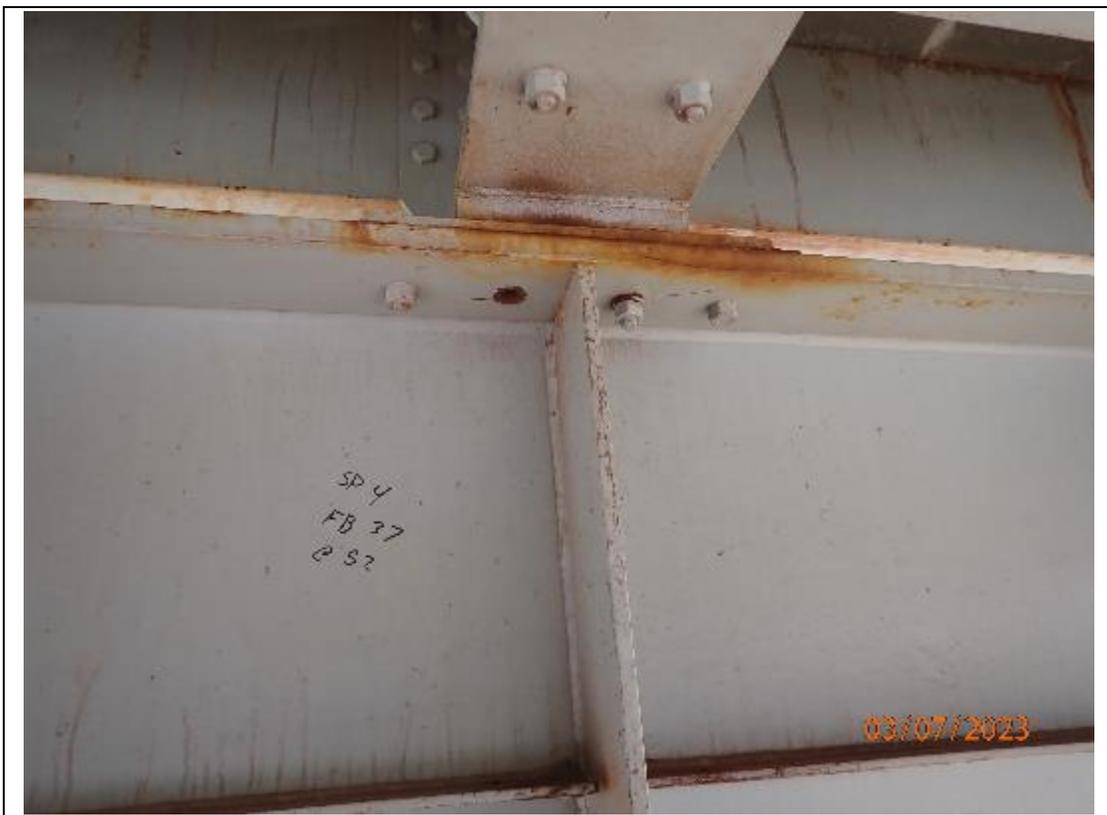
PHOTO 227

Item #	Span(s)	Member(s)	Location(s)	Photo(s)	Deficiency(ies)	Corrective Action	Year	Load Cap. Re-Eval.
292	4	East Tie	5' north of T11 at center opening	227 LN	Water intrusion. Source of intrusion appears to be from the access hatch.	Repair - remove water/corrosion and reseal access hatch	2023	
293	4	Stringer 2	@ Floorbeam 37, Panel 36	228 LS	1 missing bolt, 1 loose bolt	Repair	2023	
212	4	Floorbeam 37	@ Stringer 3, under bearing plate	75 LNE	4% SL in Top Flange, 1.08" avg. rem., 1 1/8" nom.	N/A	2019	
180	4	Stringer 3	@ Floorbeam 37, Panel 38	75 LN	1 broken bolt in Stringer to Floorbeam connection	Repair	2017	
213	4	Stringer 5	@ Floorbeam 37, Panel 38	76 LN	1 broken bolt in Stringer to Floorbeam connection	Repair	2019	
151	4	Stringer 6	@ Floorbeam 37, Panel 38	77 LN	2 broken bolts in Stringer to Floorbeam connection	Repair	2015	
128	4	West Arch	Between R11 & R12, upper chamber, inside Web	78 LS	2-1/2" cracked welds at top 1 st & 2 nd stiffener South of T11	N/A	2013
