RE: IL 53 Ramp Evaluation
IDOT Contract Number 62N91
IDOT Job Number D-91-144-21
Section 2018-100-BR
Cook County
District 1
PTB 203-021
Gonzalez Job No. 23-1003

SUBJECT: TECHNICAL MEMO

This memorandum was produced by Gonzalez Companies, LLC working as a sub-consultant to Strand Associates, Inc. and is part of a Phase II contract with the Illinois Department of Transportation (IDOT). The work is included as part of the IL 53 Bridge Rehabilitation Project from IL 62 (Algonquin Road) to Lake Cook Road. The results of the IL 53 ramp evaluation for Lake Cook Road and Dundee Road are presented herein.

Pavement Core Summary Table – PTB 203-021 62N91 IL 53 Supplement Coring in Cook County, IL
Core Photos Page 2 of 6

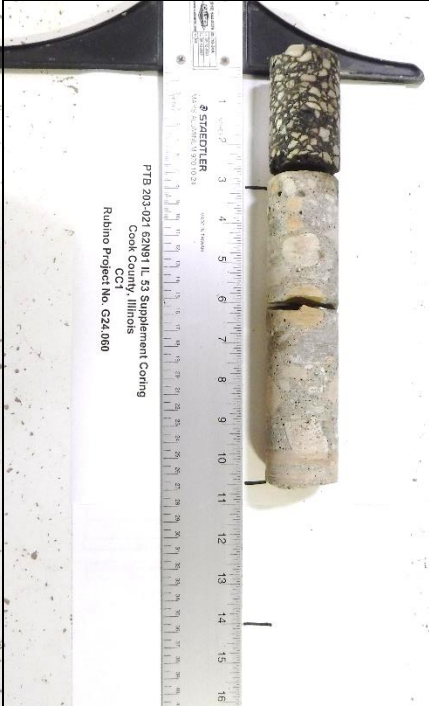
<u>Total Thickness = 10 ½ inches</u>

HMA Surface ₁ = 3 in.

Weathering & Deterioration

Broken Concrete = 7 ½ in.

Subbase Stone = 3 ½ inches

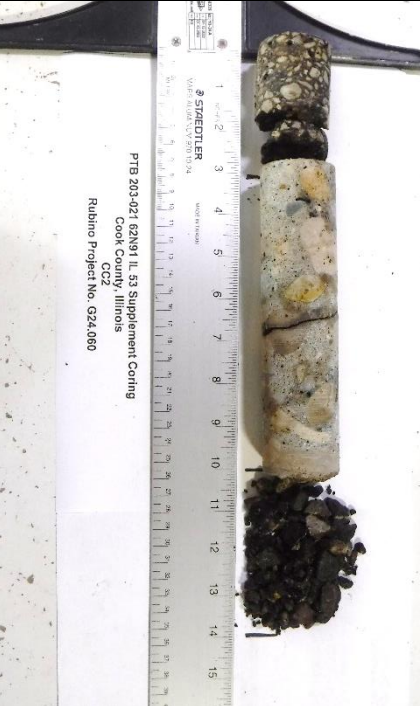
(Not Recovered)	<u>Total Thickness = 14 inches</u>

HMA Surface ₁ = 3 in.

NOT FULLY RECOVERED   Broken Concrete = 7 in.

Weathering & Deterioration

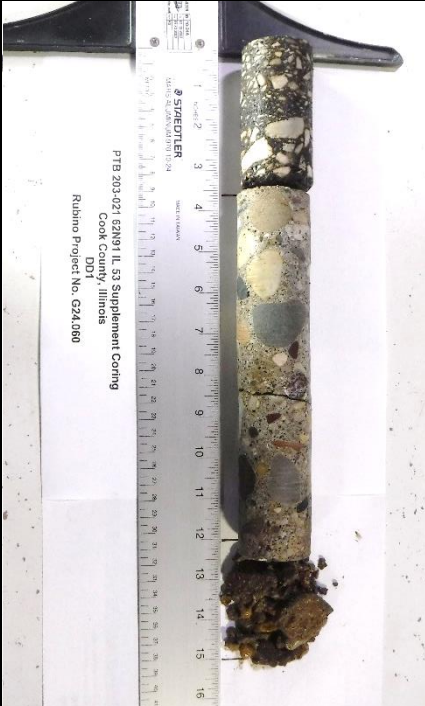
Subbase Stone Not Observed	<u>Total Thickness = 12 inches</u>

HMA Surface ₁ = 1 ½ in.

HMA Leveling Binder ₁ = ½ in.

HMA Binder ₂ = 1 ½ in.

Weathering & Deterioration

Broken Concrete = 8 ½ in.

Subbase Stone = 3 inches

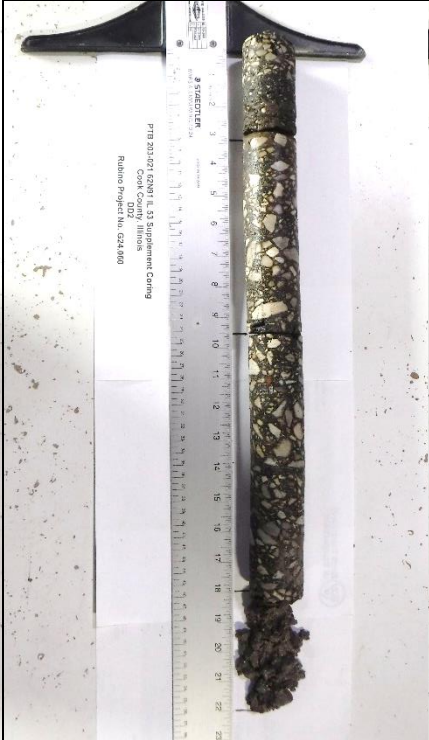
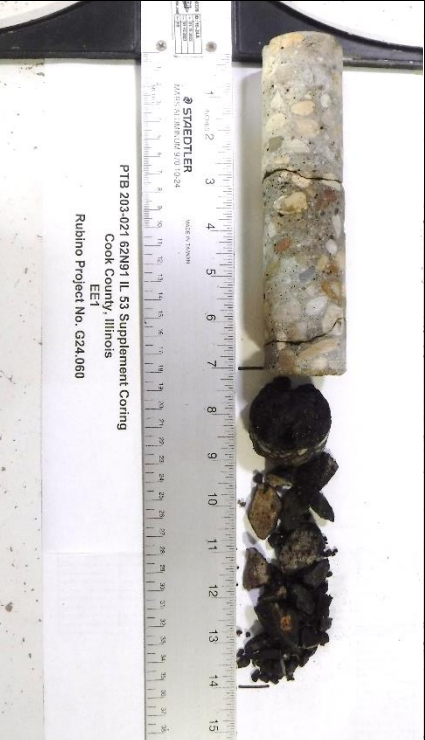
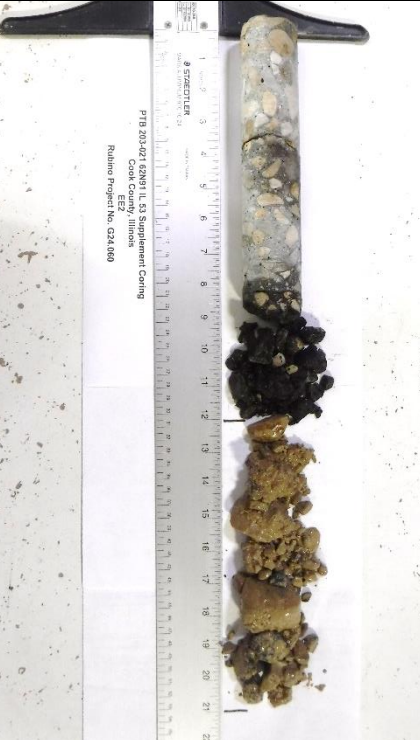
DD-2 (NB Off Ramp from IL 53 to Dundee Rd)	EE-1 (SB Off Ramp from IL 53 to Dundee Rd)	EE-2 (SB Off Ramp from IL 53 to Dundee Rd)

<p><u>Total Thickness = 18 inches</u></p> <ul style="list-style-type: none"> HMA Surface₁ = 1 ½ in. HMA Leveling Binder₁ = 1 ½ in. Weathering & Deterioration HMA Binder₂ = 6 ½ in. Weathering & Deterioration HMA Binder₃ = 8 ½ in. Subbase Stone = 4 inches <p>Core Barrel Reached Max Depth at 22 inches</p>	<p><u>Total Thickness = 14 inches</u></p> <ul style="list-style-type: none"> Broken Concrete = 7 in. Weathering & Deterioration HMA Binder₁ = 7 in. NOT FULLY RECOVERED Subbase Stone Not Observed 	<p><u>Total Thickness = 12 inches</u></p> <ul style="list-style-type: none"> Broken Concrete = 8 ½ in. HMA Binder₁ = 3 ½ in. NOT FULLY RECOVERED Subbase Stone = 9 inches

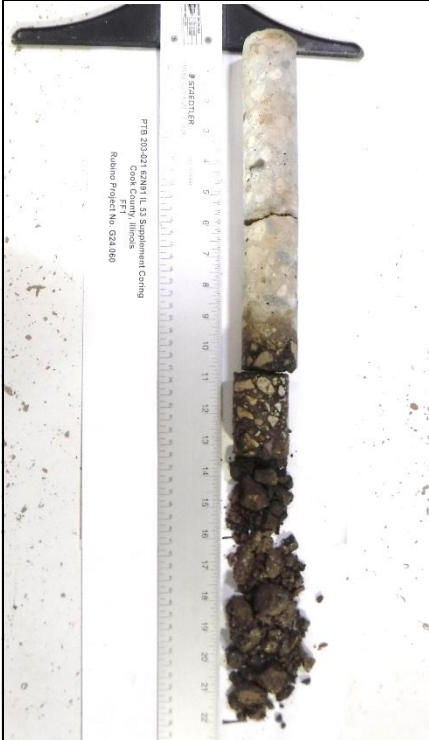
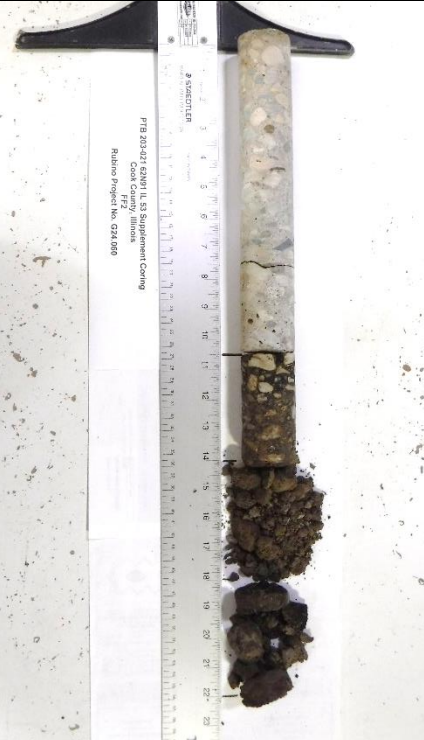
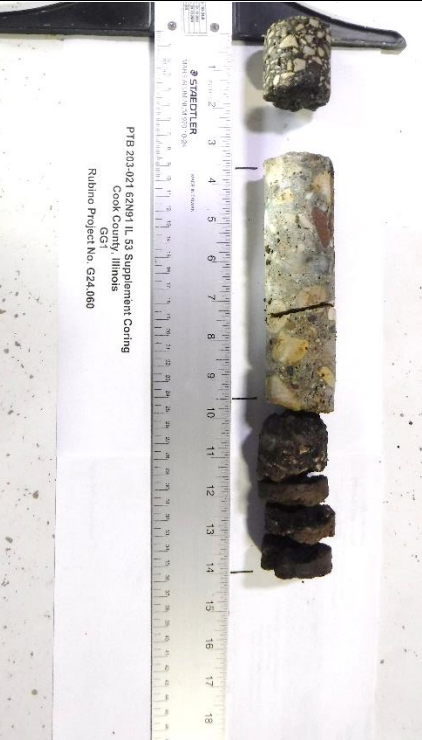
FF-1 (SB On Ramp from WB Dundee Rd)	FF-2 (SB On Ramp from WB Dundee Rd)	GG-1 (NB On Ramp from Dundee Rd to IL 53)

<p><u>Total Thickness = 16 inches</u></p> <ul style="list-style-type: none"> Broken Concrete = 9 ½ in. HMA Binder₁ = 1 in. Weathering & Deterioration HMA Binder₂ = 5 ½ in. NOT FULLY RECOVERED Subbase Stone = 6 inches <p>Core Barrel Reached Max Depth at 22 inches</p>	<p><u>Total Thickness = 18 inches</u></p> <ul style="list-style-type: none"> Broken Concrete = 10 ½ in. Weathering & Deterioration HMA Binder₁ = 3 ½ in. Subbase Stone = 4 inches HMA Layer₄ = 4 in. NOT FULLY RECOVERED <p>Core Barrel Reached Max Depth at 22 inches</p>	<p><u>Total Thickness = 14 inches</u></p> <ul style="list-style-type: none"> HMA Surface₁ = 2 in. Weathering & Deterioration HMA Layer₂ = 1 ½ in. Broken Concrete = 6 in. Weathering & Deterioration HMA Binder₁ = 4 ½ in. NOT FULLY RECOVERED Possible Subbase Stone = 8 inches (Not Recovered) <p>Core Barrel Reached Max Depth at 22 inches</p>

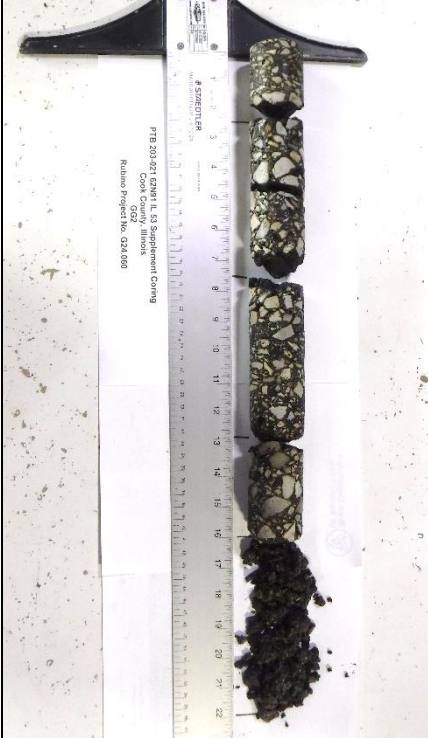
<p><u>Total Thickness = 16 inches</u></p> <ul style="list-style-type: none">

HMA Surface₁ = 1 ¼ in.

HMA Binder₁ = 1 in.

Weathering & Deterioration

HMA Binder₂ = 5 ¼ in.

HMA Binder₃ = 1 ½ in.

HMA Binder₄ = 3 ¾ in.

HMA Binder₅ = 3 ¼ in. Asphalt Grindings = 6 inches Core Barrel Reached Max Depth at 22 inches 	<p><u>Total Thickness = 15 inches</u></p> <ul style="list-style-type: none">

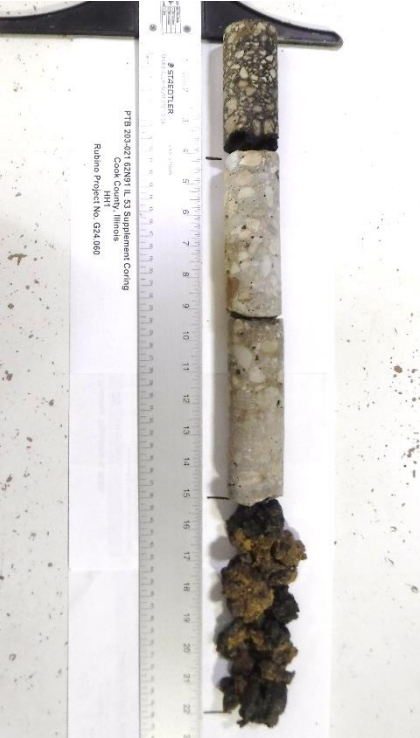
HMA Surface₁ = 2 in.

HMA Binder₁ = 2 in.

Weathering & Deterioration

Broken Concrete = 11 in. Subbase Stone = 7 inches Core Barrel Reached Max Depth at 22 inches 	<p><u>Total Thickness = 17 inches</u></p> <ul style="list-style-type: none">

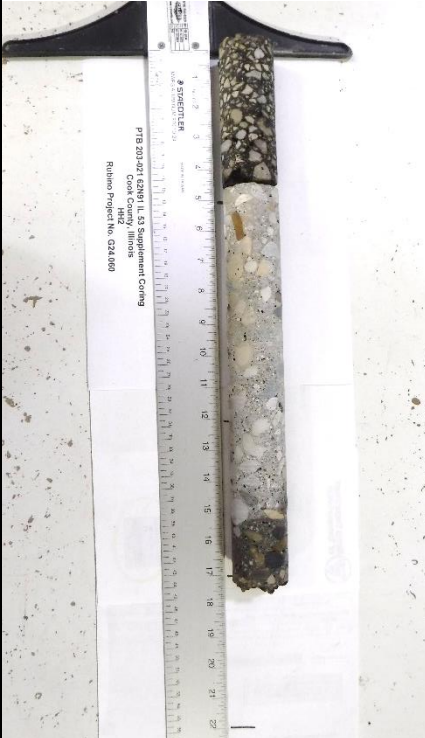
HMA Surface₁ = 2 ½ in.

HMA Binder₁ = 2 ½ in.

Weathering & Deterioration

Broken Concrete = 12 in. Subbase Stone = 5 inches (Not Recovered) Core Barrel Reached Max Depth at 22 inches

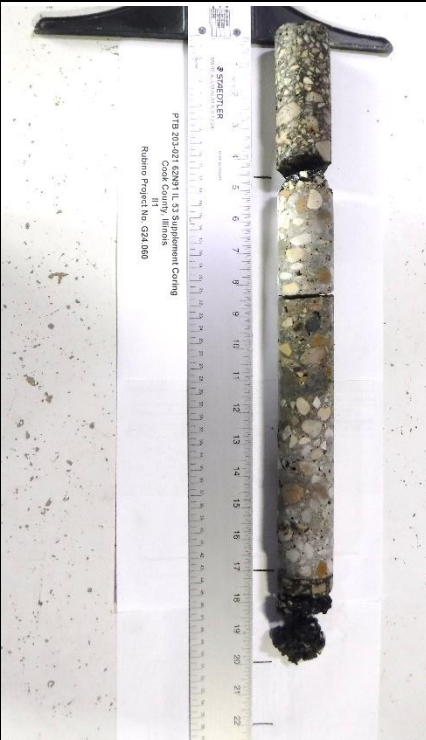
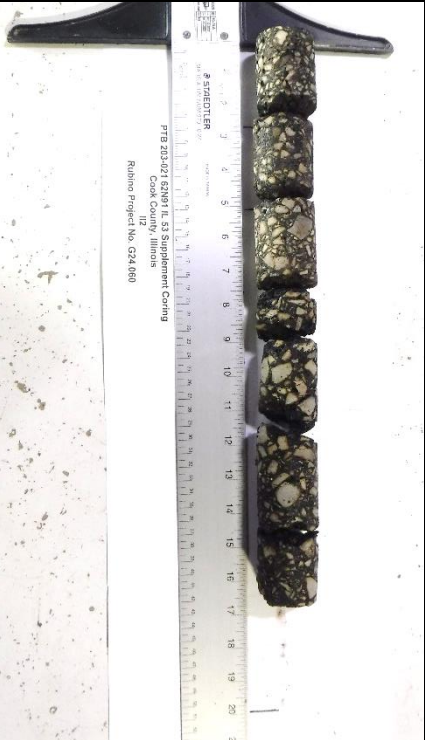
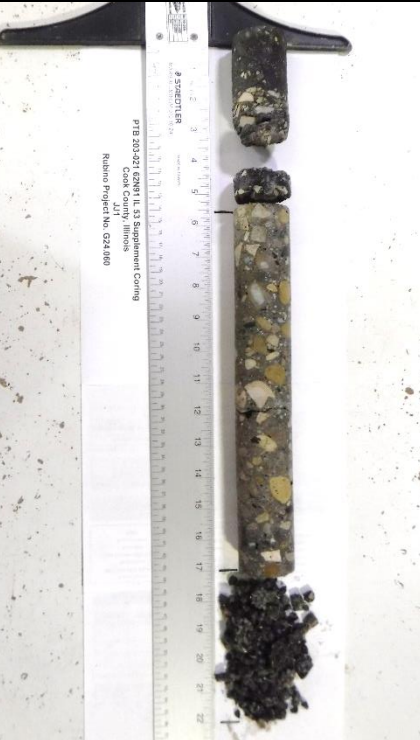
II-1 (NB Off Ramp from 53 to Lake Cook Rd)	II-2 (NB Off Ramp from 53 to Lake Cook Rd)	JJ-1 (NB Off Ramp to WB Lake Cook Rd)

<p><u>Total Thickness = 20 inches</u></p> <ul style="list-style-type: none"> HMA Surface₁ = 2 in. HMA Binder₁ = 2 ½ in. Weathering & Deterioration Broken Concrete = 12 ½ in. HMA Binder₂ = 3 in. NOT FULLY RECOVERED Possible Asphalt Grindings = 2 inches (Not Recovered) Core Barrel Reached Max Depth at 22 inches 	<p><u>Total Thickness = 20 inches</u></p> <ul style="list-style-type: none"> HMA Surface₁ = 2 ½ in. Weathering & Deterioration HMA Surface₂ = 2 ½ in. Weathering & Deterioration HMA Binder₁ = 2 ½ in. Weathering & Deterioration HMA Binder₂ = 9 in. Weathering & Deterioration HMA Layer₅ = 3 ½ in. NOT FULLY RECOVERED Possible Asphalt Grindings = 2 inches (Not Recovered) Core Barrel Reached Max Depth at 22 inches 	<p><u>Total Thickness = 17 inches</u></p> <ul style="list-style-type: none"> Possible SMA Surface₁ = 2 in. HMA Binder₁ = 3 ½ in. NOT FULLY RECOVERED Concrete = 11 ½ in. Asphalt Grindings = 5 inches Core Barrel Reached Max Depth at 22 inches

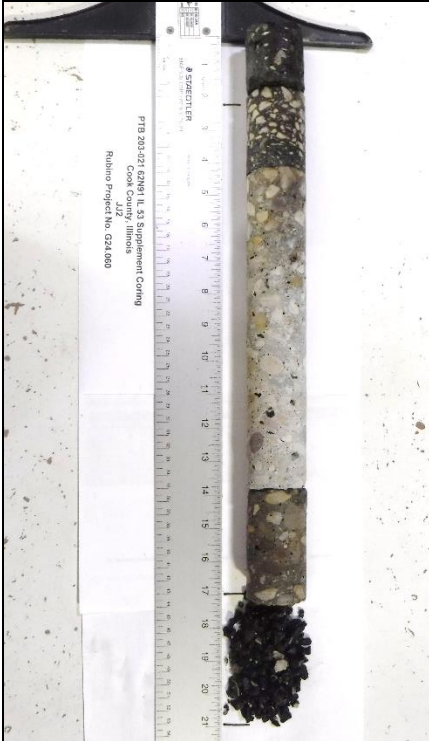
<p><u>Total Thickness = 17 inches</u></p> <p>

Possible SMA Surface₁ = 2 in. Weathering & Deterioration

HMA Binder₁ = 2 in.

HMA Leveling Binder₂ = ½ in.

Concrete = 12 ½ in.

Asphalt Grindings = 4 inches</p>	<p><u>Total Thickness = 18 inches</u></p> <p>

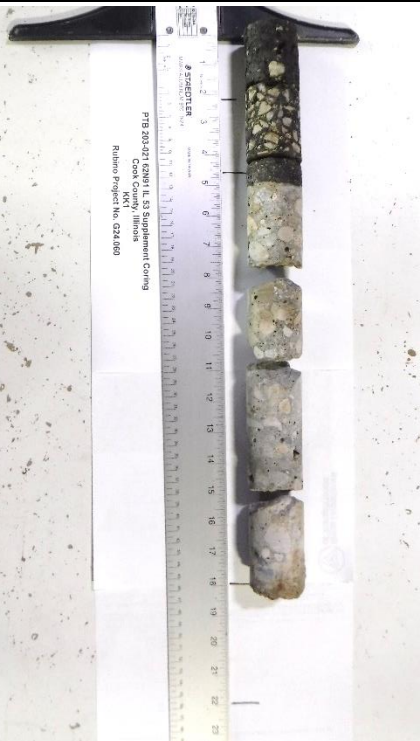
Possible SMA Surface₁ = 2 in.

HMA Binder₁ = 2 ½ in. Weathering & Deterioration

HMA Leveling Binder₂ = ¾ in.

Broken Concrete = 12 ¾ in.

Possible Asphalt Grindings = 4 inches (Not Recovered) <p align="center">Core Barrel Reached Max Depth at 22 inches</p> </p>	<p><u>Total Thickness = 16 inches</u></p> <p>

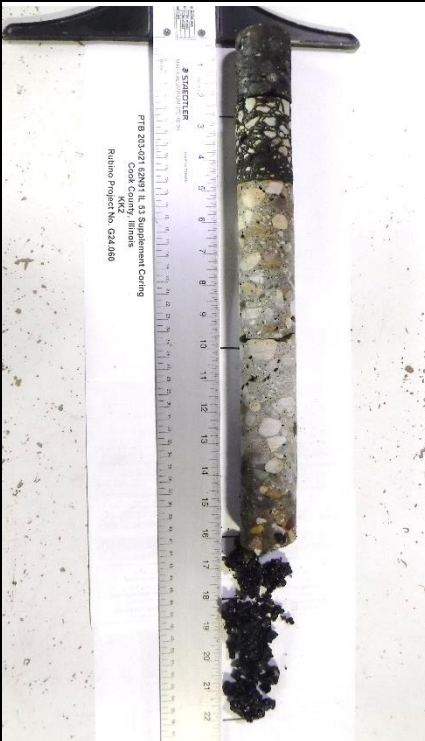
Possible SMA Surface₁ = 2 ½ in. Weathering & Deterioration

HMA Binder₁ = 1 ¾ in.

HMA Leveling Binder₂ = ¾ in.

Broken Concrete = 11 in.

Asphalt Grindings = 6 inches <p align="center">Core Barrel Reached Max Depth at 22 inches</p> </p>
