RE: IL 53 Mainline and Shoulder Evaluation  
IDOT Contract Number 62N91  
IDOT Job Number D-91-144-21  
Section 2018-100-BR  
Cook County  
District 1  
PTB 203-021  
Gonzalez Job No. 23-1003

SUBJECT: TECHNICAL MEMO

IDOT Project Number 62N91  
 IDOT Job Number D-91-144-21  
 Route IL 53 (FAP 342) Supplement Coring - I-90 to Lake Cook Road  
 Section 2018-100-BR  
 County Cook  
 District 1  
 PTB 203-021

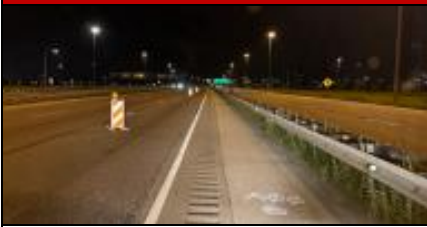
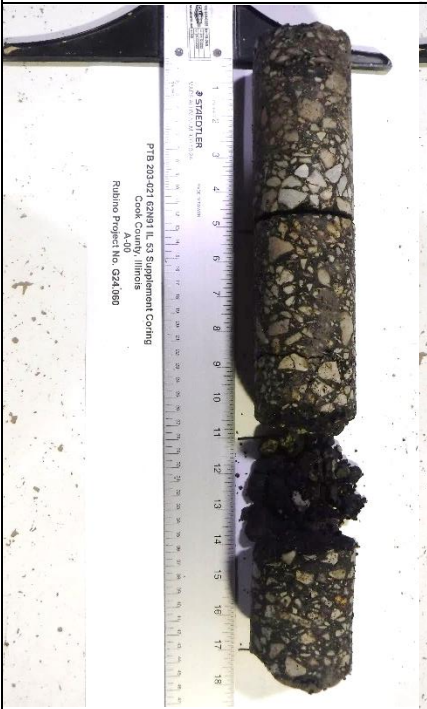
| <b>A-00</b><br><b>(SB Outside Shoulder)</b> | <b>B - 00</b><br><b>(SB Inside Shoulder)</b> | <b>C - 00</b><br><b>(NB Inside Shoulder)</b> |
|---|---|---|
| <p><b><u>Total Thickness = 17 inches</u></b></p> <ul style="list-style-type: none"> <li> HMA Surface<sub>1</sub> = 1 ¼ in.</li> <li> HMA Binder<sub>1</sub> = 2 ½ in.</li> <li> HMA Binder<sub>2</sub> = 1 ¼ in.</li> <li> <b>Weathering &amp; Deterioration</b></li> <li> HMA Binder<sub>3</sub> = 6 in.</li> <li> <b>Weathering &amp; Deterioration</b></li> <li> HMA Binder<sub>4</sub> = 6 in.</li> <li> <b>NOT FULLY RECOVERED</b></li> <li> Subbase Stone Not Observed</li> <li> <b>Subbase Type: Gravelly CLAY</b></li> <li> DCP Start Depth: 17 inches</li> <li> DCP Blows (per 6-inches):</li> <li> 4 – 7, 4 – 3, 9 – 18</li> </ul> | <p><b><u>Total Thickness = 18 inches</u></b></p> <ul style="list-style-type: none"> <li> HMA Surface<sub>1</sub> = 1 ½ in.</li> <li> HMA Binder<sub>1</sub> = 1 ¾ in.</li> <li> <b>Weathering &amp; Deterioration</b></li> <li> HMA Binder<sub>2</sub> = 5 ¾ in.</li> <li> <b>Weathering &amp; Deterioration</b></li> <li> HMA Binder<sub>3</sub> = 5 ¾ in.</li> <li> <b>Weathering &amp; Deterioration</b></li> <li> HMA Binder<sub>4</sub> = 3 ¾ in.</li> <li> Subbase Stone Not Observed</li> <li> <b>Subbase Type: Gravelly CLAY</b></li> <li> DCP Start Depth: 18 inches</li> <li> DCP Blows (per 6-inches):</li> <li> 4 – 5, 7 – 7, 6 – 9, 10</li> </ul> | <p><b><u>Total Thickness = 20 inches</u></b></p> <ul style="list-style-type: none"> <li> HMA Surface<sub>1</sub> = 1 ½ in.</li> <li> HMA Binder<sub>1</sub> = 3 in.</li> <li> HMA Binder<sub>2</sub> = 1 ½ in.</li> <li> <b>Weathering &amp; Deterioration</b></li> <li> HMA Layer<sub>4</sub> = 2 ½ in.</li> <li> <b>NOT FULLY RECOVERED</b></li> <li> HMA Binder<sub>3</sub> = 2 ½ in.</li> <li> <b>Weathering &amp; Deterioration</b></li> <li> HMA Binder<sub>4</sub> = 3 in.</li> <li> <b>Weathering &amp; Deterioration</b></li> <li> HMA Binder<sub>5</sub> = 6 in.</li> <li> Subbase Stone Not Observed</li> <li> <b>Subbase Type: Gravelly CLAY</b></li> <li> DCP Start Depth: 20 inches</li> <li> DCP Blows (per 6-inches):</li> <li> 4 – 4, 3 – 4, 12 – 10</li> </ul> |

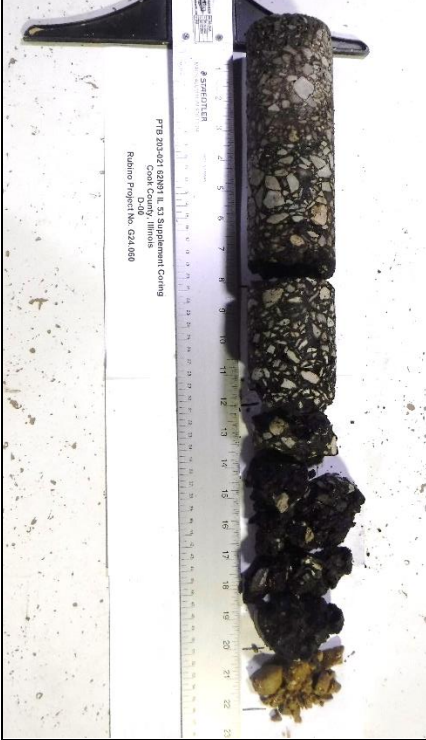
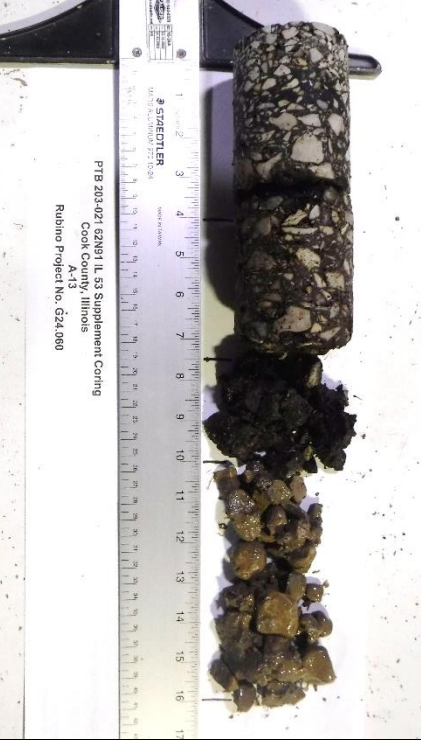
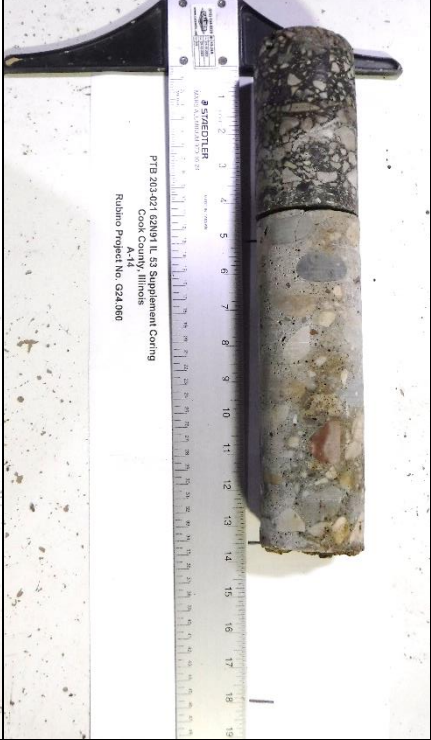
| <b>D - 00</b><br><b>(NB Outside Shoulder)</b> | <b>A - 13</b><br><b>(SB Outside Shoulder)</b> | <b>A - 14</b><br><b>(SB Outside Shoulder)</b> |
|---|---|---|
| <p><b><u>Total Thickness = 20 inches</u></b></p> <ul style="list-style-type: none"> <li> HMA Surface<sub>1</sub> = 1 in.</li> <li> HMA Binder<sub>1</sub> = 3 ¼ in.</li> <li> HMA Binder<sub>2</sub> = 2 ¼ in.</li> <li> HMA Binder<sub>3</sub> = 1 ½ in.</li> <li> <b>Weathering &amp; Deterioration</b></li> <li> HMA Binder<sub>4</sub> = 4 in.</li> <li> HMA Binder<sub>5</sub> = 8 in.</li> <li> <b>NOT FULLY RECOVERED</b></li> <li> Subbase Stone = 2 inches</li> <li> Subbase Type: Gravelly CLAY</li> <li> DCP Start Depth: 22 inches</li> <li> DCP Blows (per 6-inches):<br/>1 – 5, 5 – 5, 4 – 10</li> </ul> | <p><b><u>Total Thickness = 10 inches</u></b></p> <ul style="list-style-type: none"> <li> HMA Surface<sub>1</sub> = 2 in.</li> <li> HMA Binder<sub>1</sub> = 2 in.</li> <li> <b>Weathering &amp; Deterioration</b></li> <li> HMA Binder<sub>2</sub> = 3 ½ in.</li> <li> <b>Weathering &amp; Deterioration</b></li> <li> HMA Binder<sub>3</sub> = 2 ½ in.</li> <li> <b>NOT FULLY RECOVERED</b></li> <li> Subbase Stone = 6 inches</li> <li> Subbase Type: Gravelly CLAY</li> <li> DCP Start Depth: 16 inches</li> <li> DCP Blows (per 6-inches):<br/>5 – 9, 7 – 4, 5 – 5, 7</li> </ul> | <p><b><u>Total Thickness = 18 inches</u></b></p> <ul style="list-style-type: none"> <li> HMA Surface<sub>2</sub> = 2 in.</li> <li> HMA Binder<sub>1</sub> = 3 in.</li> <li> <b>Weathering &amp; Deterioration</b></li> <li> Concrete = 8 ½ in.</li> <li> HMA Binder<sub>2</sub> = 4 ½ in.</li> <li> <b>NOT FULLY RECOVERED</b></li> <li> Subbase Stone Not Observed</li> <li> Subbase Type: sand and gravel</li> <li> DCP Start Depth: 18 inches</li> <li> DCP Blows (per 6-inches):<br/>10 – 14, 21 – 17, 25/2" (DCP Refusal)</li> </ul> |

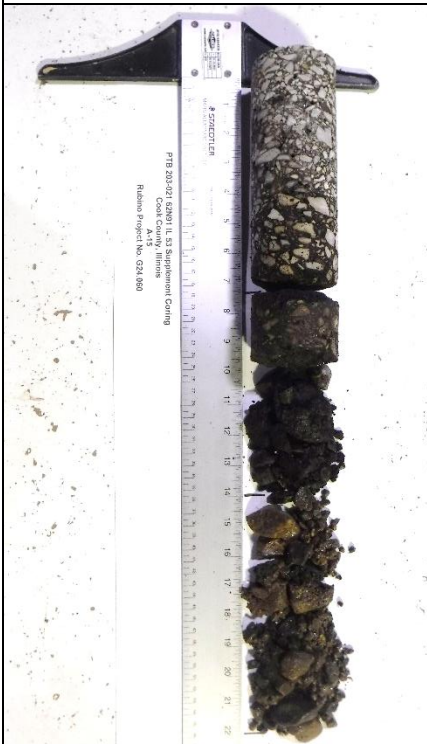
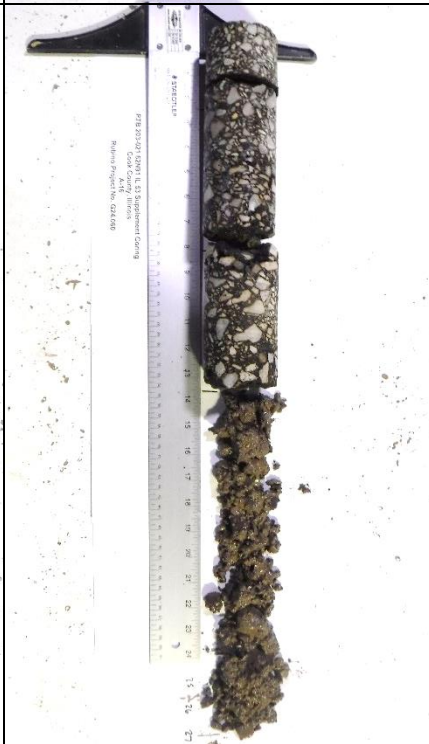
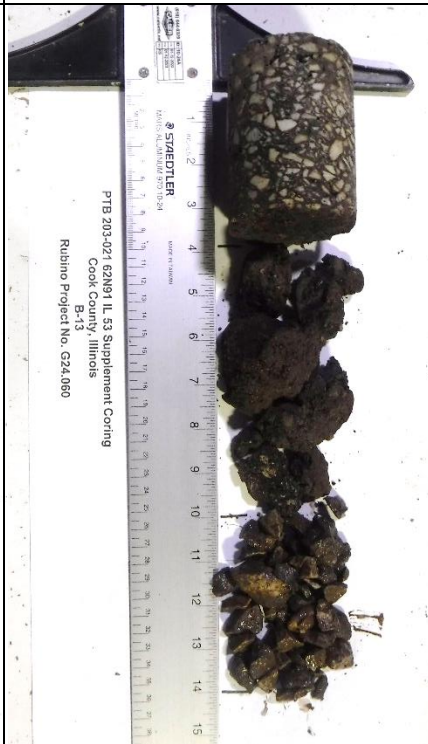
| <b>A - 15</b><br><b>(SB Outside Shoulder)</b> | <b>A - 16</b><br><b>(SB Outside Shoulder)</b> | <b>B - 13</b><br><b>(SB Inside Shoulder)</b> |
|---|---|---|
| <p><b><u>Total Thickness = 14 inches</u></b></p> <ul style="list-style-type: none"> <li> HMA Surface<sub>1</sub> = 1 ½ in.</li> <li> HMA Binder<sub>1</sub> = 3 ¼ in.</li> <li> HMA Binder<sub>2</sub> = 2 ½ in.</li> <li> <b>Weathering &amp; Deterioration</b></li> <li> HMA Binder<sub>3</sub> = 2 ½ in.</li> <li> <b>Weathering &amp; Deterioration</b></li> <li> HMA Binder<sub>4</sub> = 4 ¼ in.</li> <li> <b>NOT FULLY RECOVERED</b></li> <li> Subbase Stone = 8 inches</li> <li> <b>Subbase Type: sand and gravel</b></li> <li> DCP Start Depth: 22 inches</li> <li> DCP Blows (per 6-inches):<br/>25/0" (DCP Refusal)</li> </ul> | <p><b><u>Total Thickness = 13 ½ inches</u></b></p> <ul style="list-style-type: none"> <li> HMA Surface<sub>1</sub> = 2 ¼ in.</li> <li> <b>Weathering &amp; Deterioration</b></li> <li> HMA Binder<sub>1</sub> = 3 in.</li> <li> HMA Binder<sub>2</sub> = 2 ¾ in.</li> <li> <b>Weathering &amp; Deterioration</b></li> <li> HMA Binder<sub>3</sub> = 5 ½ in.</li> <li> Subbase Stone = 13 ½ inches</li> <li> <b>Subbase Type: sand and gravel</b></li> <li> DCP Start Depth: 27 inches</li> <li> DCP Blows (per 6-inches):<br/>25/0" (DCP Refusal)</li> </ul> | <p><b><u>Total Thickness = 10 inches</u></b></p> <ul style="list-style-type: none"> <li> HMA Surface<sub>1</sub> = 1 ½ in.</li> <li> HMA Surface<sub>2</sub> = 2 ¼ in.</li> <li> <b>Weathering &amp; Deterioration</b></li> <li> HMA Binder<sub>1</sub> = 6 ¼ in.</li> <li> <b>NOT FULLY RECOVERED</b></li> <li> Subbase Stone = 4 inches</li> <li> <b>Subbase Type: Gravelly CLAY</b></li> <li> DCP Start Depth: 14 inches</li> <li> DCP Blows (per 6-inches):<br/>5 – 11, 10 – 8, 9 – 9</li> </ul> |

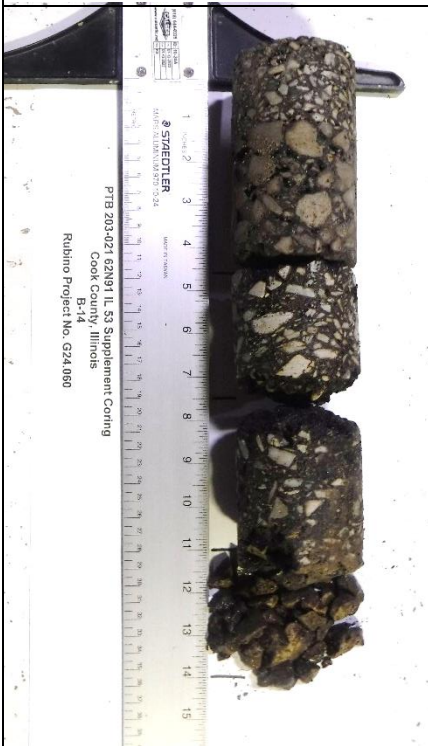
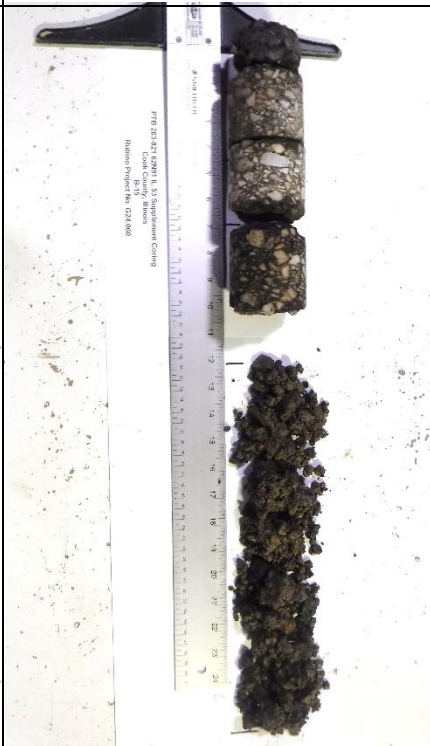
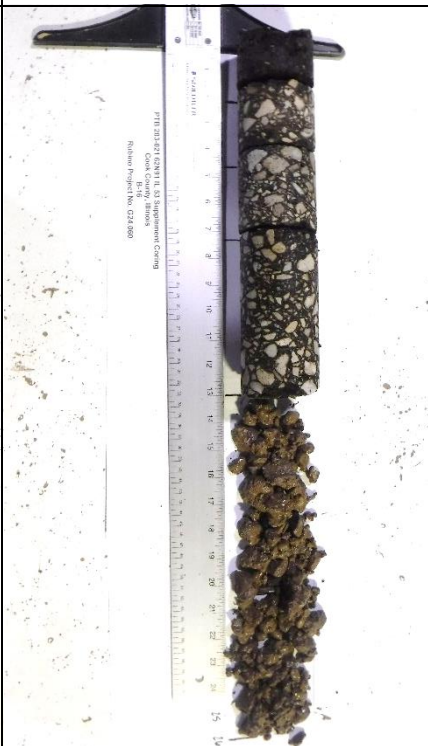
| <b>B - 14</b><br><b>(SB Inside Shoulder)</b> | <b>B - 15</b><br><b>(SB Inside Shoulder)</b> | <b>B - 16</b><br><b>(SB Inside Shoulder)</b> |
|---|---|---|
| <p><u><b>Total Thickness = 11 inches</b></u></p> <ul style="list-style-type: none"> <li> HMA Surface<sub>1</sub> = 1 ¾ in.</li> <li> HMA Binder<sub>1</sub> = 2 ¾ in.</li> <li> <b>Weathering &amp; Deterioration</b></li> <li> HMA Binder<sub>2</sub> = 3 in.</li> <li> <b>Weathering &amp; Deterioration</b></li> <li> HMA Binder<sub>3</sub> = 3 ½ in.</li> <li> Subbase Stone = 3 inches</li> <li> Subbase Type: Gravelly CLAY</li> <li> DCP Start Depth: 14 inches</li> <li> DCP Blows (per 6-inches):<br/>16 – 20, 21 – 10, 7 – 6</li> </ul> | <p><u><b>Total Thickness = 12 inches</b></u></p> <ul style="list-style-type: none"> <li> Possible SMA Surface<sub>1</sub> = 1 ½ in.</li> <li> <b>Weathering &amp; Deterioration</b></li> <li> HMA Binder<sub>1</sub> = 2 ¾ in.</li> <li> <b>Weathering &amp; Deterioration</b></li> <li> HMA Binder<sub>2</sub> = 2 ½ in.</li> <li> <b>Weathering &amp; Deterioration</b></li> <li> HMA Binder<sub>3</sub> = 5 ½ in.</li> <li> <b>NOT FULLY RECOVERED</b></li> <li> Subbase Stone = 14 inches</li> <li> Subbase Type: sand and gravel</li> <li> DCP Start Depth: 26 inches</li> <li> DCP Blows (per 6-inches):<br/>25/0" (DCP Refusal)</li> </ul> | <p><u><b>Total Thickness = 13 inches</b></u></p> <ul style="list-style-type: none"> <li> Possible SMA Surface<sub>1</sub> = 2 in.</li> <li> <b>Weathering &amp; Deterioration</b></li> <li> HMA Binder<sub>1</sub> = 2 ½ in.</li> <li> <b>Weathering &amp; Deterioration</b></li> <li> HMA Surface<sub>2</sub> = 2 ¾ in.</li> <li> <b>Weathering &amp; Deterioration</b></li> <li> HMA Surface<sub>3</sub> = 5 ¾ in.</li> <li> Subbase Stone = 13 inches</li> <li> Subbase Type: Gravelly CLAY</li> <li> DCP Start Depth: 26 inches</li> <li> DCP Blows (per 6-inches):<br/>7 – 4, 6 – 5</li> </ul> |

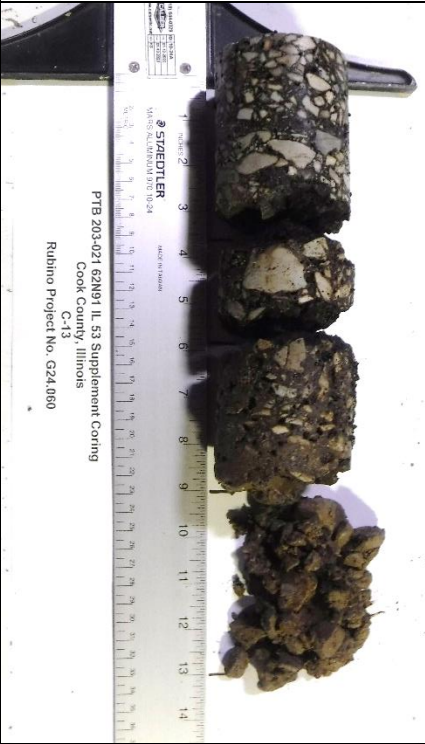
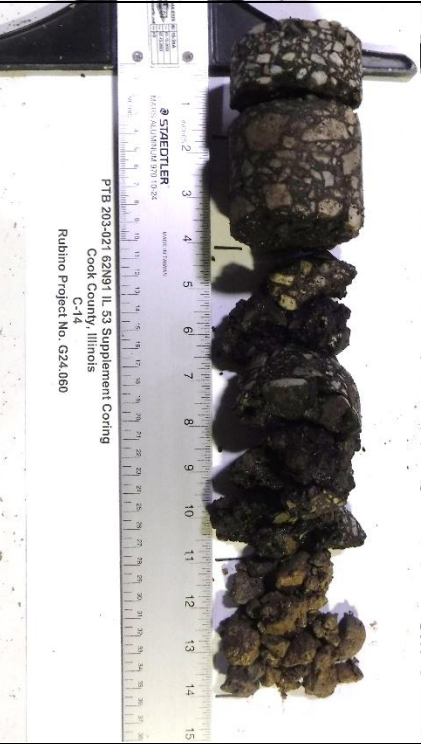
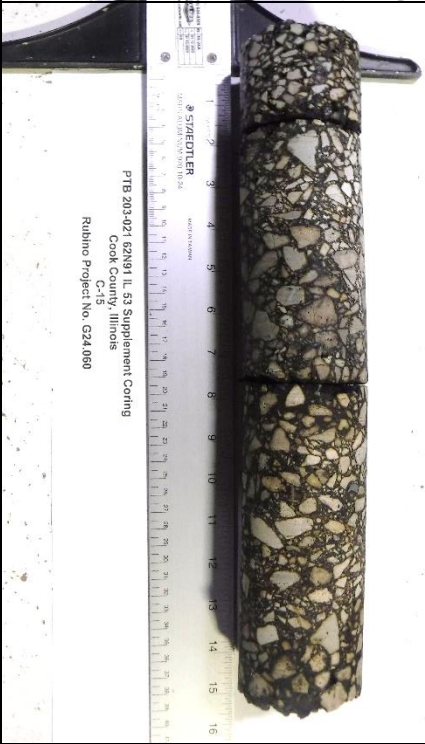
| C - 13<br>(NB Inside Shoulder) | C - 14<br>(NB Inside Shoulder) | C - 15<br>(NB Inside Shoulder) |
|---|---|---|
| <p><u>Total Thickness = 9 inches</u></p> <ul style="list-style-type: none"> <li>HMA Surface<sub>1</sub> = 1 ¾ in.</li> <li>HMA Leveling Binder<sub>1</sub> = ¼ in.</li> <li>HMA Binder<sub>2</sub> = 1 ½ in.</li> <li><b>Weathering &amp; Deterioration</b></li> <li>HMA Binder<sub>3</sub> = 2 ¼ in.</li> <li><b>Weathering &amp; Deterioration</b></li> <li>HMA Binder<sub>4</sub> = 3 ¼ in.</li> <li>Subbase Stone = 4 inches</li> <li>Subbase Type: Gravelly CLAY</li> <li>DCP Start Depth: 13 inches</li> <li>DCP Blows (per 6-inches):<br/>5 – 6, 7 – 8, 7 – 7</li> </ul> | <p><u>Total Thickness = 11 inches</u></p> <ul style="list-style-type: none"> <li>HMA Surface<sub>1</sub> = 1 ½ in.</li> <li><b>Weathering &amp; Deterioration</b></li> <li>HMA Binder<sub>1</sub> = 2 ½ in.</li> <li><b>Weathering &amp; Deterioration</b></li> <li>HMA Binder<sub>2</sub> = 7 in.</li> <li><b>NOT FULLY RECOVERED</b></li> <li>Subbase Stone = 3 inches</li> <li>Subbase Type: Gravelly CLAY</li> <li>DCP Start Depth: 14 inches</li> <li>DCP Blows (per 6-inches):<br/>12 – 19, 17 – 16, 13 – 12</li> </ul> | <p><u>Total Thickness = 14 ½ inches</u></p> <ul style="list-style-type: none"> <li>HMA Surface<sub>1</sub> = 1 in.</li> <li>HMA Surface<sub>2</sub> = 1 in.</li> <li><b>Weathering &amp; Deterioration</b></li> <li>HMA Binder<sub>1</sub> = 2 ¼ in.</li> <li>HMA Binder<sub>2</sub> = 3 ¼ in.</li> <li><b>Weathering &amp; Deterioration</b></li> <li>HMA Binder<sub>3</sub> = 7 in.</li> <li>Asphalt Grindings = 2 ½ inches (Not Recovered)</li> <li>Subbase Type: sand and gravel</li> <li>DCP Start Depth: 17 inches</li> <li>DCP Blows (per 6-inches):<br/>25/2" (DCP Refusal)</li> </ul> |

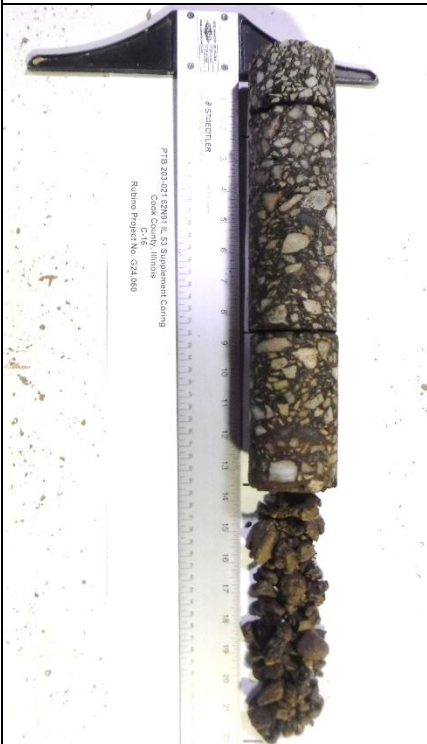
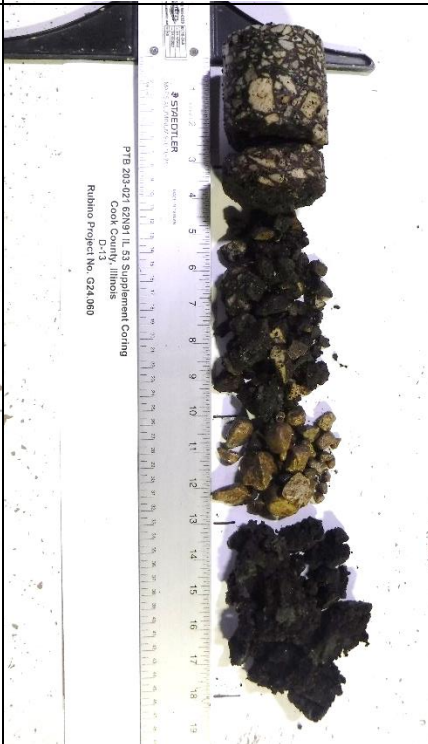
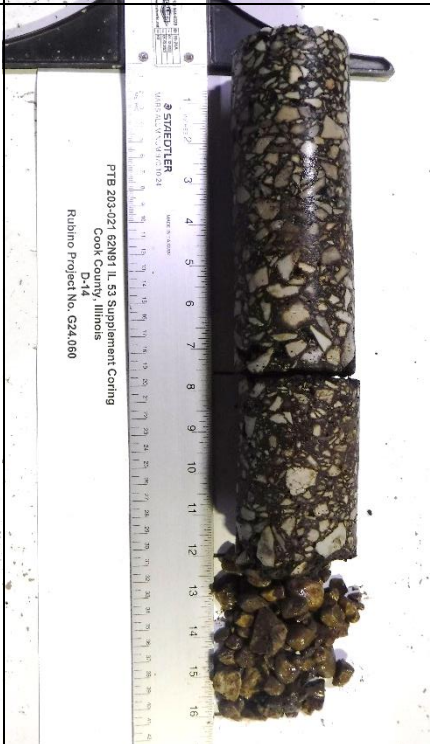
| <b>C - 16</b><br><b>(NB Inside Shoulder)</b> | <b>D - 13</b><br><b>(NB Outside Shoulder)</b> | <b>D - 14</b><br><b>(NB Outside Shoulder)</b> |
|---|---|---|
| <p><u><b>Total Thickness = 13 ½ inches</b></u></p> <ul style="list-style-type: none"> <li> HMA Surface<sub>1</sub> = 1 in.</li> <li> HMA Surface<sub>2</sub> = 1 in.</li> <li> <b>Weathering &amp; Deterioration</b></li> <li> HMA Binder<sub>1</sub> = 2 ½ in.</li> <li> HMA Binder<sub>2</sub> = 4 in.</li> <li> <b>Weathering &amp; Deterioration</b></li> <li> HMA Binder<sub>3</sub> = 5 in.</li> <li> Subbase Stone = 8 ½ inches</li> <li><b>Subbase Type: sand and gravel</b></li> <li><b>DCP Start Depth: 22 inches</b></li> <li><b>DCP Blows (per 6-inches):</b><br/><b>25/3" (DCP Refusal)</b></li> </ul> | <p><u><b>Total Thickness = 10 inches</b></u></p> <ul style="list-style-type: none"> <li> HMA Surface<sub>1</sub> = 1 ¼ in.</li> <li> HMA Binder<sub>1</sub> = 1 ¾ in.</li> <li> <b>Weathering &amp; Deterioration</b></li> <li> HMA Binder<sub>2</sub> = 7 in.</li> <li> <b>NOT FULLY RECOVERED</b></li> <li> Subbase Stone<sub>1</sub> = 3 inches</li> <li> Subbase Stone<sub>2</sub> = 5 inches</li> <li><b>Subbase Type: Gravelly CLAY</b></li> <li><b>DCP Start Depth: 18 inches</b></li> <li><b>DCP Blows (per 6-inches):</b><br/><b>15 – 23, 11 – 11, 13 – 15, 12</b></li> </ul> | <p><u><b>Total Thickness = 12 inches</b></u></p> <ul style="list-style-type: none"> <li> HMA Surface<sub>1</sub> = 1 ½ in.</li> <li> HMA Binder<sub>1</sub> = 3 ½ in.</li> <li> HMA Binder<sub>2</sub> = 2 ½ in.</li> <li> <b>Weathering &amp; Deterioration</b></li> <li> HMA Binder<sub>3</sub> = 4 ½ in.</li> <li> Subbase Stone = 4 inches</li> <li><b>Subbase Type: Gravelly CLAY</b></li> <li><b>DCP Start Depth: 16 inches</b></li> <li><b>DCP Blows (per 6-inches):</b><br/><b>6 – 14, 17 – 24, 22 – 16, 10</b></li> </ul> |

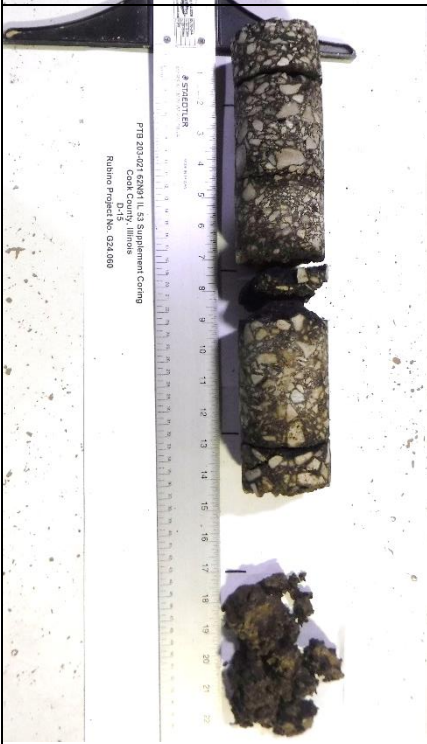
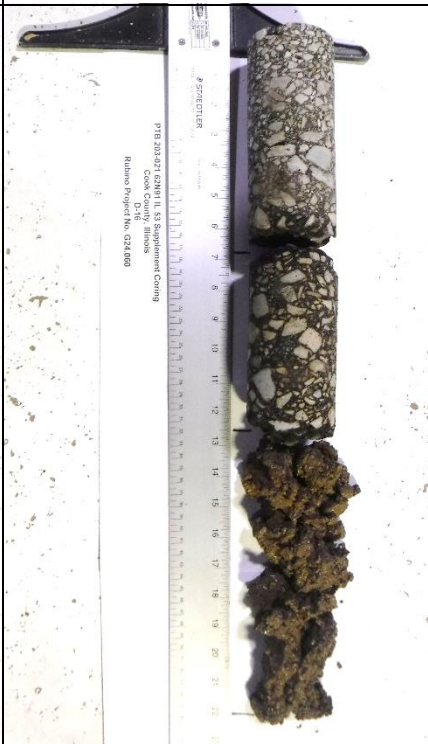
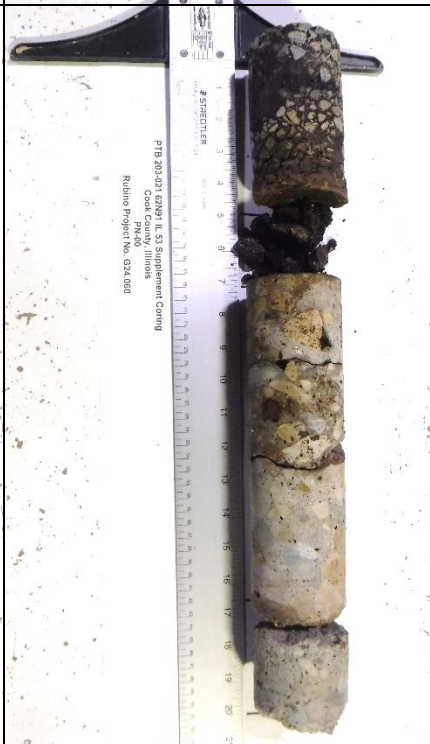
| <b>D - 15</b><br><b>(NB Outside Shoulder)</b> | <b>D - 16</b><br><b>(NB Outside Shoulder)</b> | <b>PN - 00</b><br><b>(NB Inside Lane)</b> |
|---|---|---|
| <p><u><b>Total Thickness = 17 inches</b></u></p> <ul style="list-style-type: none"> <li> HMA Surface<sub>1</sub> = 1 ¾ in.</li> <li> <b>Weathering &amp; Deterioration</b></li> <li> HMA Binder<sub>1</sub> = 3 in.</li> <li> HMA Surface<sub>2</sub> = 2 ½ in.</li> <li> <b>Weathering &amp; Deterioration</b></li> <li> HMA Binder<sub>2</sub> = 5 ¼ in.</li> <li> HMA Binder<sub>3</sub> = 4 ½ in.</li> <li> <b>Weathering &amp; Deterioration</b></li> <li> <b>NOT FULLY RECOVERED</b></li> <li> Subbase Stone = 5 inches</li> <li> Subbase Type: sand and gravel</li> <li> DCP Start Depth: 22 inches</li> <li> DCP Blows (per 6-inches):<br/><b>25/1"</b></li> </ul> | <p><u><b>Total Thickness = 12 ½ inches</b></u></p> <ul style="list-style-type: none"> <li> HMA Surface<sub>1</sub> = 1 ¾ in.</li> <li> HMA Binder<sub>1</sub> = 2 ¼ in.</li> <li> HMA Binder<sub>2</sub> = 2 ¾ in.</li> <li> <b>Weathering &amp; Deterioration</b></li> <li> HMA Binder<sub>3</sub> = 5 ¾ in.</li> <li> Subbase Stone = 9 ½ inches</li> <li> Subbase Type: sand and gravel</li> <li> DCP Start Depth: 22 inches</li> <li> DCP Blows (per 6-inches):<br/><b>25/2"</b></li> </ul> | <p><u><b>Total Thickness = 20 inches</b></u></p> <ul style="list-style-type: none"> <li> Possible SMA Surface<sub>1</sub> = 2 in.</li> <li> HMA Binder<sub>1</sub> = 2 ¾ in.</li> <li> <b>Weathering &amp; Deterioration</b></li> <li> HMA Layer<sub>3</sub> = 2 ¼ in.</li> <li> <b>Weathering &amp; Deterioration</b></li> <li> Broken Concrete = 13 in.</li> <li> Subbase Stone Not Observed</li> </ul> |

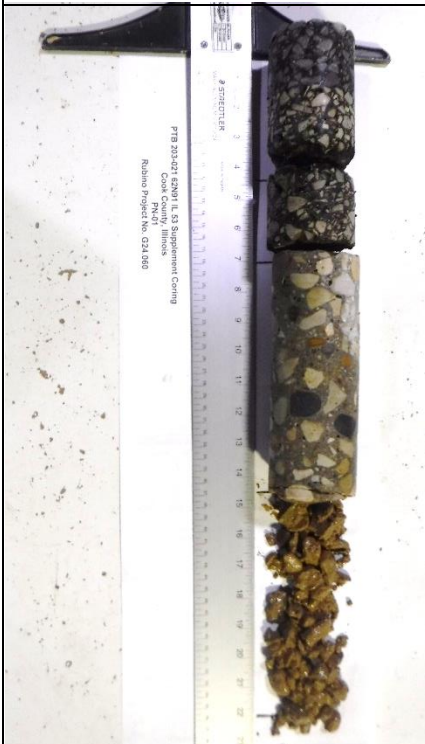
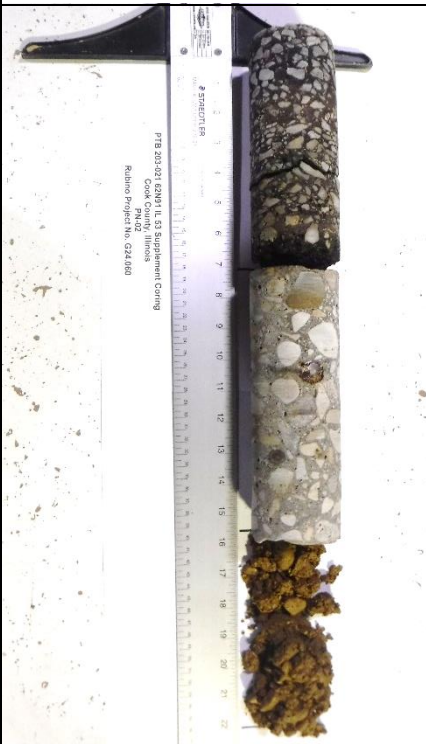
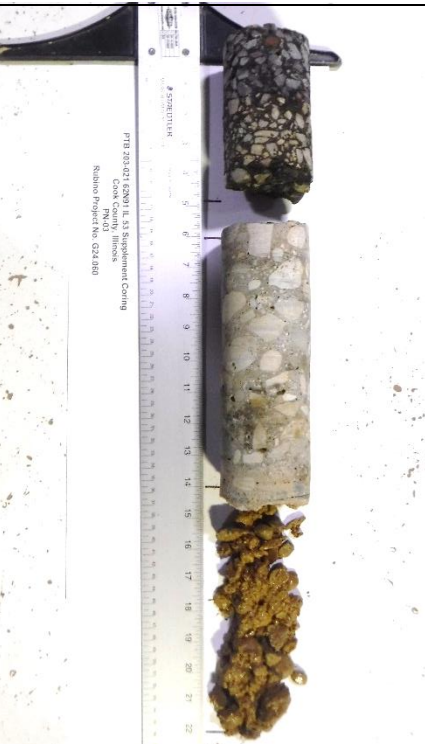
| PN - 01<br>(NB Outside Lane) | PN - 02<br>(NB Inside Lane) | PN - 03<br>(NB Inside Lane) |
|---|---|---|
| <p><u>Total Thickness = 14 ½ inches</u></p> <ul style="list-style-type: none"> <li>Possible SMA Surface<sub>1</sub> = 2 in.</li> <li>HMA Binder<sub>1</sub> = 2 ¼ in.</li> <li><b>Weathering &amp; Deterioration</b></li> <li>HMA Binder<sub>2</sub> = 2 ¾ in.</li> <li><b>Weathering &amp; Deterioration</b></li> <li>Concrete = 7 ½ in.</li> <li>Subbase Stone = 7 ½ inches</li> </ul> <p>Core Barrel Reached Max Depth at 22 inches</p> | <p><u>Total Thickness = 15 ½ inches</u></p> <ul style="list-style-type: none"> <li>Possible SMA Surface<sub>1</sub> = 2 ¼ in.</li> <li>HMA Binder<sub>1</sub> = 2 ½ in.</li> <li><b>Weathering &amp; Deterioration</b></li> <li>HMA Binder<sub>2</sub> = 2 ¼ in.</li> <li><b>Weathering &amp; Deterioration</b></li> <li>Concrete = 8 ½ in.</li> <li>Subbase Stone = 6 ½ inches</li> </ul> <p>Core Barrel Reached Max Depth at 22 inches</p> | <p><u>Total Thickness = 14 inches</u></p> <ul style="list-style-type: none"> <li>Possible SMA Surface<sub>1</sub> = 2 ¼ in.</li> <li>HMA Binder<sub>1</sub> = 2 ½ in.</li> <li><b>Weathering &amp; Deterioration</b></li> <li>HMA Layer<sub>3</sub> = 1 ¼ in.</li> <li><b>NOT FULLY RECOVERED</b></li> <li>Concrete = 8 in.</li> <li>Subbase Stone = 8 inches</li> </ul> <p>Core Barrel Reached Max Depth at 22 inches</p> |

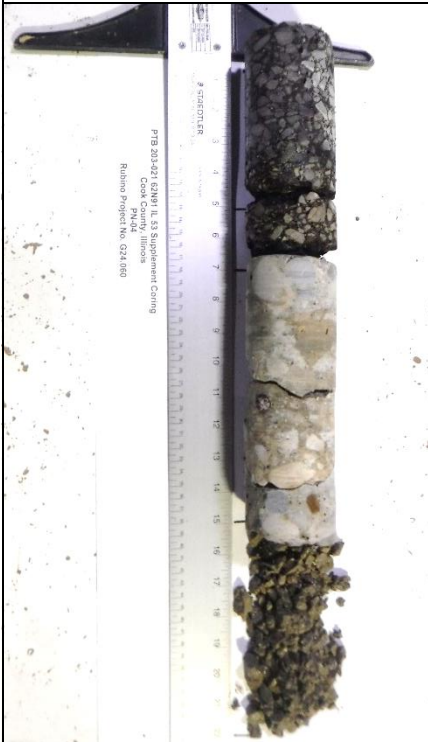
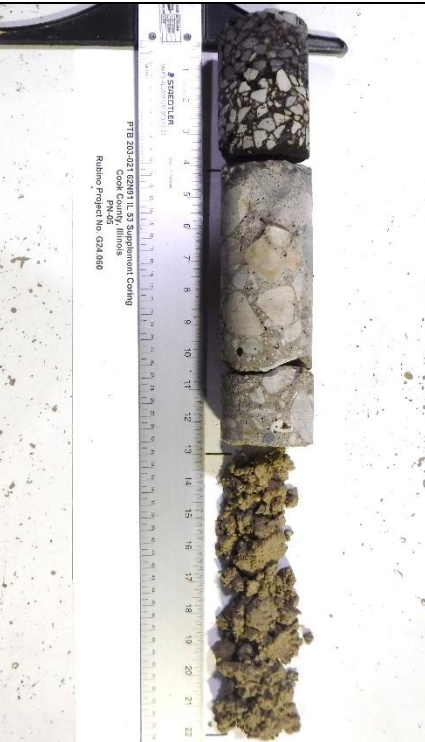
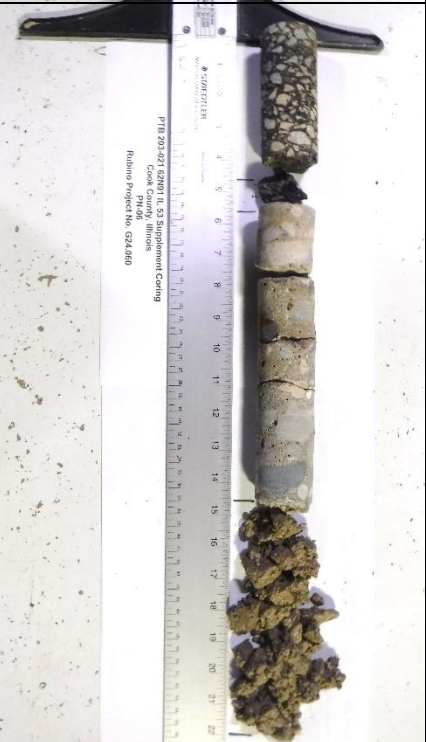
| PN - 04<br>(NB Outside Lane) | PN - 05<br>(NB Inside Lane) | PN - 06<br>(NB Inside Lane) |
|---|---|---|
| <p><u>Total Thickness = 15 inches</u></p> <p> Possible SMA Surface<sub>1</sub> = 4 ¼ in.</p> <p> HMA Binder<sub>1</sub> = ¾ in.</p> <p> Weathering &amp; Deterioration</p> <p> HMA Binder<sub>2</sub> = 2 in.</p> <p> Weathering &amp; Deterioration</p> <p> Broken Concrete = 8 in.</p> <p> Subbase Stone = 7 inches</p> <p>Core Barrel Reached Max Depth at 22 inches</p> | <p><u>Total Thickness = 13 inches</u></p> <p> Possible SMA Surface<sub>1</sub> = 2 in.</p> <p> HMA Binder<sub>1</sub> = 2 in.</p> <p> Weathering &amp; Deterioration</p> <p> Broken Concrete = 9 in.</p> <p> Subbase Stone = 9 inches</p> <p>Core Barrel Reached Max Depth at 22 inches</p> | <p><u>Total Thickness = 14 ½ inches</u></p> <p> Possible SMA Surface<sub>1</sub> = 2 in.</p> <p> HMA Binder<sub>1</sub> = 2 ½ in.</p> <p> Weathering &amp; Deterioration</p> <p> HMA Binder<sub>2</sub> = 1 in.</p> <p> Weathering &amp; Deterioration</p> <p> Broken Concrete = 9 in.</p> <p> Subbase Stone = 7 ½ inches</p> <p>Core Barrel Reached Max Depth at 22 inches</p> |

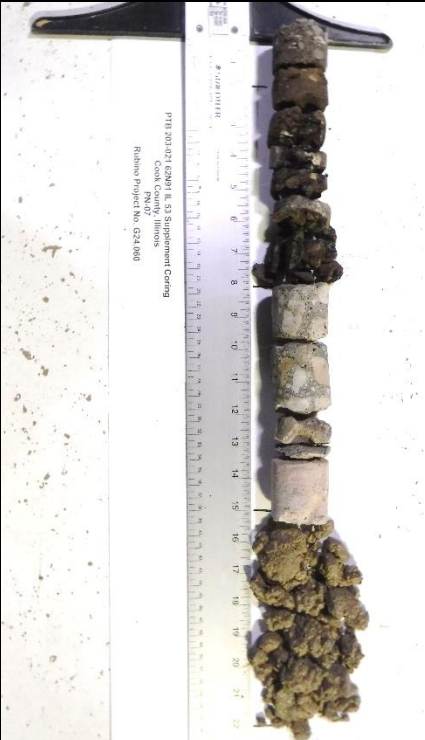
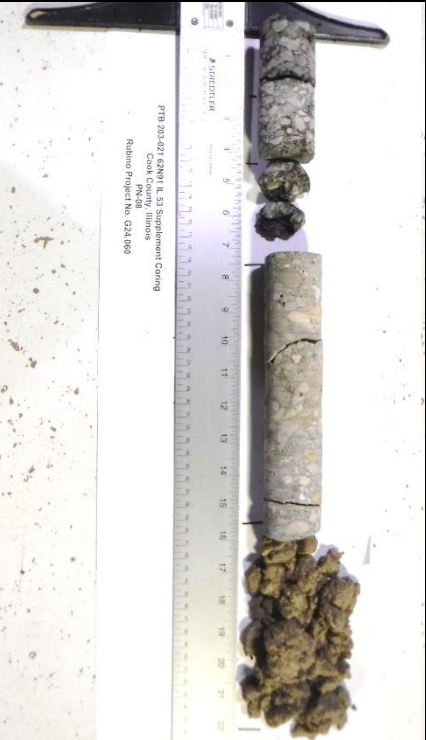
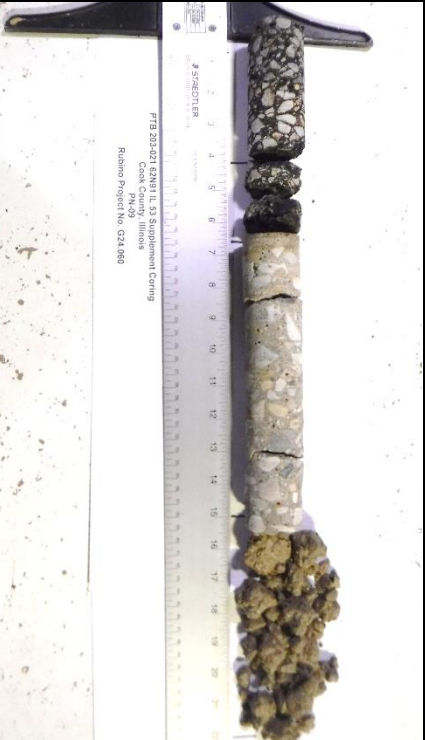
| PN - 07<br>(NB Inside Lane) | PN - 08<br>(NB Inside Lane) | PN - 09<br>(NB Inside Lane) |
|---|---|---|
| <p><u>Total Thickness = 15 inches</u></p> <p> Possible SMA Surface<sub>1</sub> = 1 ½ in.<br/><b>Weathering &amp; Deterioration</b></p> <p> HMA Binder<sub>1</sub> = 6 ½ in.<br/><b>NOT FULLY RECOVERED</b></p> <p> Broken Concrete = 7 in.<br/>Subbase Stone = 7 inches</p> <p>Core Barrel Reached Max Depth at 22 inches</p> | <p><u>Total Thickness = 15 ½ inches</u></p> <p> Possible SMA Surface<sub>1</sub> = 2 in.<br/><b>Weathering &amp; Deterioration</b></p> <p> HMA Binder<sub>1</sub> = 2 ¼ in.<br/><b>Weathering &amp; Deterioration</b></p> <p> HMA Binder<sub>2</sub> = 3 ¼ in.<br/><b>NOT FULLY RECOVERED</b></p> <p> Broken Concrete = 8 in.<br/>Subbase Stone = 6 ½ inches</p> <p>Core Barrel Reached Max Depth at 22 inches</p> | <p><u>Total Thickness = 15 inches</u></p> <p> Possible SMA Surface<sub>1</sub> = 2 in.<br/>HMA Binder<sub>1</sub> = 2 in.<br/><b>Weathering &amp; Deterioration</b></p> <p> HMA Binder<sub>2</sub> = 2 ½ in.<br/><b>NOT FULLY RECOVERED</b></p> <p> Broken Concrete = 8 ½ in.<br/>Subbase Stone = 7 inches</p> <p>Core Barrel Reached Max Depth at 22 inches</p> |

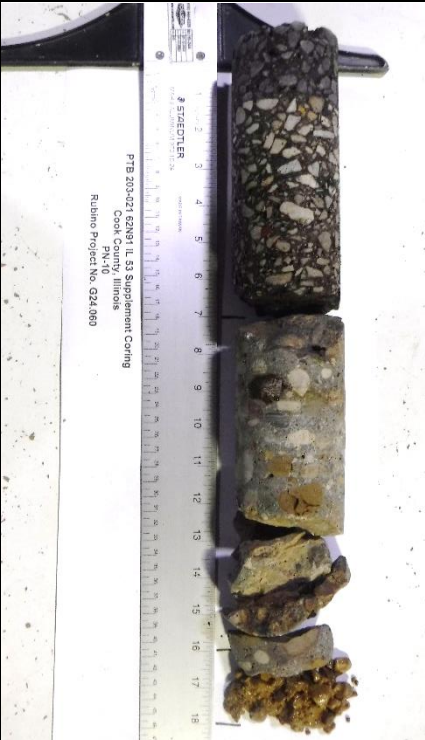
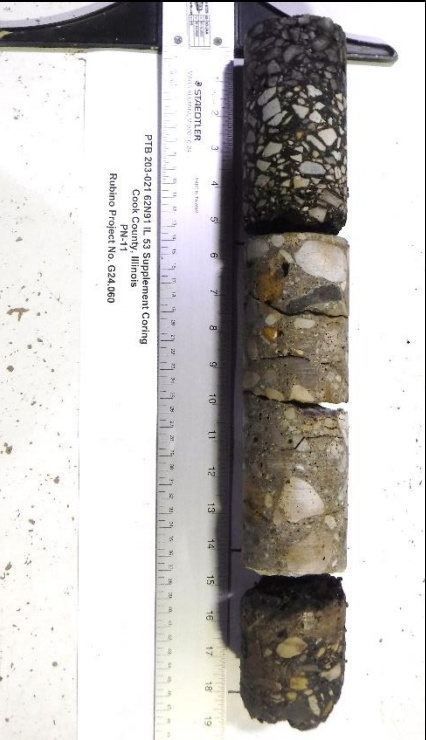
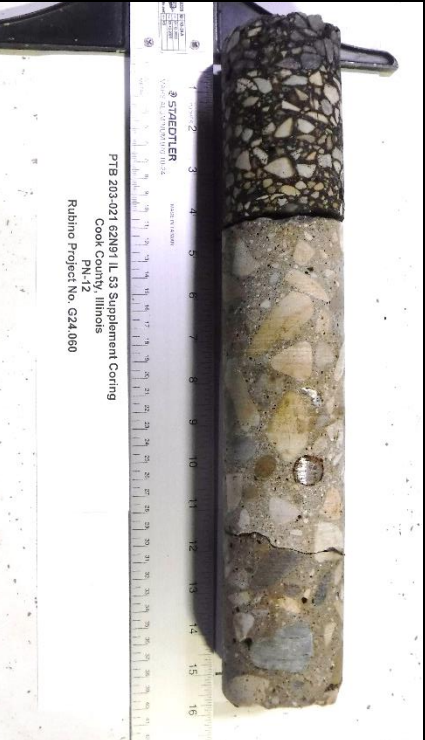
| PN - 10<br>(NB Inside Lane) | PN - 11<br>(NB Inside Lane) | PN - 12<br>(NB Inside Lane) |
|---|---|---|
| <p><u>Total Thickness = 16 inches</u></p> <p> Possible SMA Surface<sub>1</sub> = 1 ¾ in.</p> <p> HMA Binder<sub>1</sub> = 2 ½ in.</p> <p> HMA Binder<sub>2</sub> = 2 ¾ in.</p> <p> Weathering &amp; Deterioration</p> <p> Broken Concrete = 9 in.</p> <p> Subbase Stone = 2 inches</p> | <p><u>Total Thickness = 18 inches</u></p> <p> Possible SMA Surface<sub>1</sub> = 2 in.</p> <p> HMA Binder<sub>1</sub> = 2 ½ in.</p> <p> HMA Binder<sub>2</sub> = 1 in.</p> <p> Weathering &amp; Deterioration</p> <p> Broken Concrete = 8 ½ in.</p> <p> Weathering &amp; Deterioration</p> <p> HMA Binder<sub>3</sub> = 4 in.</p> <p> Subbase Stone Not Observed</p> | <p><u>Total Thickness = 15 inches</u></p> <p> Possible SMA Surface<sub>1</sub> = 1 ¾ in.</p> <p> HMA Binder<sub>1</sub> = 2 ½ in.</p> <p> HMA Binder<sub>2</sub> = ¾ in.</p> <p> Weathering &amp; Deterioration</p> <p> Concrete = 10 ½ in.</p> <p> Subbase Stone Not Observed</p> |

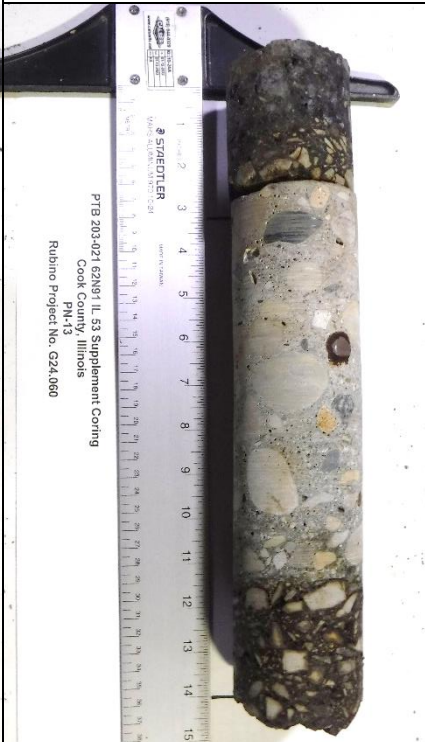
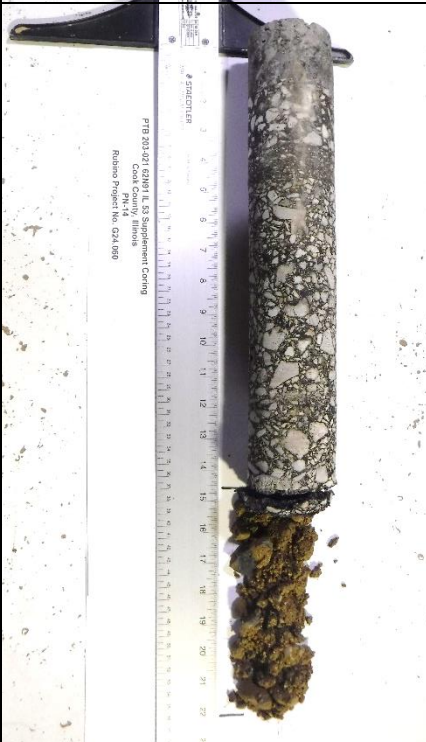
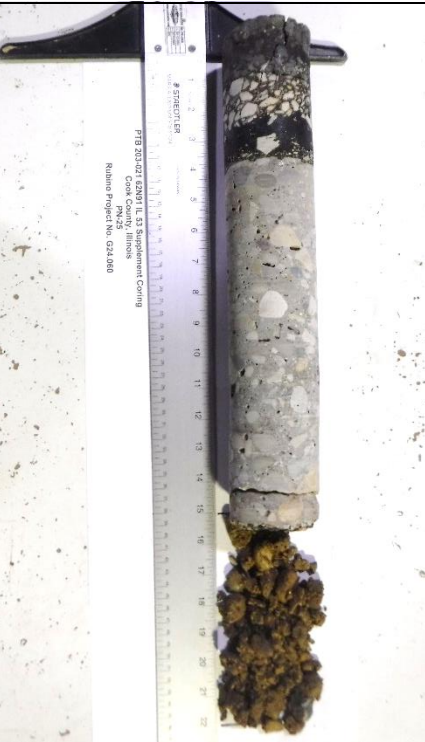
| PN - 13<br>(NB Outside Lane) | PN - 14<br>(NB Outside Lane) | PN - 15<br>(NB Outside Lane) |
|---|---|---|
| <p><u>Total Thickness = 14 inches</u></p> <p> Possible SMA Surface<sub>1</sub> = 1 ½ in.<br/> HMA Binder<sub>1</sub> = 1 ½ in.<br/> <b>Weathering &amp; Deterioration</b><br/> Concrete = 8 in.<br/> HMA Binder<sub>2</sub> = 3 in.<br/> Subbase Stone Not Observed</p> | <p><u>Total Thickness = 14 ½ inches</u></p> <p> Possible SMA Surface<sub>1</sub> = 2 in.<br/> HMA Binder<sub>1</sub> = 2 in.<br/> HMA Leveling Binder<sub>2</sub> = 1 in.<br/> HMA Binder<sub>3</sub> = 9 ½ in.<br/> Fabric Interlayer<br/> Subbase Stone = 7 ½ inches<br/> Core Barrel Reached Max Depth at 22 inches</p> | <p><u>Total Thickness = 15 inches</u></p> <p> Possible SMA Surface<sub>1</sub> = 1 ¾ in.<br/> HMA Binder<sub>1</sub> = 1 ½ in.<br/> Longitudinal Joint Sealing<br/> HMA Leveling Binder<sub>2</sub> = 1 in.<br/> Broken Concrete = 10 ¾ in.<br/> Subbase Stone = 7 inches<br/> Core Barrel Reached Max Depth at 22 inches</p> |

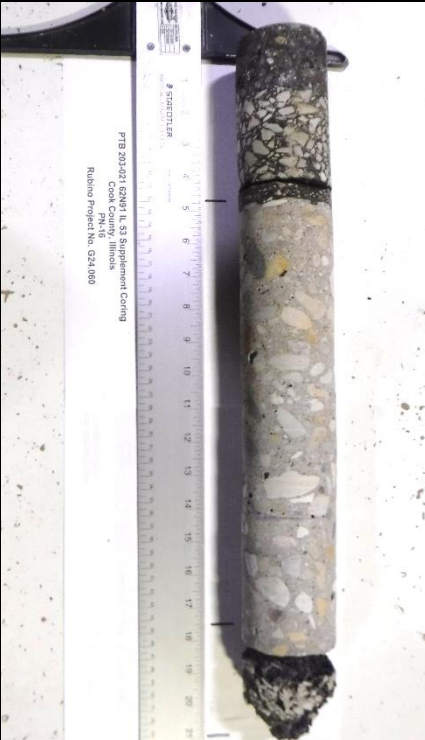
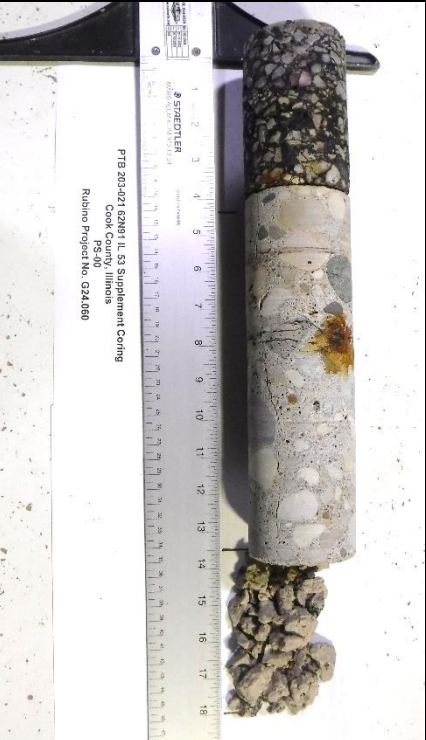
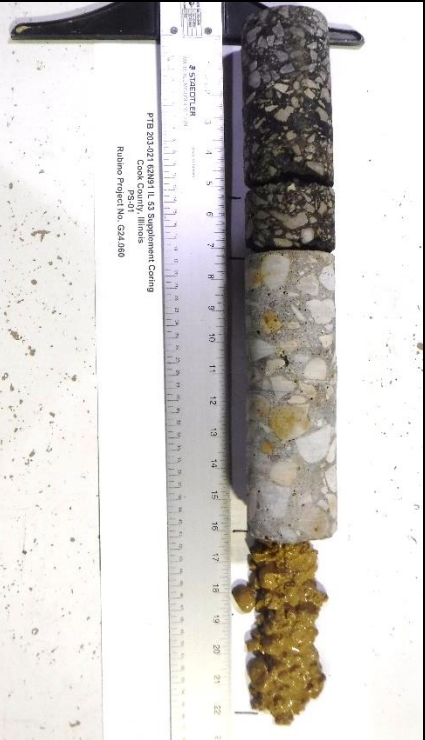
| PN - 16<br>(NB Outside Lane) | PS - 00<br>(SB Inside Lane) | PS - 01<br>(SB Outside Lane) |
|---|---|---|
| <p><u>Total Thickness = 21 inches</u></p> <p> Possible SMA Surface<sub>1</sub> = 2 in.<br/> HMA Binder<sub>1</sub> = 2 ½ in.<br/> <b>Weathering &amp; Deterioration</b><br/> HMA Leveling Binder<sub>2</sub> = ¾ in.<br/> Concrete = 12 ¼ in.<br/> HMA Surface<sub>3</sub> = 3 ½ in.<br/> Subbase Stone Not Observed </p> | <p><u>Total Thickness = 13 ½ inches</u></p> <p> Possible SMA Surface<sub>1</sub> = 1 ¾ in.<br/> HMA Binder<sub>1</sub> = 2 ½ in.<br/> <b>Weathering &amp; Deterioration</b><br/> Concrete = 9 ¼ in.<br/> Subbase Stone = 4 ½ inches </p> | <p><u>Total Thickness = 16 inches</u></p> <p> Possible SMA Surface<sub>1</sub> = 2 ½ in.<br/> HMA Binder<sub>1</sub> = 1 ½ in.<br/> HMA Binder<sub>2</sub> = 1 ¼ in.<br/> <b>Weathering &amp; Deterioration</b><br/> HMA Binder<sub>3</sub> = 2 in.<br/> <b>Weathering &amp; Deterioration</b><br/> Concrete = 8 ¾ in.<br/> Subbase Stone = 6 inches<br/> Core Barrel Reached Max Depth at 22 inches </p> |

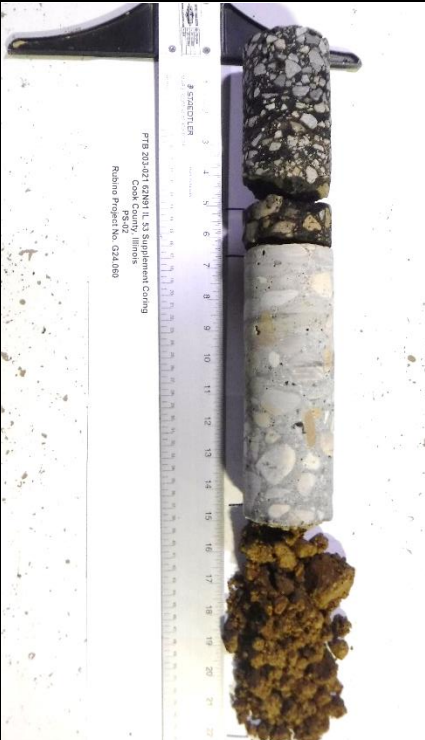
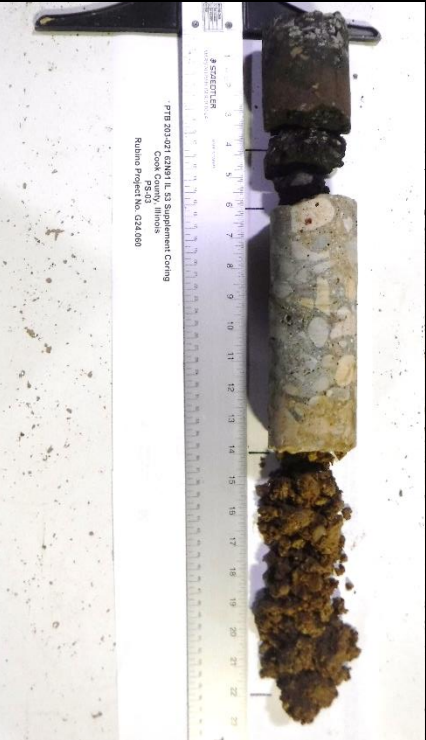
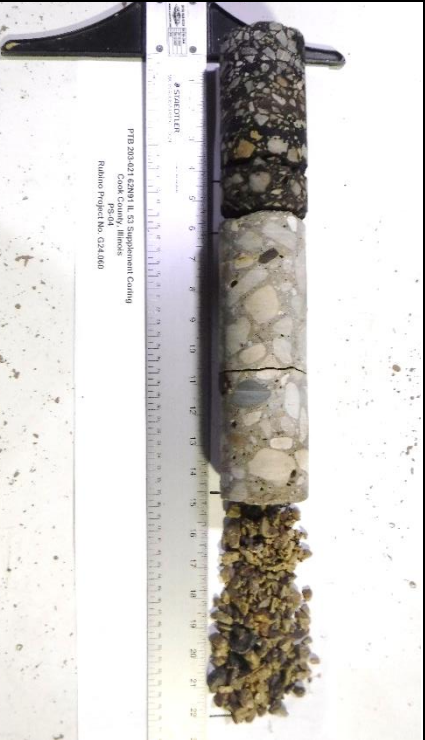
| PS - 02<br>(SB Inside Lane) | PS - 03<br>(SB Inside Lane) | PS - 04<br>(SB Outside Lane) |
|---|---|---|
| <p><u>Total Thickness = 14 ½ inches</u></p> <ul style="list-style-type: none"> <li>Possible SMA Surface<sub>1</sub> = 2 ¼ in.</li> <li>HMA Binder<sub>1</sub> = 2 ¾ in.</li> <li><b>Weathering &amp; Deterioration</b></li> <li>HMA Binder<sub>2</sub> = 1 ½ in.</li> <li><b>Weathering &amp; Deterioration</b></li> <li>Concrete = 8 in.</li> <li>Subbase Stone = 7 ½ inches</li> </ul> <p>Core Barrel Reached Max Depth at 22 inches</p> | <p><u>Total Thickness = 14 inches</u></p> <ul style="list-style-type: none"> <li>Possible SMA Surface<sub>1</sub> = 1 ½ in.</li> <li>HMA Binder<sub>1</sub> = 2 ½ in.</li> <li><b>Weathering &amp; Deterioration</b></li> <li>HMA Binder<sub>2</sub> = 2 in.</li> <li><b>NOT FULLY RECOVERED</b></li> <li>Concrete = 8 in.</li> <li>Subbase Stone = 8 inches</li> </ul> <p>Core Barrel Reached Max Depth at 22 inches</p> | <p><u>Total Thickness = 14 ½ inches</u></p> <ul style="list-style-type: none"> <li>Possible SMA Surface<sub>1</sub> = 1 ½ in.</li> <li>HMA Binder<sub>1</sub> = 1 ½ in.</li> <li>HMA Binder<sub>2</sub> = 1 ¼ in.</li> <li><b>Weathering &amp; Deterioration</b></li> <li>HMA Binder<sub>3</sub> = 1 ¾ in.</li> <li><b>Weathering &amp; Deterioration</b></li> <li>Broken Concrete = 8 ½ in.</li> <li>Subbase Stone = 7 ½ inches</li> </ul> <p>Core Barrel Reached Max Depth at 22 inches</p> |

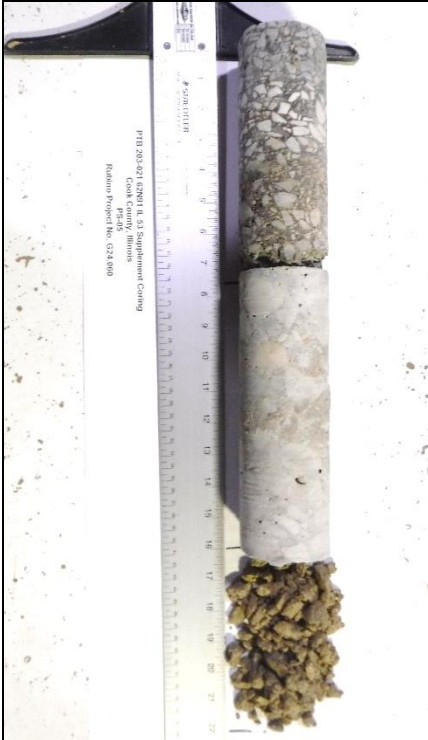
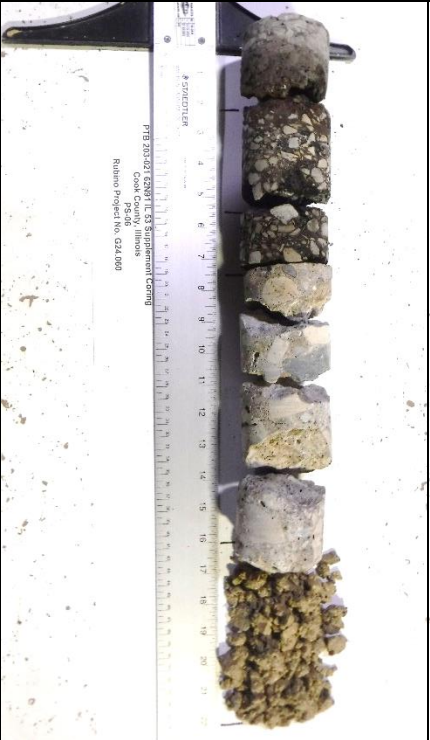
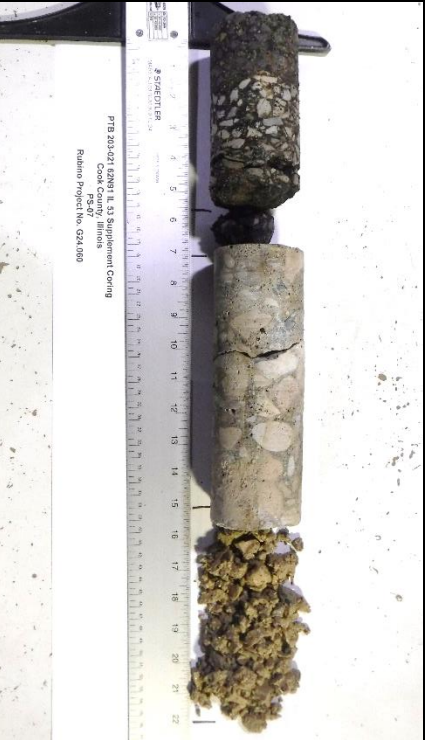
| PS - 05<br>(SB Inside Lane) | PS - 06<br>(SB Inside Lane) | PS - 07<br>(SB Inside Lane) |
|---|---|---|
| <p><u>Total Thickness = 16 inches</u></p> <ul style="list-style-type: none"> <li>Possible SMA Surface<sub>1</sub> = 2 in.</li> <li>HMA Binder<sub>1</sub> = 2 in.</li> <li>HMA Binder<sub>2</sub> = 3 ½ in.</li> <li><b>Weathering &amp; Deterioration</b></li> <li>Concrete = 8 ½ in.</li> <li>Subbase Stone = 6 inches</li> </ul> <p>Core Barrel Reached Max Depth at 22 inches</p> | <p><u>Total Thickness = 16 inches</u></p> <ul style="list-style-type: none"> <li>Possible SMA Surface<sub>1</sub> = 2 in.</li> <li><b>Weathering &amp; Deterioration</b></li> <li>HMA Binder<sub>1</sub> = 3 ½ in.</li> <li><b>Weathering &amp; Deterioration</b></li> <li>HMA Binder<sub>2</sub> = 2 in.</li> <li><b>Weathering &amp; Deterioration</b></li> <li>Broken Concrete = 8 ½ in.</li> <li>Subbase Stone = 6 inches</li> </ul> <p>Core Barrel Reached Max Depth at 22 inches</p> | <p><u>Total Thickness = 15 inches</u></p> <ul style="list-style-type: none"> <li>Possible SMA Surface<sub>1</sub> = 2 in.</li> <li>HMA Binder<sub>1</sub> = 2 in.</li> <li>HMA Binder<sub>2</sub> = 1 ½ in.</li> <li><b>Weathering &amp; Deterioration</b></li> <li>HMA Binder<sub>3</sub> = 1 ½ in.</li> <li><b>Weathering &amp; Deterioration</b></li> <li>Broken Concrete = 8 in.</li> <li>Subbase Stone = 7 inches</li> </ul> <p>Core Barrel Reached Max Depth at 22 inches</p> |

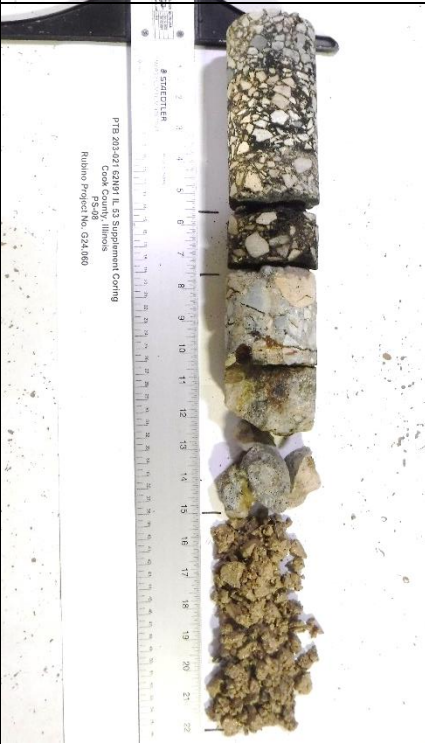
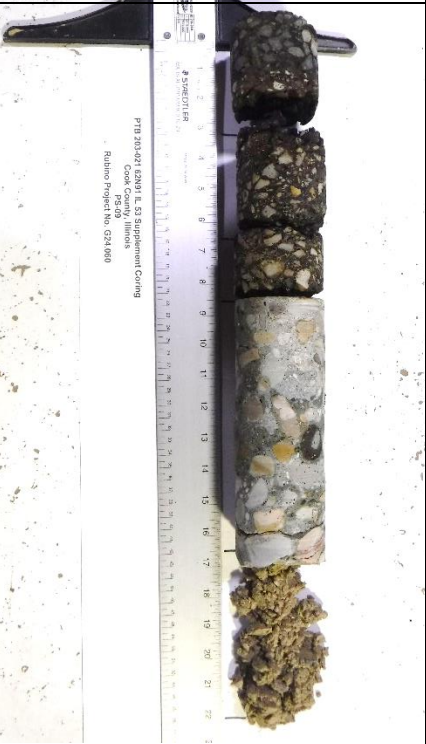
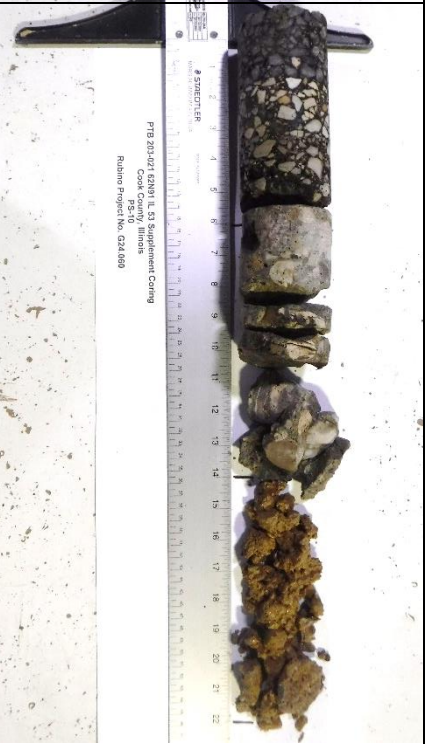
| PS - 08<br>(SB Inside Lane) | PS - 09<br>(SB Inside Lane) | PS - 10<br>(SB Inside Lane) |
|---|---|---|
| <p><u>Total Thickness = 15 inches</u></p> <ul style="list-style-type: none"> <li>Possible SMA Surface<sub>1</sub> = 2 in.</li> <li>HMA Binder<sub>1</sub> = 2 ¼ in.</li> <li>HMA Binder<sub>2</sub> = 1 ¼ in.</li> <li><b>Weathering &amp; Deterioration</b></li> <li>HMA Binder<sub>3</sub> = 2 in.</li> <li><b>Weathering &amp; Deterioration</b></li> <li>Broken Concrete = 7 ½ in.</li> <li>Subbase Stone = 7 inches</li> <li>Core Barrel Reached Max Depth at 22 inches</li> </ul> | <p><u>Total Thickness = 16 ½ inches</u></p> <ul style="list-style-type: none"> <li>Possible SMA Surface<sub>1</sub> = 2 in.</li> <li>HMA Binder<sub>1</sub> = 1 in.</li> <li><b>Weathering &amp; Deterioration</b></li> <li>HMA Binder<sub>2</sub> = 3 ½ in.</li> <li><b>Weathering &amp; Deterioration</b></li> <li>HMA Binder<sub>3</sub> = 2 in.</li> <li><b>Weathering &amp; Deterioration</b></li> <li>Broken Concrete = 8 in.</li> <li>Subbase Stone = 5 ½ inches</li> <li>Core Barrel Reached Max Depth at 22 inches</li> </ul> | <p><u>Total Thickness = 14 inches</u></p> <ul style="list-style-type: none"> <li>Possible SMA Surface<sub>1</sub> = 2 ¼ in.</li> <li>HMA Binder<sub>1</sub> = 1 ¾ in.</li> <li>HMA Binder<sub>2</sub> = 2 in.</li> <li><b>Weathering &amp; Deterioration</b></li> <li>Broken Concrete = 8 in.</li> <li>Subbase Stone = 8 inches</li> <li>Core Barrel Reached Max Depth at 22 inches</li> </ul> |
