RE: IL 53 Mainline and Shoulder Evaluation  
IDOT Contract Number 62N91  
IDOT Job Number D-91-144-21  
Section 2018-100-BR  
Cook County  
District 1  
PTB 203-021  
Gonzalez Job No. 23-1003

SUBJECT: TECHNICAL MEMO

IDOT Project Number 62N91  
 IDOT Job Number D-91-144-21  
 Route IL 53 (FAP 342) Supplement Coring - I-90 to Lake Cook Road  
 Section 2018-100-BR  
 County Cook  
 District 1  
 PTB 203-021

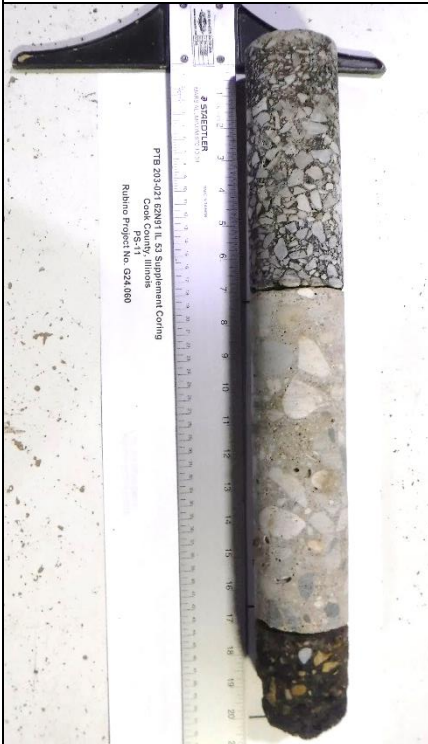
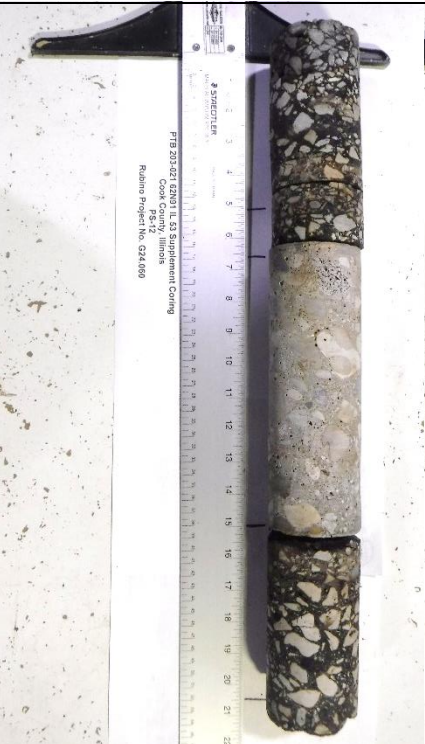
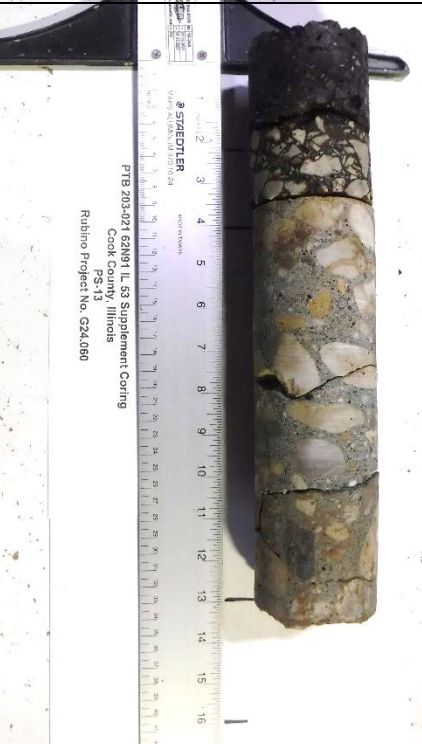
| PS - 11<br>(SB Inside Lane) | PS - 12<br>(SB Inside Lane) | PS - 13<br>(SB Outside Lane) |
|---|---|---|
| <p><u>Total Thickness = 20 inches</u></p> <ul style="list-style-type: none"> <li>HMA Surface<sub>1</sub> = 2 in.</li> <li>HMA Binder<sub>1</sub> = 3 ½ in.</li> <li>HMA Binder<sub>2</sub> = 1 ¾ in.</li> <li><b>Weathering &amp; Deterioration</b></li> <li>Concrete = 9 ¼ in.</li> <li><b>Weathering &amp; Deterioration</b></li> <li>HMA Binder<sub>3</sub> = 3 ½ in.</li> <li>Subbase Stone Not Observed</li> </ul> | <p><u>Total Thickness = 20 ½ inches</u></p> <ul style="list-style-type: none"> <li>Possible SMA Surface<sub>1</sub> = 1 ½ in.</li> <li>HMA Binder<sub>1</sub> = 2 ¾ in.</li> <li>HMA Surface<sub>1</sub> = ¾ in.</li> <li><b>Weathering &amp; Deterioration</b></li> <li>HMA Surface<sub>2</sub> = ¾ in.</li> <li>HMA Binder<sub>3</sub> = ¾ in.</li> <li><b>Weathering &amp; Deterioration</b></li> <li>Concrete = 8 ½ in.</li> <li><b>Weathering &amp; Deterioration</b></li> <li>HMA Binder<sub>4</sub> = 5 ½ in.</li> <li>Subbase Stone Not Observed</li> </ul> | <p><u>Total Thickness = 16 inches</u></p> <ul style="list-style-type: none"> <li>Possible SMA Surface<sub>1</sub> = 2 in.</li> <li><b>Weathering &amp; Deterioration</b></li> <li>HMA Binder<sub>1</sub> = 2 in.</li> <li><b>Weathering &amp; Deterioration</b></li> <li>Broken Concrete = 9 in.</li> <li>HMA Surface<sub>3</sub> = 3 in.</li> <li>Subbase Stone Not Observed</li> </ul> |

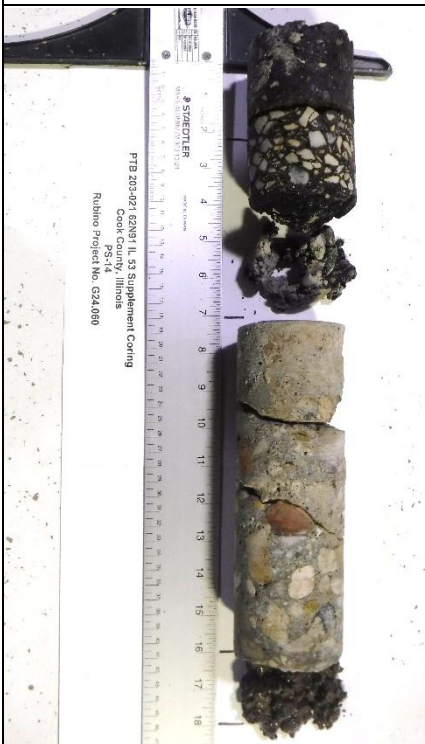
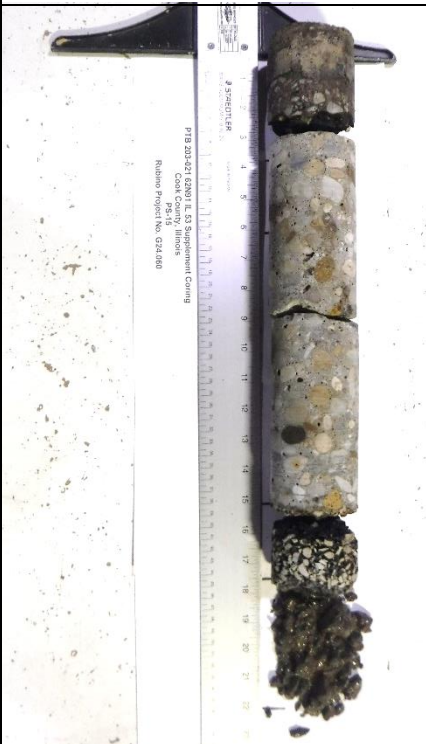
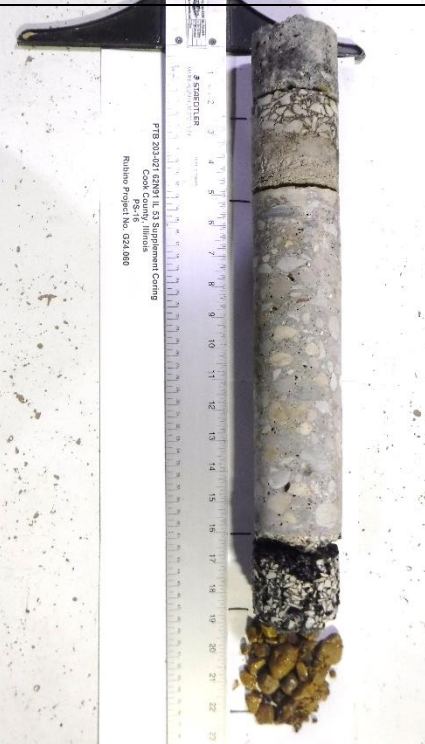
| PS - 14<br>(SB Outside Lane) | PS - 15<br>(SB Outside Lane) | PS - 16<br>(SB Outside Lane) |
|---|---|---|
| <p><u>Total Thickness = 16 inches</u></p> <ul style="list-style-type: none"> <li>Possible SMA Surface<sub>1</sub> = 2 in.</li> <li><b>Weathering &amp; Deterioration</b></li> <li>HMA Binder<sub>1</sub> = 2 in.</li> <li>HMA Layer<sub>3</sub> = 3 in.</li> <li><b>Weathering &amp; Deterioration</b></li> <li>Broken Concrete = 9 in.</li> <li>Subbase Stone = 2 inches</li> </ul> | <p><u>Total Thickness = 17 ½ inches</u></p> <ul style="list-style-type: none"> <li>Possible SMA Surface<sub>1</sub> = 1 ¾ in.</li> <li>HMA Binder<sub>1</sub> = 1 ¾ in.</li> <li><b>Weathering &amp; Deterioration</b></li> <li>Broken Concrete = 11 ½ in.</li> <li><b>Weathering &amp; Deterioration</b></li> <li>HMA Binder<sub>2</sub> = 2 ½ in.</li> <li>Subbase Stone = 4 ½ inches</li> <li>Core Barrel Reached Max Depth at 22 inches</li> </ul> | <p><u>Total Thickness = 18 ½ inches</u></p> <ul style="list-style-type: none"> <li>Possible SMA Surface<sub>1</sub> = 2 ¼ in.</li> <li><b>Weathering &amp; Deterioration</b></li> <li>HMA Binder<sub>1</sub> = 2 ¼ in.</li> <li><b>Weathering &amp; Deterioration</b></li> <li>Broken Concrete = 11 in.</li> <li><b>Weathering &amp; Deterioration</b></li> <li>HMA Binder<sub>2</sub> = 2 ½ in.</li> <li>Subbase Stone = 3 ½ inches</li> <li>Core Barrel Reached Max Depth at 22 inches</li> </ul> |
