STATE OF ILLINOIS  
 DEPARTMENT OF TRANSPORTATION

EXISTING BOX CULVERT REPAIR DETAILS  
 STRUCTURE NUMBER 042-2470

SHEET NO. 4 OF 4 SHEETS

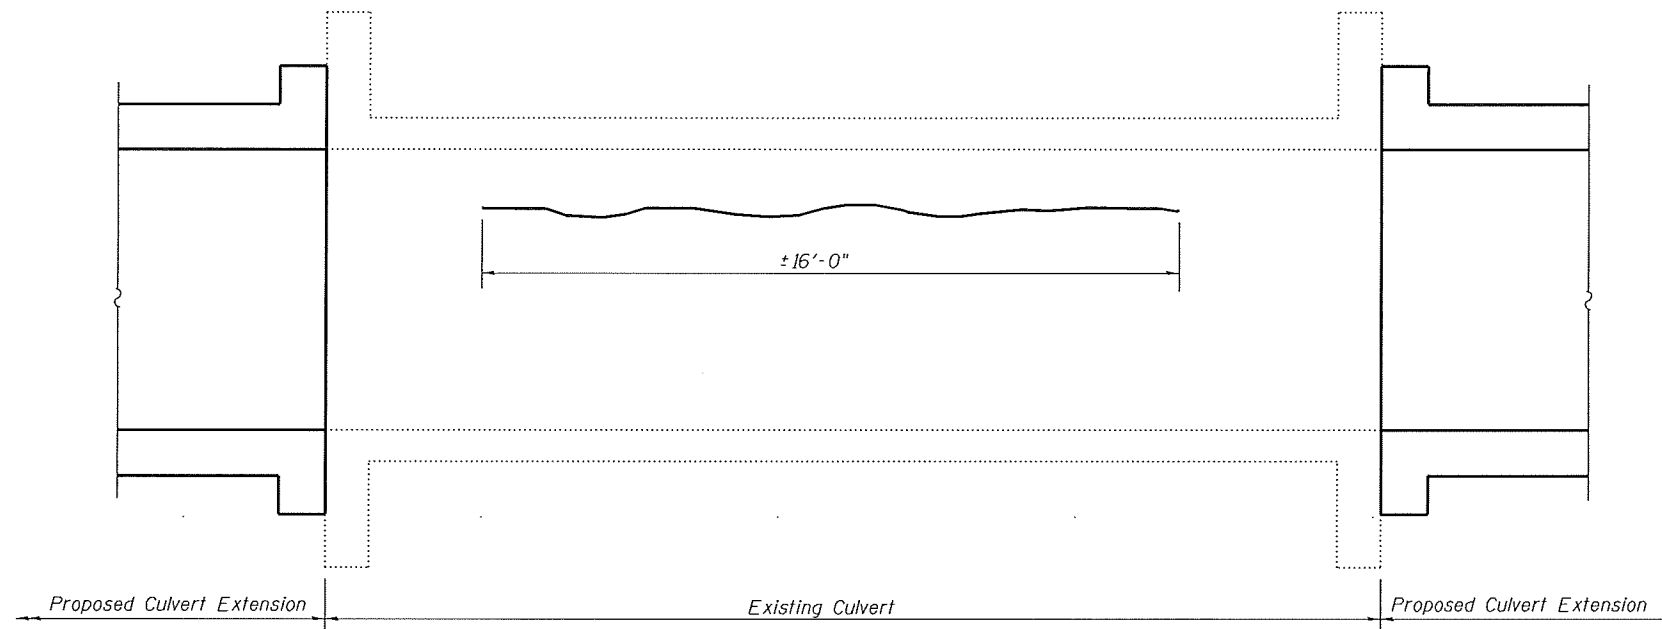
**ELEVATION**  
(Showing Inside Face of East Wall)

~~~~~ Indicates Epoxy Crack Injection Required

*Note:*  
The limits of Epoxy Crack Injection shown are approximate. The limits of Epoxy Crack Injection may vary in the field. Changes in the quantity of Epoxy Crack Injection shall be approved by the Engineer.
