# Pre-Demolition Asbestos Survey Report

Single-Family Residence – IDOT Work Order 51

203 East Fayette Avenue

June 4, 2026 | Terracon Project Number: 11267090

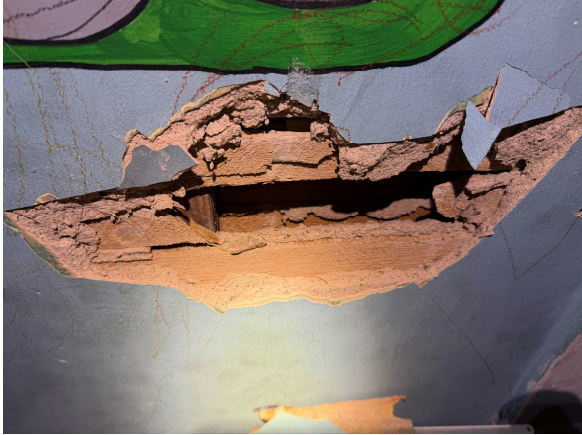
| <p><b>Photo #1</b> HA 1: Hard layered plaster walls and ceilings (non-ACM)</p> | | <p><b>Photo #2</b> HA 2: Tan felt paper under wood flooring (non-ACM)</p> |

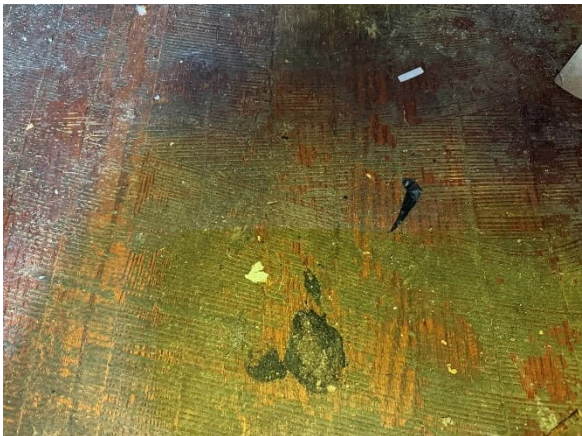
| <p><b>Photo #3</b> HA 3: Tan mastic on wood flooring (non-ACM)</p> | | <p><b>Photo #4</b> HA 4: 1' X 1' white smooth tongue and groove ceiling tile (no glue) (non-ACM)</p> |

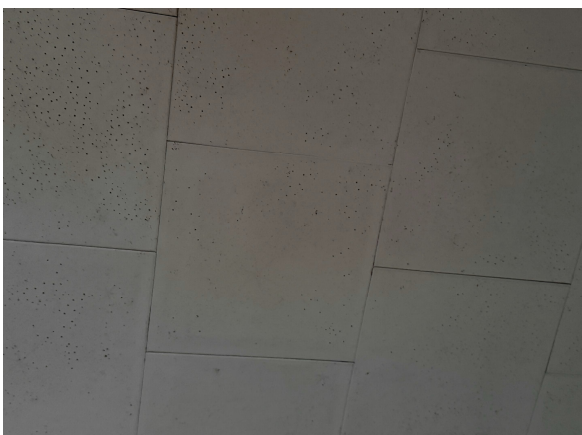
| <p><b>Photo #5</b> HA 5: 1' X 1' white pinhole tongue and groove ceiling tile (no glue) (non-ACM)</p> | | <p><b>Photo #6</b> HA 6: Beige square pattern vinyl sheet flooring and clear mastic (non-ACM)</p> |

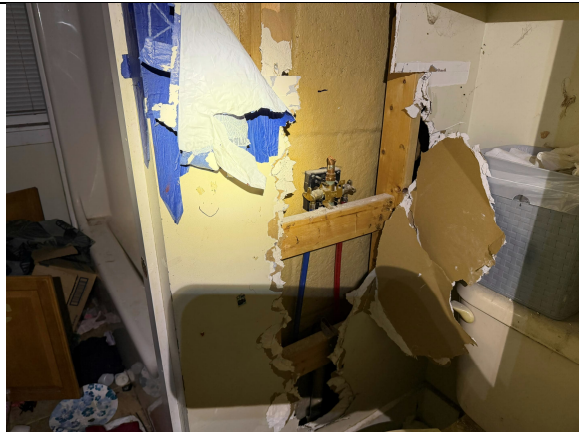
| Sample No. | Material Description | Material Location | Sample Location | Lab Result |
|---|---|---|---|---|
| 51-7-24 | | | 2 <sup>nd</sup> floor ceiling-south | ND-drywall material<br>2 % Chrysotile-joint compound |
| 51-7-25 | | | 2nd floor wall-north | ND-drywall material<br>2 % Chrysotile-joint compound |

| <p><b>Photo #7</b> HA 7: Drywall (non-ACM), joint compound (ACM)</p> | | <p><b>Photo #8</b> HA 8: Beige rectangle pattern vinyl sheet flooring and clear mastic (non-ACM)</p> |

- Identified ACMs should be removed and disposed of by an IDPH-licensed asbestos abatement contractor prior to the demolition activity that would disturb them in accordance with federal, state, and local asbestos regulations. Terracon recommends that an IDPH-licensed asbestos professional should represent the responsible party/Client on-site during abatement activities to

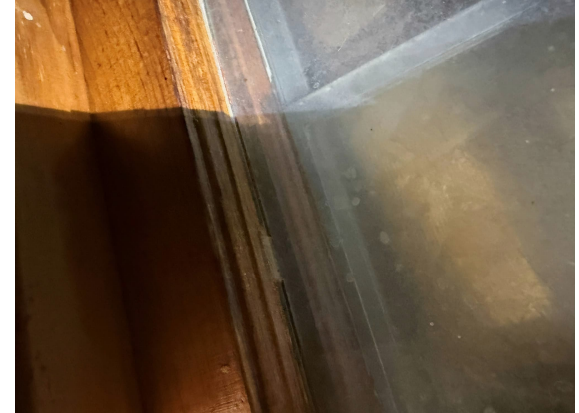
| Sample No. | Material Description | Material Location | Sample Location | Lab Result |
|---|---|---|---|---|
| 51-9-30 | | | Kitchen window | 2 % Chrysotile-window glazing |

| Sample No. | Material Description | Material Location | Sample Location | Lab Result |
|---|---|---|---|---|
| 51-9-31 | | | 2 <sup>nd</sup> floor west window | 2 % Chrysotile-window glazing |

| <p><b>Photo #9</b> HA 9: Tan exterior window glazing (ACM)</p> | | <p><b>Photo #10</b> HA 10: Blue and beige octagon pattern vinyl sheet flooring with light gray fiber backing (non-ACM) and clear mastic (non-ACM)</p> |

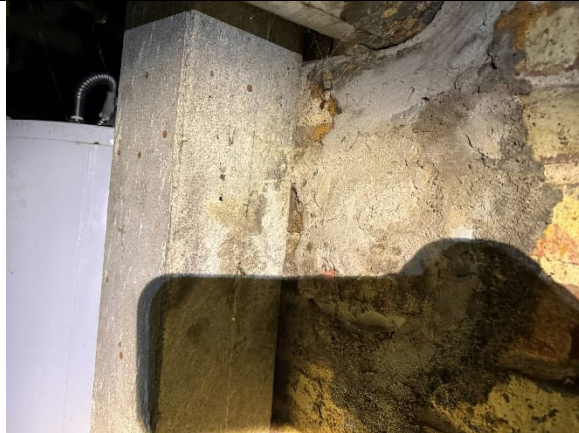
| <p><b>Photo #11</b> HA 11: Gray boiler flue cement (non-ACM)</p> | | <p><b>Photo #12</b> HA 12: 9" X 9" brown with black streaks vinyl floor tile (ACM) and black mastic over felt/tar paper (non-ACM)</p> |

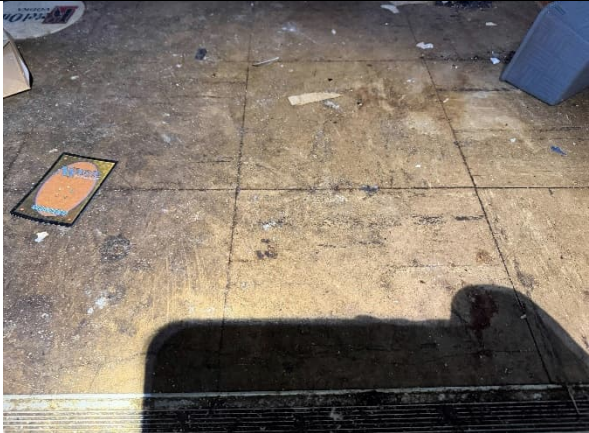
| Sample No. | Material Description | Material Location | Sample Location | Lab Result |
|---|---|---|---|---|
| 51-12-39 | | | Center portion of 2 <sup>nd</sup> floor | 5 % Chrysotile-floor tile<br>ND-black mastic<br>ND-felt/tar paper |
| 51-12-40 | | | 2 <sup>nd</sup> floor hallway | 5 % Chrysotile-floor tile<br>ND-black mastic<br>ND-felt/tar paper |

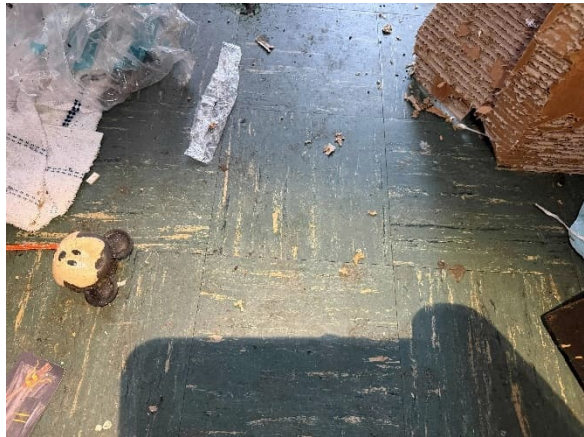
| Sample No. | Material Description | Material Location | Sample Location | Lab Result |
|---|---|---|---|---|
| 51-13-41 | 9" X 9" green with beige and black streaks vinyl floor tile | North portion of 2 <sup>nd</sup> floor | North portion of 2 <sup>nd</sup> floor | 5 % Chrysotile-floor tile<br>ND-black mastic<br>ND-felt/tar paper |

| Sample No. | Material Description | Material Location | Sample Location | Lab Result |
|---|---|---|---|---|
| 51-13-42 | and black mastic over felt/tar paper | | North portion of 2 <sup>nd</sup> floor | 5 % Chrysotile-floor tile<br>ND-black mastic<br>ND-felt/tar paper |
| 51-13-43 | | | North portion of 2 <sup>nd</sup> floor | 5 % Chrysotile-floor tile<br>ND-black mastic<br>ND-felt/tar paper |

| <p><b>Photo #13</b> HA 13: 9" X 9" green with beige and black streaks vinyl floor tile (ACM) and black mastic over felt/tar paper (non-ACM)</p> | | <p><b>Photo #14</b> HA 14: Beige boiler flue cement (non-ACM) with gray insulation (ACM)</p> |

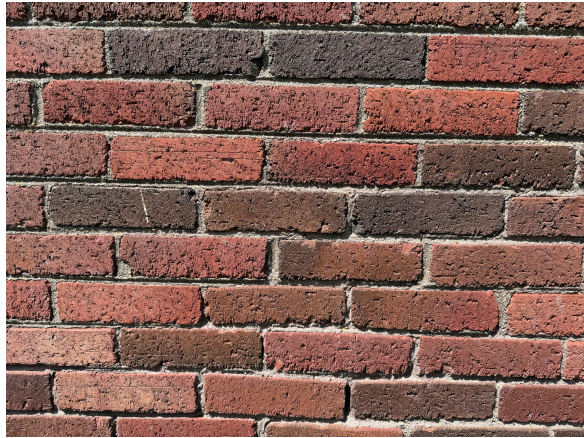
| <p><b>Photo #15</b> HA 15: Red brick (non-ACM) and gray mortar (non-ACM)</p> | | <p><b>Photo #16</b> HA 16: Tar paper under exterior siding (non-ACM)</p> |

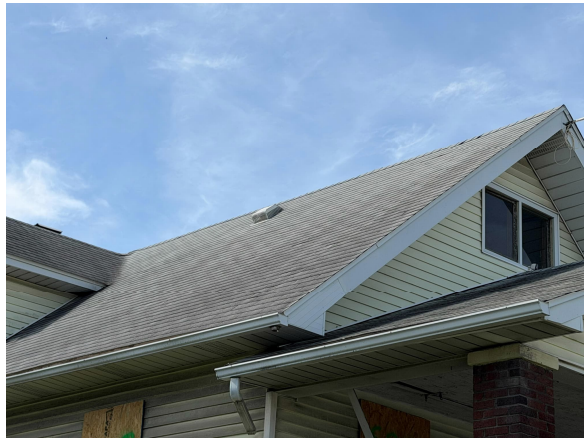
| <p><b>Photo #17</b> HA 17: White/black asphalt shingles (non-ACM) and underlying black tar paper (non-ACM)</p> | | |
