SHEET NO. S30 RTE. TOTAL SHEET NO. SECTION COUNTY 04-00090-07-BR WILL 57 38 S47 SHEETS CONTRACT NO. 63442 FED. ROAD DIST. NO. | ILLINOIS | FED. AID PROJECT

PIER 1 AND 2 REPAIRS

STRUCTURE NO. 099-3298

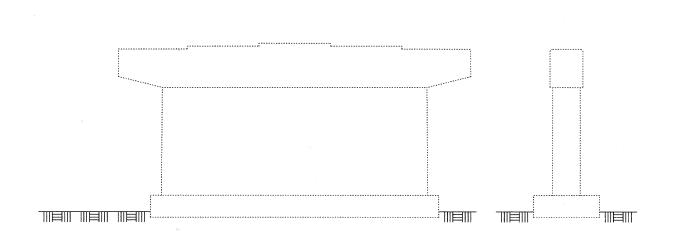
indicates Epoxy Crack Injection

indicates Structural Repair of Concrete (Depth Equal to or Less Than 5 Inches)

- The quantities shown are provided as a contingency for estimating purposes only. The area to be repaired shall be determined by the Engineer at the time of construction. Actual repair locations shall be shown on the as-built plans.
- 2. Crack widths are  $\frac{1}{8}$ "  $\pm \frac{1}{16}$ " unless otherwise noted.
