BILL OF MATERIAL

SHEET NO. S31 F.A.U. RTE. TOTAL SHEET NO. SECTION COUNTY 341 04-00090-07-BR WILL 57 39 S47 SHEETS CONTRACT NO. 63442 FED. ROAD DIST. NO. ILLINOIS FED. AID PROJECT

PIER 3 REPAIR 1 OF 2 STRUCTURE NO. 099-3298

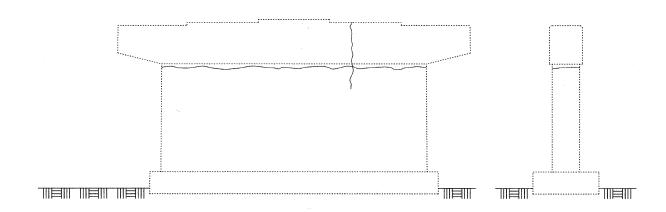
indicates Epoxy Crack Injection

- The quantities shown are provided as a contingency for estimating purposes only. The area to be repaired shall be determined by the Engineer at the time of construction. Actual repair locations shall be shown on the as-built plans.
- 2. Crack widths are $\frac{1}{8}$ " $\pm \frac{1}{16}$ " unless otherwise noted.
