STATE OF ILLINOIS
DEPARTMENT OF TRANSPORTATION

Inspection Date: 12/11/07

WEST ABUTMENT
OLD IL 13 OVER BANKSTON FORK
FAS ROUTE 899 - SECTION 8BR-2
SALINE COUNTY
STATION R02+60.00
STRUCTURE NO. 083-0036

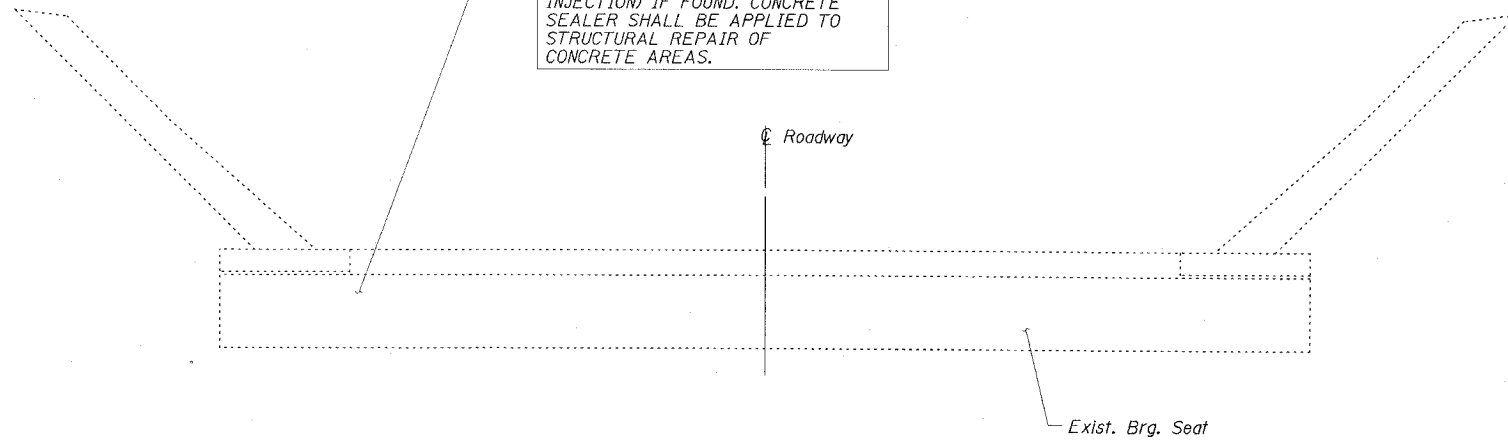
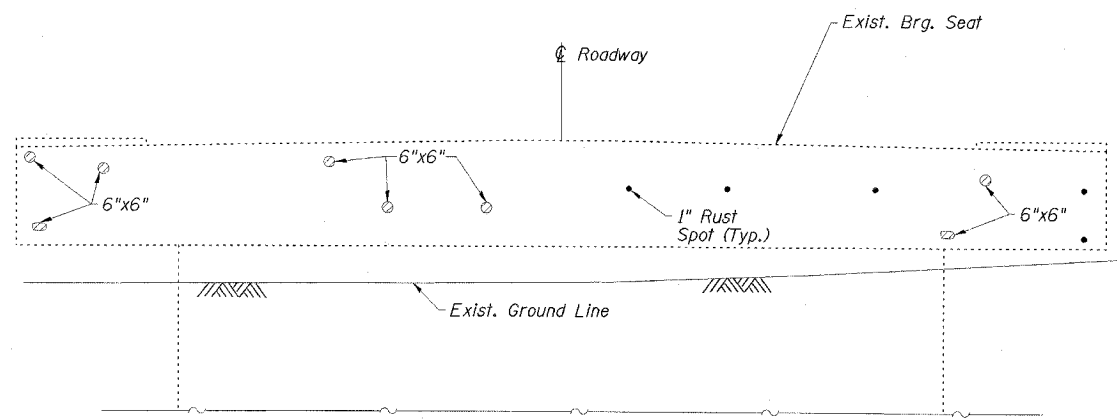
EXISTING BEARING SEAT TO BE INSPECTED BY THE ENGINEER AFTER DECK BEAM REMOVAL. DETERIORATED CONCRETE AREAS SHALL BE REPAIRED (ESTIMATED 15 S.F. STRUCTURAL REPAIR OF CONCRETE DEPTH < 5") AND CRACKS SHALL BE SEALED (ESTIMATED 20' EPOXY CRACK INJECTION) IF FOUND. CONCRETE SEALER SHALL BE APPLIED TO STRUCTURAL REPAIR OF CONCRETE AREAS.

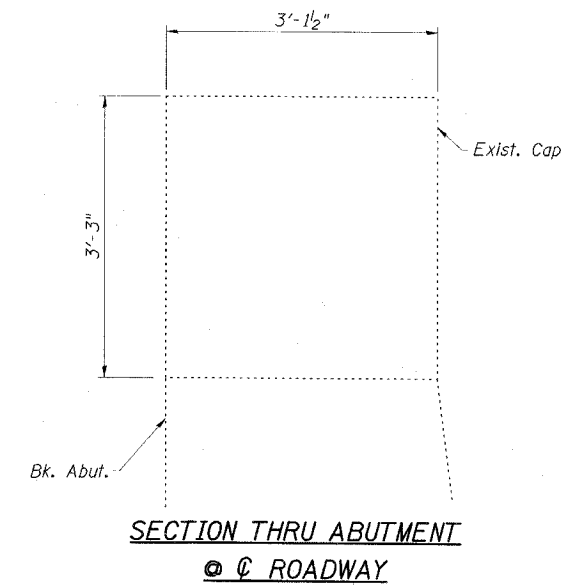
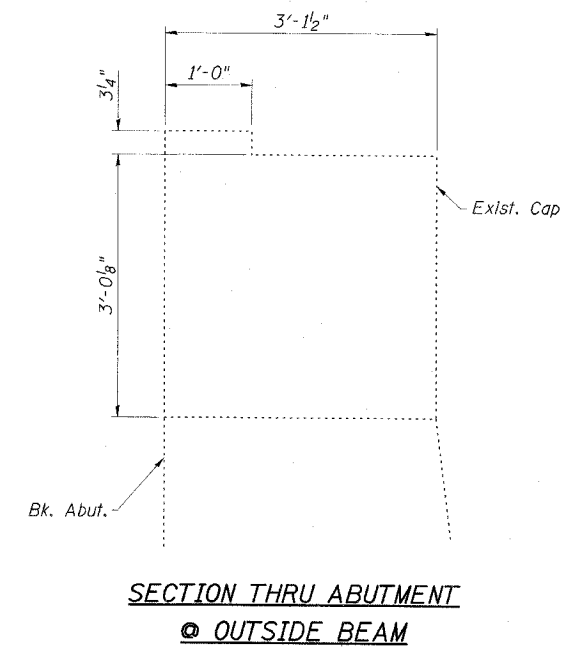
ABUTMENT CRACK REPAIR LENGTHS AND STRUCTURAL REPAIR OF CONCRETE AREAS ARE ESTIMATED FROM 12-11-07 SURVEY WORK. ACTUAL LOCATIONS AND QUANTITIES OF REPAIRS SHALL BE SHOWN BY THE ENGINEER ON THE AS-BUILT PLANS FOR THIS SECTION.
