ABUTMENT REPAIRS
F.A.P. Route 303 & F.A.P. Route 738
(IL 251) OVER Rockton Road
SECTION (5VB, 5HB, 1-2HB)M
WINNEBAGO COUNTY
SN 101-0031 & 101-0032

SHEET NO. 6

CONTRACT #64A88

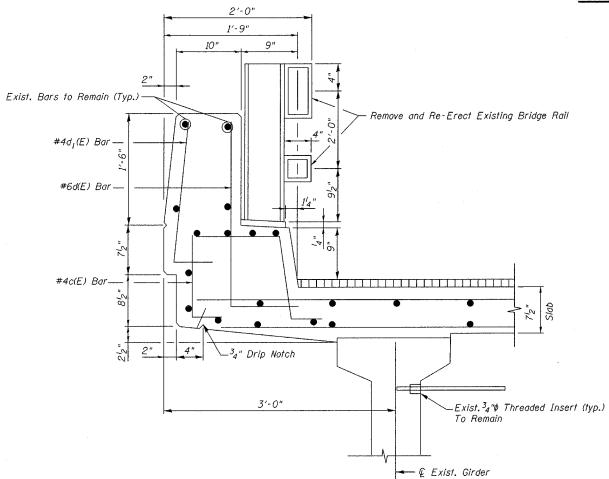
TYP. SECTION THRU EXIST. PARAPET

SHOWING STEEL RETROFIT RAIL
(For Information Only)

Note: Contractor must ensure that rails are properly marked before removal to ensure proper placement during re-erection.
