Procedure for Repair Detail

Contract No. 76894

STEEL REPAIR DETAILS FAI ROUTE 270 MADISON COUNTY STR. No. 060-0035 (WB)

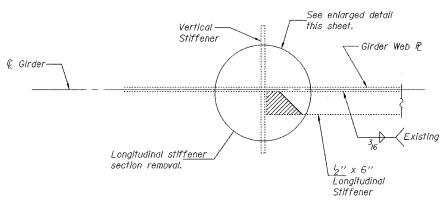
REPAIR DETAIL

Grind to smooth transition. -1" R Min. Grind smo<u>oth</u> (Typ_*) ±4"

Hatched area indicates section removal. (Typ. at piers 7, 10, 11, 15, 19, 24 & 28. 26 Locations.)

1. Cut existing longitudinal stiffener ±4" from face of vertical stiffener and along web as shown, with a 1"R (Min) at Web. The minimum distance from cut to face of web shall be the larger of 4" or stiffener to web weld size with removal of remaining material by grinding as described below. The cut shall be made vertically through the stiffener without angling the cut towards the web. Equipment and method of cutting shall be approved by the Engineer. Any method of removal to be used shall ensure that no damage is done to the existing web, vertical stiffener or welds connecting these elements. Cutting shall be done

and grind smooth at web surface. Web plate surfaces shall have a roughness average (Ra) of 250 µ in. or less. Grinding equipment shall be approved by the Engineer. The grinding operation should not gouge the girder web R.

3. Remove all burrs from cut end of stiffener. Cut surface

4. The web surface at the modification shall be inspected using dye penetrant or magnetic particle methods. Any cracks found shall be identified and reported to the

shall be ground smooth and shall have an Ra of 500 µ in.

Bureau of Bridges and Structures for further disposition.

2. Remove material between cut and web by grinding
