### STATE OF ILLINOIS DEPARTMENT OF TRANSPORTATION

Contract: 76906

REP-1 1-14-2005

> BEAM STRAIGHTENING F.A.I. RT 64 ST. CLAIR COUNTY SN 082-0150

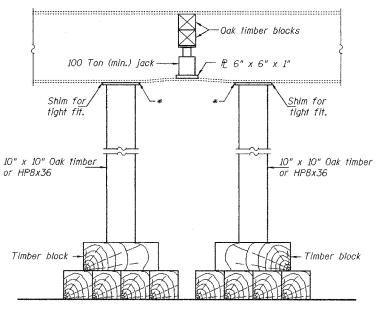
### SUGGESTED VERTICAL STRAIGHTENING DETAIL

(To correct localized vertical flange deformations.)

\* Edge of plate shall line up with edge of deformation.

#### Note:

Braces and jack assembly shall be placed on same side of web. Bent bottom flange shall be straightened before starting any horizontal straightening operations.
