| REVISIONS | | ILLINOIS DEPARTMENT | OF TRANSPORTATION | |
|---|---|---|---|--|
| | | NB DAN RYAN EL | _EVATED BRIDGE | |
| | | REPAIR FROM 15TH | TO 28TH STREETS | |
| | | CONCRETE PIER REPAIRS | | |
| | | SN 016-1113, | PIERS 1, C-11 | |

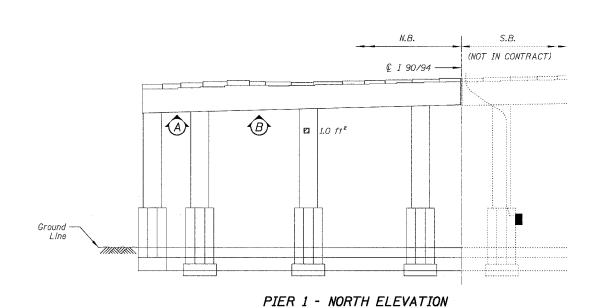
### <u>PIER 1 - VIEW A</u>

4.5 ft<sup>2</sup>

Looking up at bottom of cap

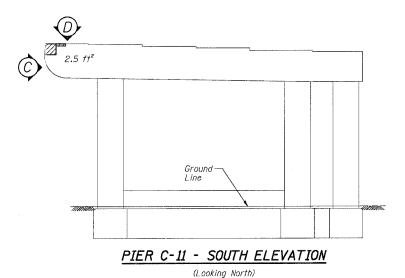
# PIER C-11 - VIEW C

3.0 ft<sup>2</sup>

Looking East at end of cap
