STATE OF ILLINOIS
DEPARTMENT OF TRANSPORTATION

ROUTE NO.	SECTION	COUNTY	TOTAL SHEETS	SHEET NO.	SHEET NO. 3
S.B.L. P.A.P. 305	*	COOK	72	49	7 SHEETS
*2004-108 BR			Contract No. 62853

CONCRETE DECK BEAM REPAIRS
EAST FRONTAGE ROAD OVER PALATINE ROAD
FAP 305/PALATINE ROAD
SECTION 2004-108 BR
COOK COUNTY
STA. 0+88.85
STRUCTURE NO. 016-2529

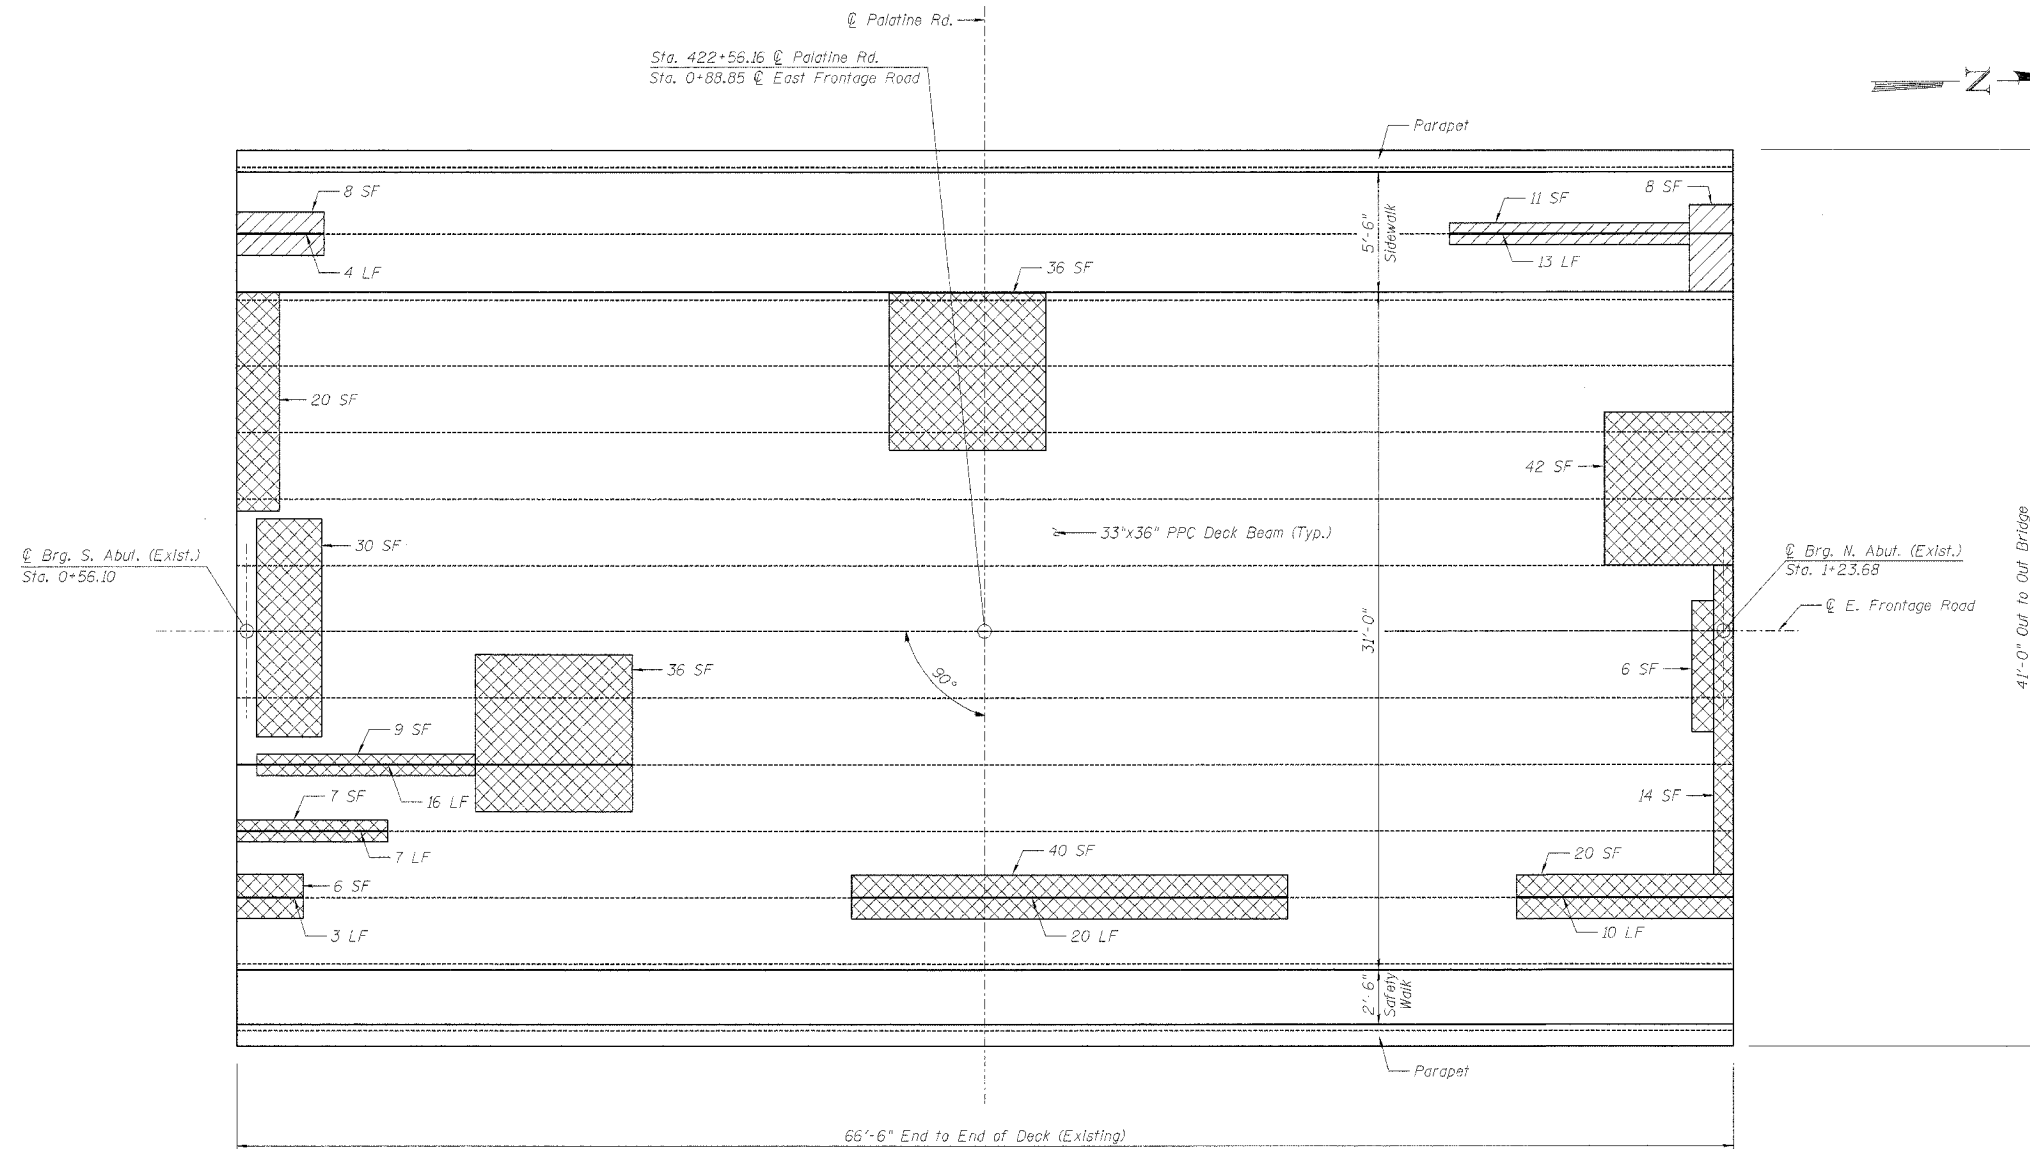
PLAN OF CONCRETE DECK BEAM REPAIRS
TOP VIEW

Repair areas shown are the surveyed areas of deterioration. The actual area to be repaired shall be as directed by the Engineer.

Surveyed areas that show possible delamination should be investigated after removal of the bituminous overlay. Any areas with delamination extending to the top mat of reinforcement on the beam shall be cleaned of any loose concrete and filled back up with the concrete overlay. Any area where the damage extends below the top mat of reinforcement on the beam shall be brought to the attention of the Bureau of Bridges and Structures for further disposition. Work included in the cost of "Concrete Wearing Surface."

Contractor must exercise extreme care while doing sidewalk repairs so as not to damage the PPC Deck Beams.
