STATE OF ILLINOIS DEPARTMENT OF TRANSPORTATION

ABUTMENT REPAIRS F.A.P. Route 303 & F.A.P. Route 738 (IL 251) OVER Rockton Road SECTION (5VB, 5HB, 1-2HB)M WINNEBAGO COUNTY SN 101-0031 & 101-0032

SHEET NO. 6

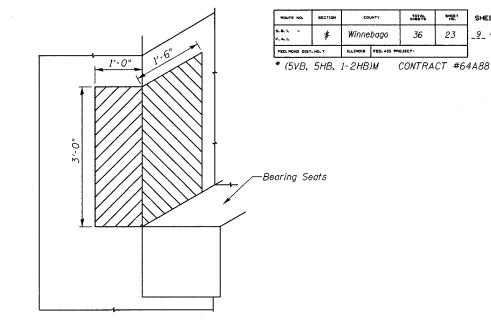
EAST WALL SOUTH ABUTMENT S.N. 101-0032

Formed Concrete Repair (Depth equal to or less than 5")

Epoxy Crack Sealing

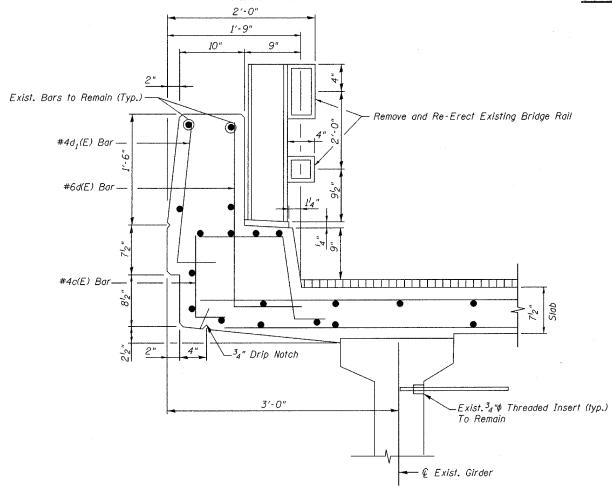
TYP. SECTION THRU EXIST. PARAPET

SHOWING STEEL RETROFIT RAIL (For Information Only)

Note: Contractor must ensure that rails are properly marked before removal to ensure proper placement during re-erection.
