DESIGNED VHV	EXAMINED	Jayne F. Jeff	DATE JUNE 29, 2011	ATATE OF 11111010	REPAIR DETAILS	F.A.I. SECTION	COUNTY TOTAL SHEET SHEETS NO.
CHECKED DAB DRAWN baliva	PASSED	ENGINEER OF STRUCTURAL HERVICES	REVISED	STATE OF ILLINOIS DEPARTMENT OF TRANSPORTATION	SN 081-0014	80 (37-1BY-1, 81-1VB, 81-1HB-1)M-1	ROCK ISLAND 15 8
CHECKED VHV DAB		INGINEER OF BRIDGES AND STRUCTURES	REVISED		SHEET NO. 3 OF 3 SHEETS	ILLINOIS FED.	AID PROJECT

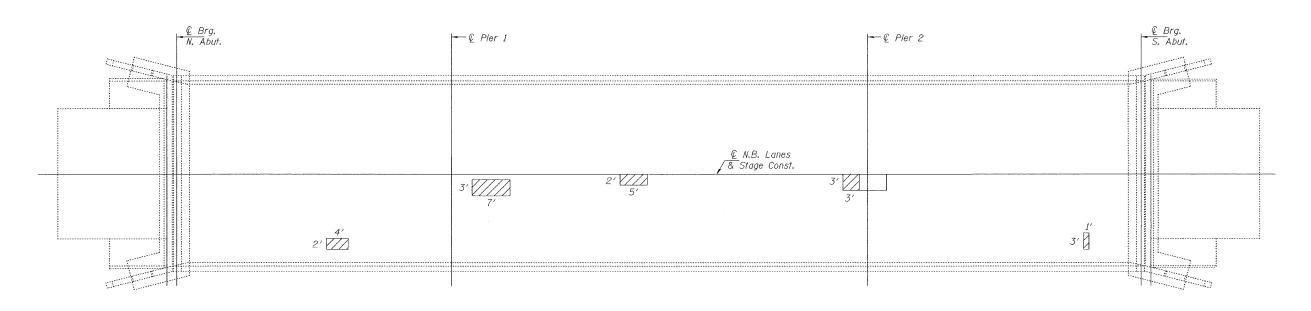
PLAN

Hatched areas indicate Deck Slab Repair (Partial).
Areas of deck repair are estimated. Actual locations shall be shown by the engineer for As Built Plans.

Cross hatched areas indicate Deck Slab Repair (Full Depth, Type I).
