## ABUTMENT REPAIR DETAILS STRUCTURE NO. 077-0035

SECTION	COUNTY	TOTAL SHEETS	SHEET NO.
	16BR-1	PULASKI	68	54
		CONTRACT	NO. 78	071
C	DAD DIST. NO. ILLINOIS FED. A	ID PROJECT

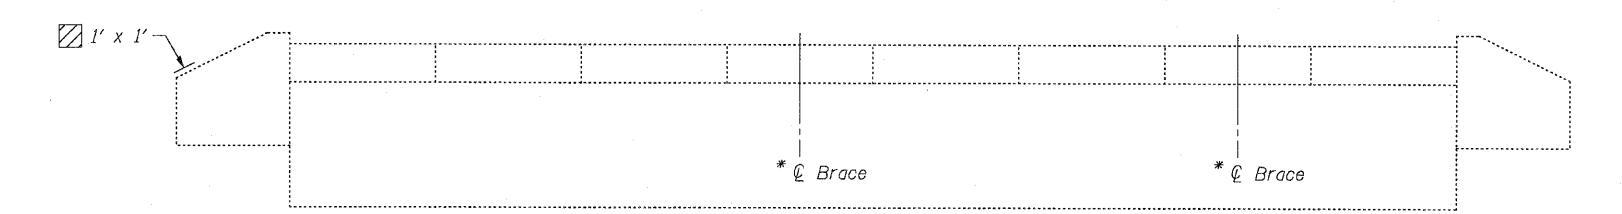
NORTH ABUTMENT ELEVATION (Looking North)

\* Additional Concrete Repair may be required at brace connection locations as directed by the Engineer. Cost included with Removal of Existing Superstructures Superstructures.
