STATE OF ILLINOIS DEPARTMENT OF TRANSPORTATION

BEAM STRAIGHTENING DETAILS F.A.I. RT. 74 TAZEWELL COUNTY SN 090-0009

REP-1 1-14-2005

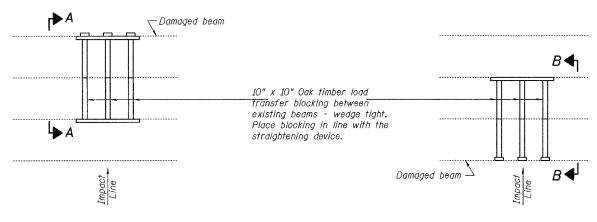
SUGGESTED BEAM STRAIGHTENING METHODS

Straightening force shall be maintained on all load transfer blocking during beam straightening.

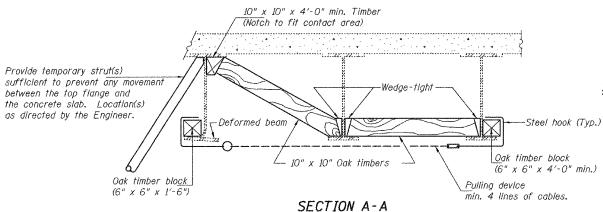
SECTION B-B

EXISTING DEFORMATION TO BE STRAIGHTENED

(Looking East) (Approximate max. deflections) Deflected length of beam to be straightened is approximately 8'-0".

Grind existing nicks, gouges and shallow cracks in the damaged beams as detailed. Ground surfaces shall be inspected for cracks using magnetic particle testing prior to initiating any beam straightening operations. Any cracks that cannot be removed by grinding approximately 4" deep shall be identified and reported to the Bureau of Bridges and Structures for further disposition. Ground surfaces shall be spot cleaned and painted with an aluminum epoxy mastic primer followed by a finish coat to match the color of the existing beam. Cost of grinding, testing and spot painting included with Beam Straightening.

Braces and jack assembly shall be placed on same side of web. Bent bottom flange shall be straightened before starting any horizontal straightening operations.
