**ROADWAY GEOTECHNICAL REPORT  
I-55 NORTH FRONTAGE ROAD AT SOUTH CASS AVENUE  
CITY OF DARIEN, DUPAGE COUNTY, ILLINOIS  
CONTRACT NO. 62R40**

4/11/2023

Illinois Department of Transportation  
201 Center Ct.  
Schaumburg, IL 60196

INTERRA, INC.  
600 Territorial Drive, Suite G, Bolingbrook, IL 60440  
Phone: (630) 754-8700, Fax: (630) 754-8705

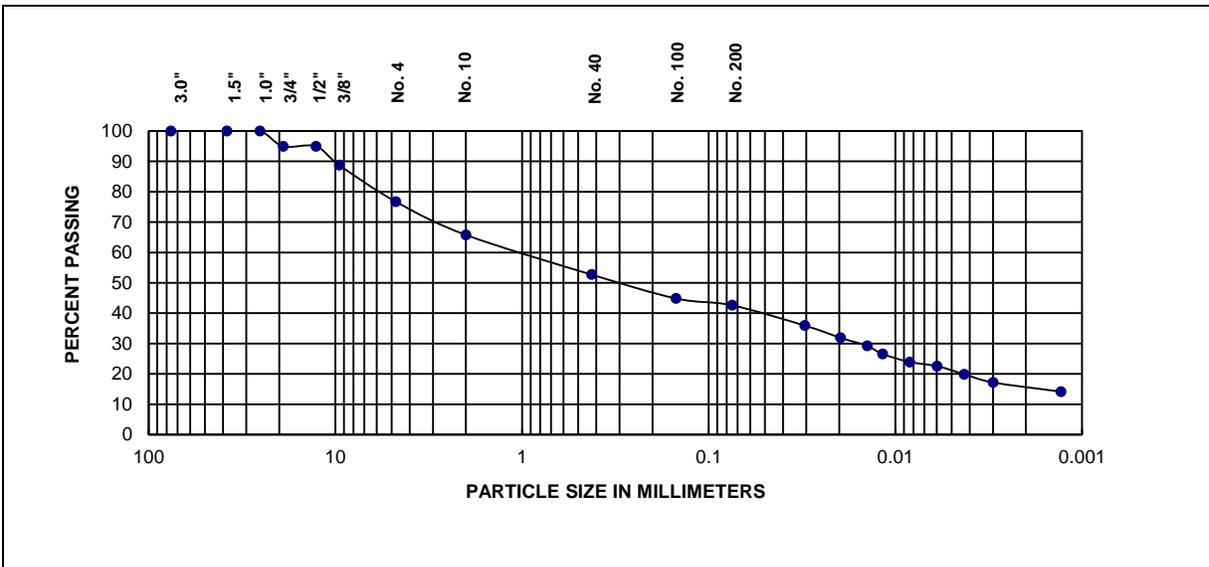
**GRAIN SIZE ANALYSIS  
AASHTO T 88**

<b>Project</b>	Geotech I-55 Frontage at Cass Ave. PTB 196-016-WO 30 Infrastructure						
<b>Client</b>	Infrastructure Engineering, Inc., 33 W.Monroe St., Suite 1540, Chicago, IL 60603						
<b>File No.</b>	9267	<b>Sample #</b>	SGB 01-SS-01	<b>Date Tested</b>	10/25/2022	<b>Tested by</b>	BKP
						<b>Qc by</b>	AB
<b>Date Sample Received:</b>	10/13/2022						
<b>Sample Location</b>	1' - 2.5'						
<b>Sample Description</b>	Dark yellowish brown sandy loam, some gravel

% + 3"	% Gravel	% Sand	Fines	
			% Silt	% Clay
0.0	34.2	23.2	26.3	16.3

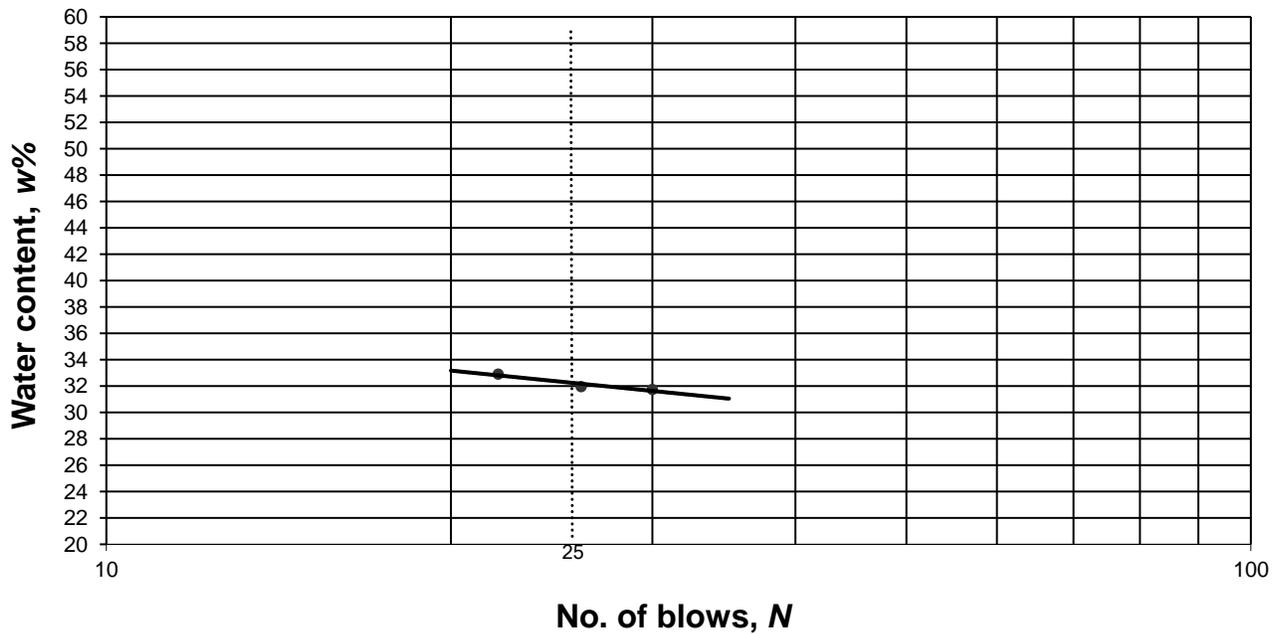
### LIQUID LIMIT DETERMINATION

<b>Results</b>					
<b>Liquid Limit, LL</b>	32	<b>Plastic Limit, PL</b>	16	<b>Plasticity Index, PI</b>	16

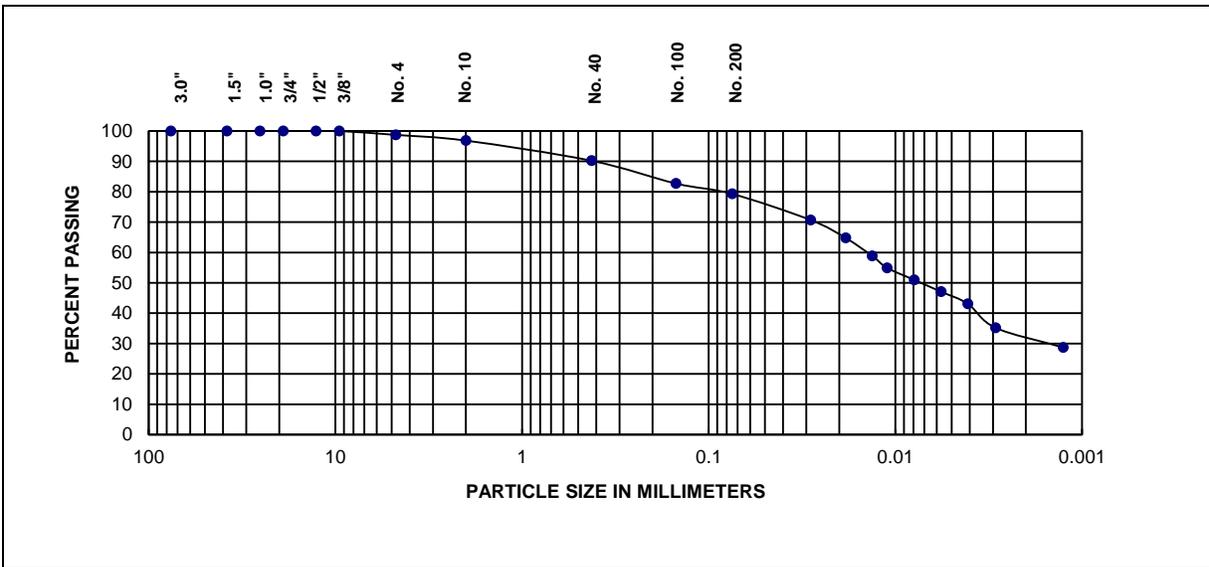
<b>Date Sample Received:</b>	10/13/2022
<b>Sample Location</b>	11' - 12.5'
<b>Sample Description</b>	Grayish olive clay, trace gravel

% + 3"	% Gravel	% Sand	Fines	
			% Silt	% Clay
0.0	3.2	17.5	45.1	34.2

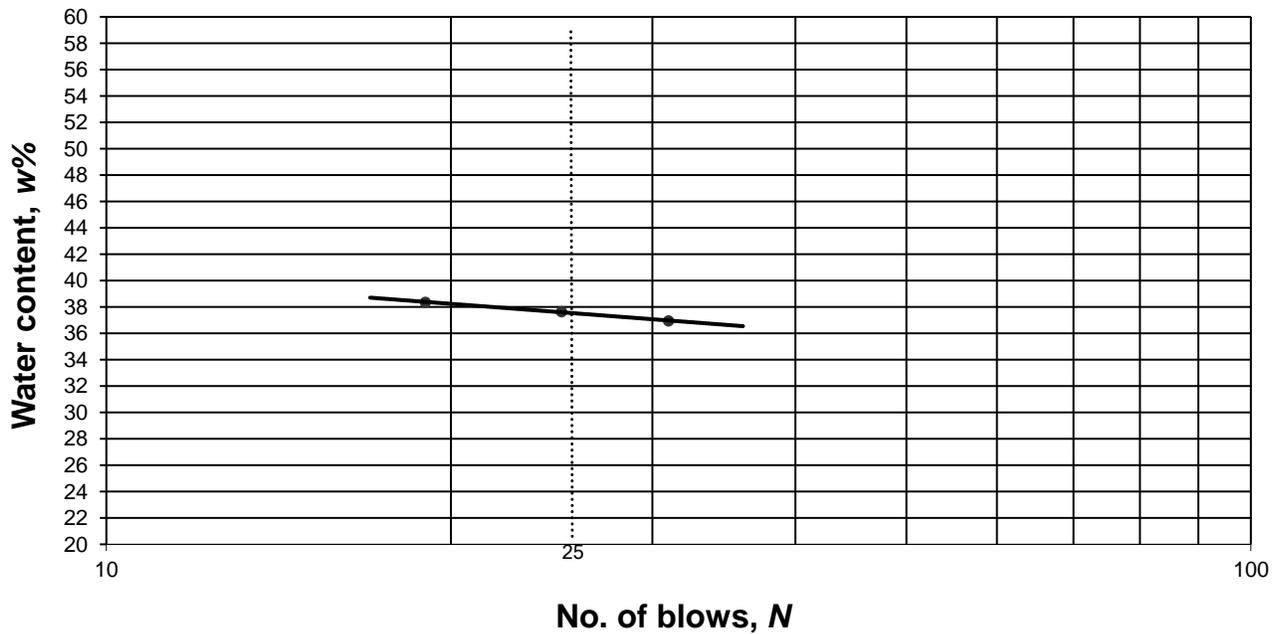
### LIQUID LIMIT DETERMINATION

<b>Results</b>					
<b>Liquid Limit, LL</b>	38	<b>Plastic Limit, PL</b>	19	<b>Plasticity Index, PI</b>	19

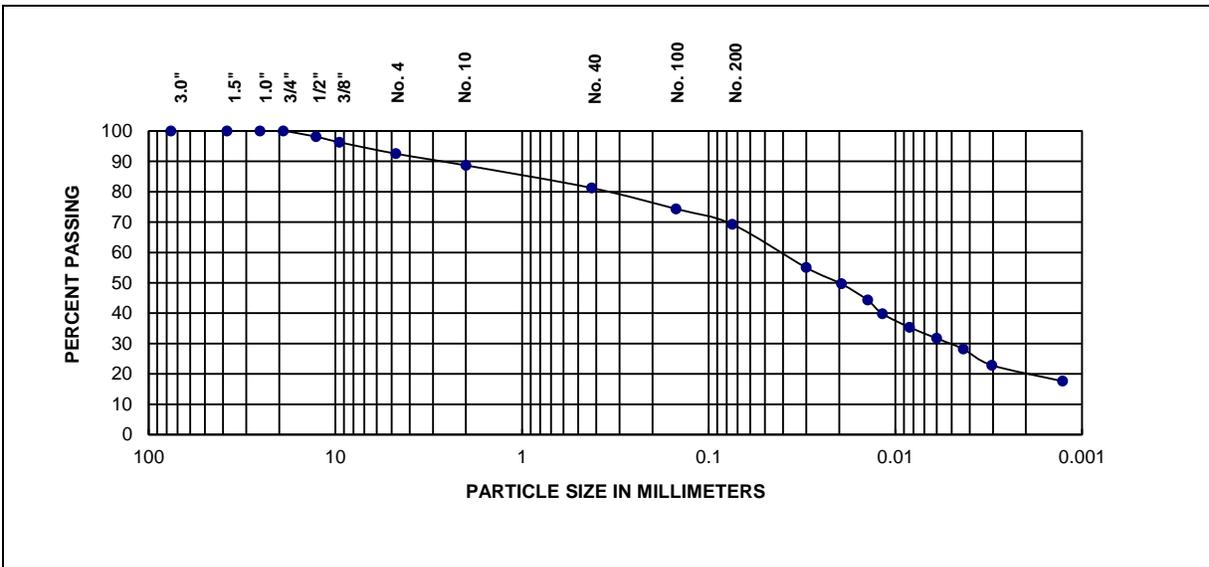
<b>Date Sample Received:</b>	10/13/2022
<b>Sample Location</b>	16' - 17.5'
<b>Sample Description</b>	Yellowish brown clay loam, little gravel

% + 3"	% Gravel	% Sand	Fines	
			% Silt	% Clay
0.0	11.3	19.4	48.0	21.3

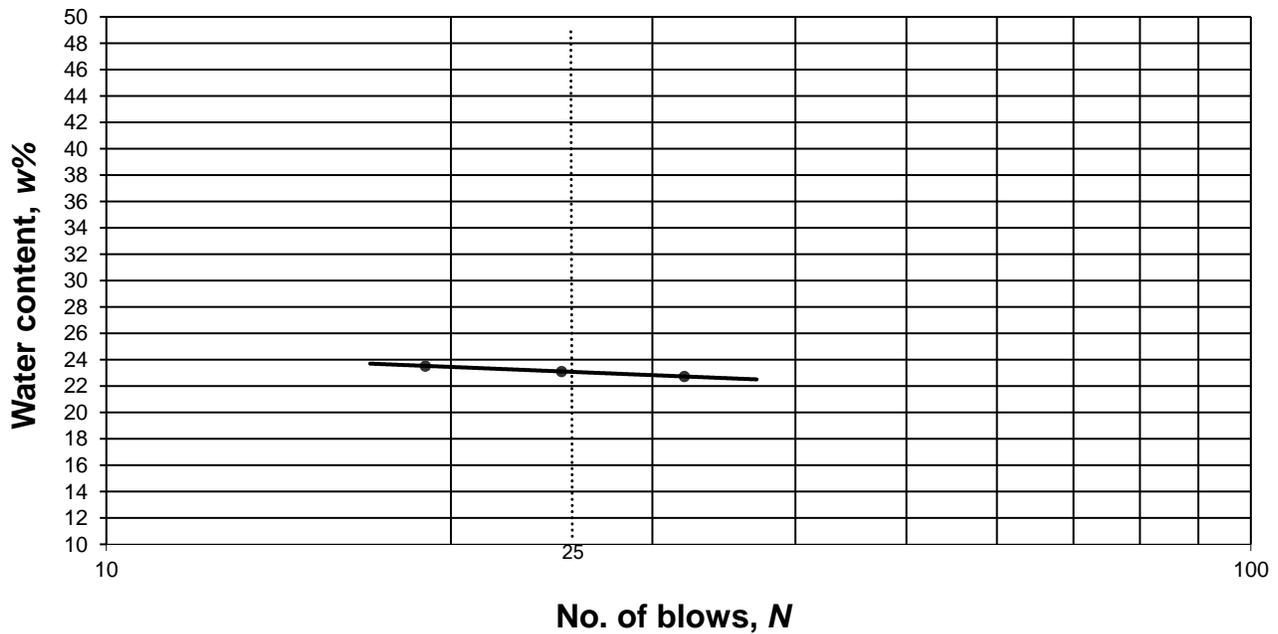
### LIQUID LIMIT DETERMINATION

<b>Results</b>					
<b>Liquid Limit, LL</b>	23	<b>Plastic Limit, PL</b>	14	<b>Plasticity Index, PI</b>	9

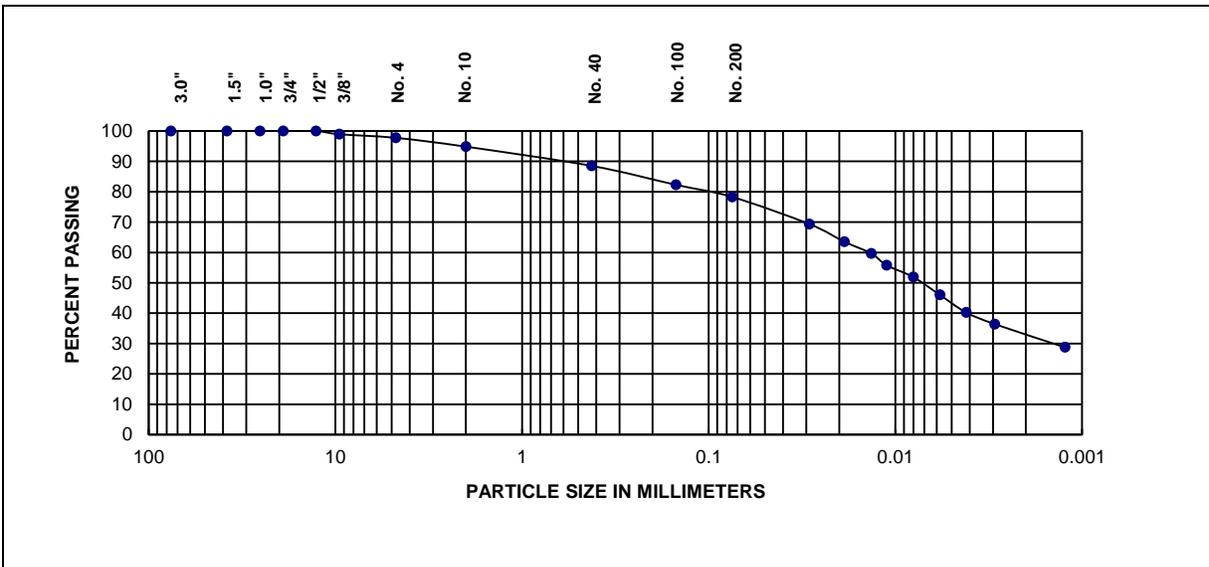
**GRAIN SIZE ANALYSIS  
AASHTO T 88**

<b>Project</b>	Geotech I-55 Frontage at Cass Ave. PTB 196-016-WO 30 Infrastructure						
<b>Client</b>	Infrastructure Engineering, Inc., 33 W.Monroe St., Suite 1540, Chicago, IL 60603						
<b>File No.</b>	9267	<b>Sample #</b>	SGB 04-SS-01	<b>Date Tested</b>	10/24/2022	<b>Tested by</b>	BKP
						<b>Qc by</b>	AB
<b>Date Sample Received:</b>	10/13/2022						
<b>Sample Location</b>	1' - 2.5'						
<b>Sample Description</b>	Dark yellowish brown clay, trace gravel

% + 3"	% Gravel	% Sand	Fines	
			% Silt	% Clay
0.0	5.1	16.6	44.8	33.5

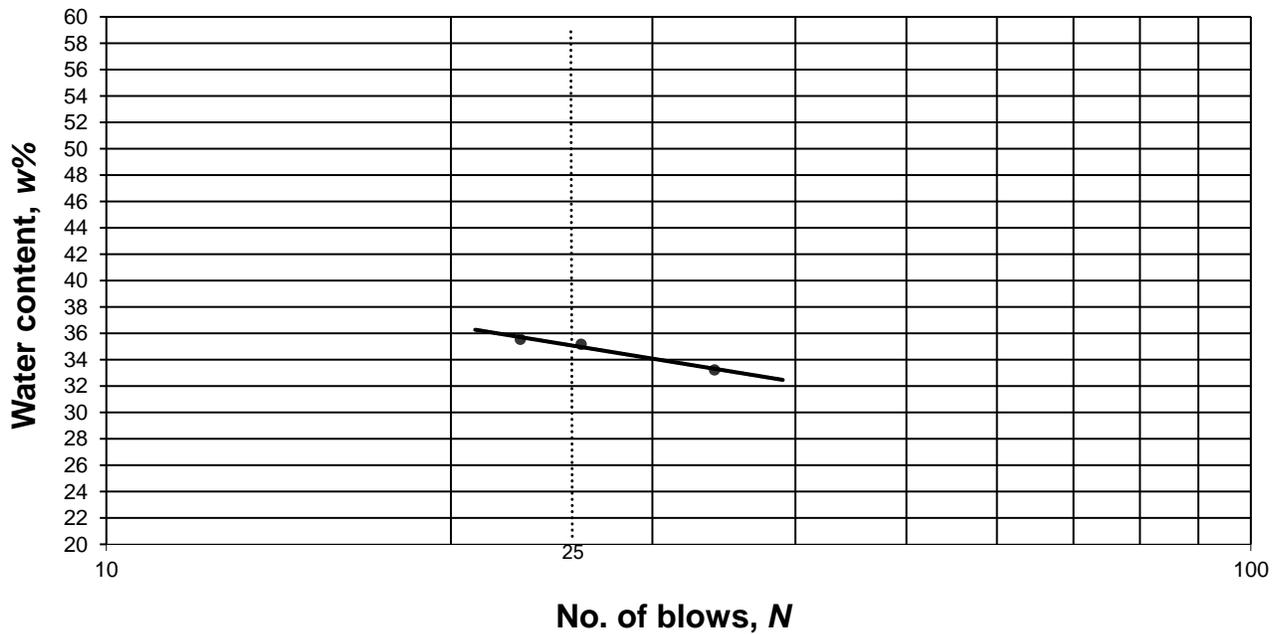
### LIQUID LIMIT DETERMINATION

<b>Results</b>					
<b>Liquid Limit, LL</b>	35	<b>Plastic Limit, PL</b>	17	<b>Plasticity Index, PI</b>	18

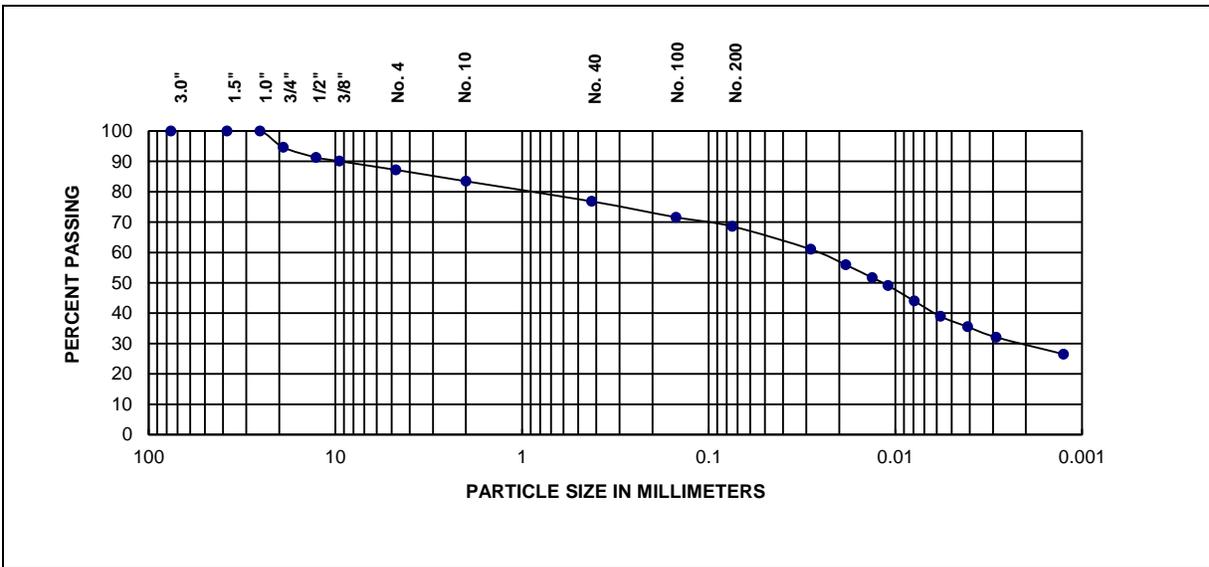
**GRAIN SIZE ANALYSIS  
AASHTO T 88**

<b>Project</b>	Geotech I-55 Frontage at Cass Ave. PTB 196-016-WO 30 Infrastructure						
<b>Client</b>	Infrastructure Engineering, Inc., 33 W.Monroe St., Suite 1540, Chicago, IL 60603						
<b>File No.</b>	9267	<b>Sample #</b>	SGB 05-SS-01	<b>Date Tested</b>	10/25/2022	<b>Tested by</b>	BKP
						<b>Qc by</b>	AB
<b>Date Sample Received:</b>	10/13/2022						
<b>Sample Location</b>	1' - 2.5'						
<b>Sample Description</b>	Pale olive clay loam, little gravel

% + 3"	% Gravel	% Sand	Fines	
			% Silt	% Clay
0.0	16.6	14.8	38.9	29.7

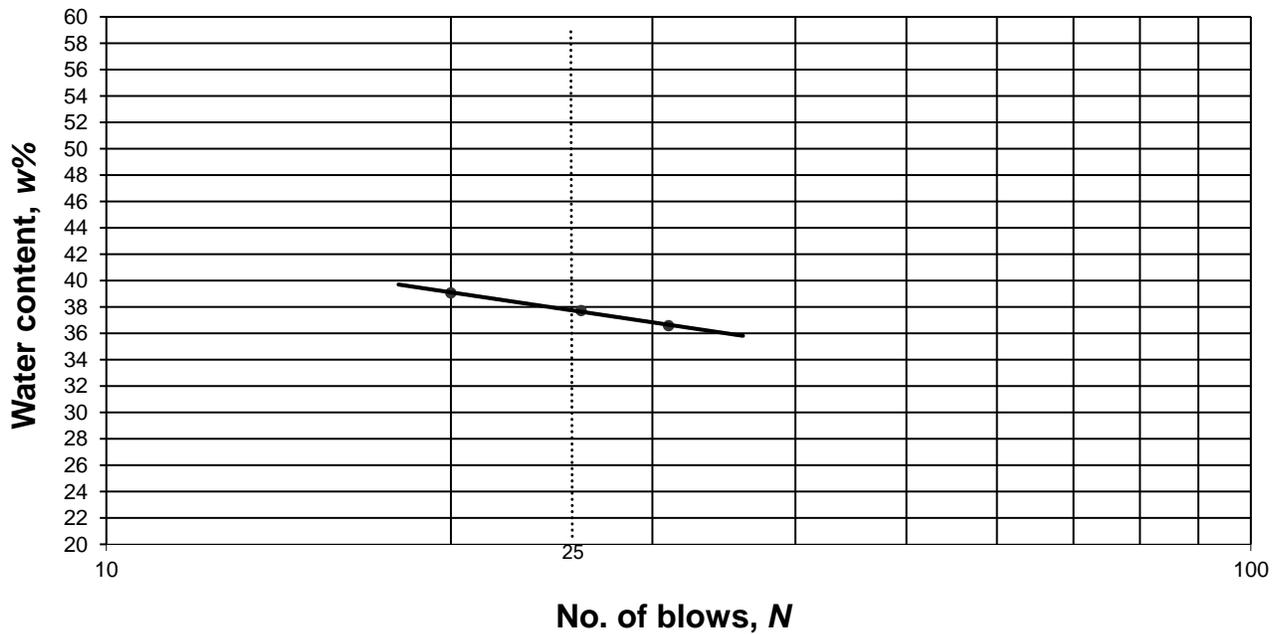
### LIQUID LIMIT DETERMINATION

<b>Results</b>					
<b>Liquid Limit, LL</b>	38	<b>Plastic Limit, PL</b>	18	<b>Plasticity Index, PI</b>	20

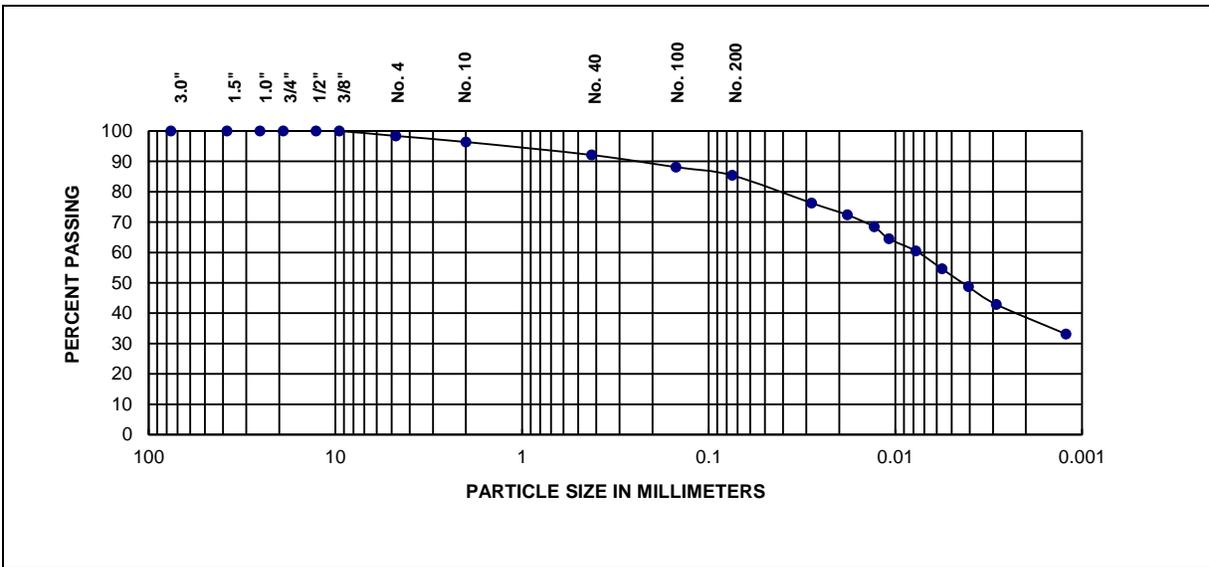
**GRAIN SIZE ANALYSIS  
AASHTO T 88**

<b>Project</b>	Geotech I-55 Frontage at Cass Ave. PTB 196-016-WO 30 Infrastructure						
<b>Client</b>	Infrastructure Engineering, Inc., 33 W.Monroe St., Suite 1540, Chicago, IL 60603						
<b>File No.</b>	9267	<b>Sample #</b>	SGB 06-SS-01	<b>Date Tested</b>	10/24/2022	<b>Tested by</b>	BKP
						<b>Qc by</b>	AB
<b>Date Sample Received:</b>	10/13/2022						
<b>Sample Location</b>	1' - 2.5'						
<b>Sample Description</b>	Dark yellowish brown clay, trace gravel

% + 3"	% Gravel	% Sand	Fines	
			% Silt	% Clay
0.0	3.6	11.0	45.6	39.8

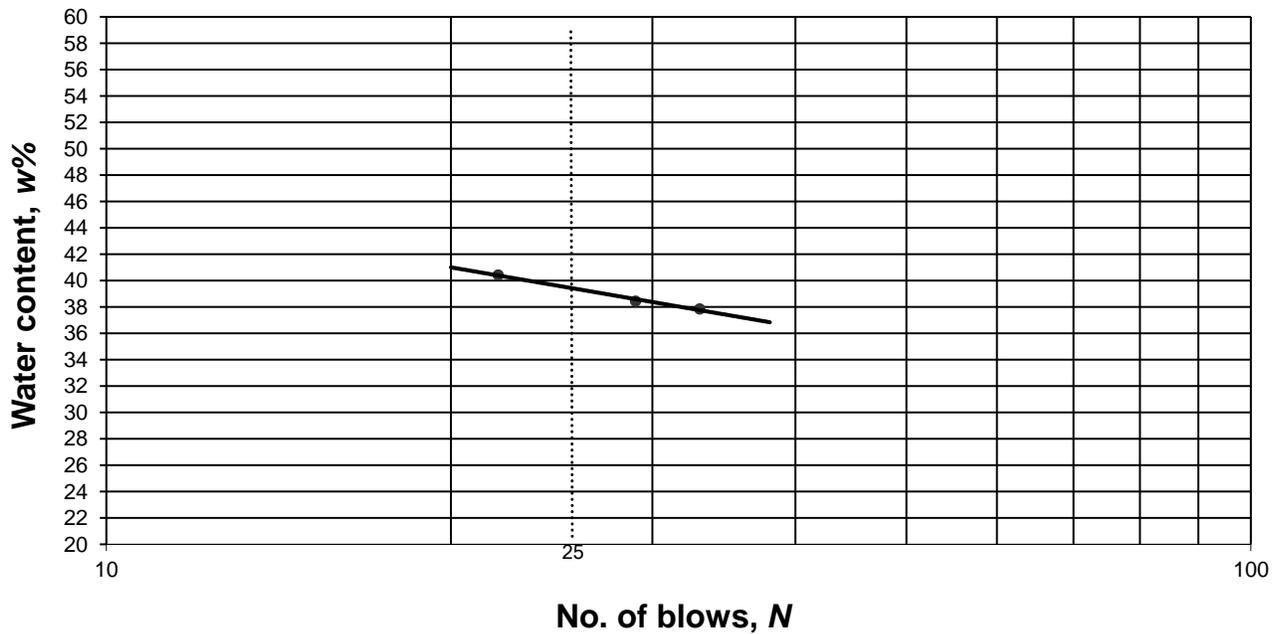
### LIQUID LIMIT DETERMINATION

<b>Results</b>					
<b>Liquid Limit, LL</b>	40	<b>Plastic Limit, PL</b>	18	<b>Plasticity Index, PI</b>	22

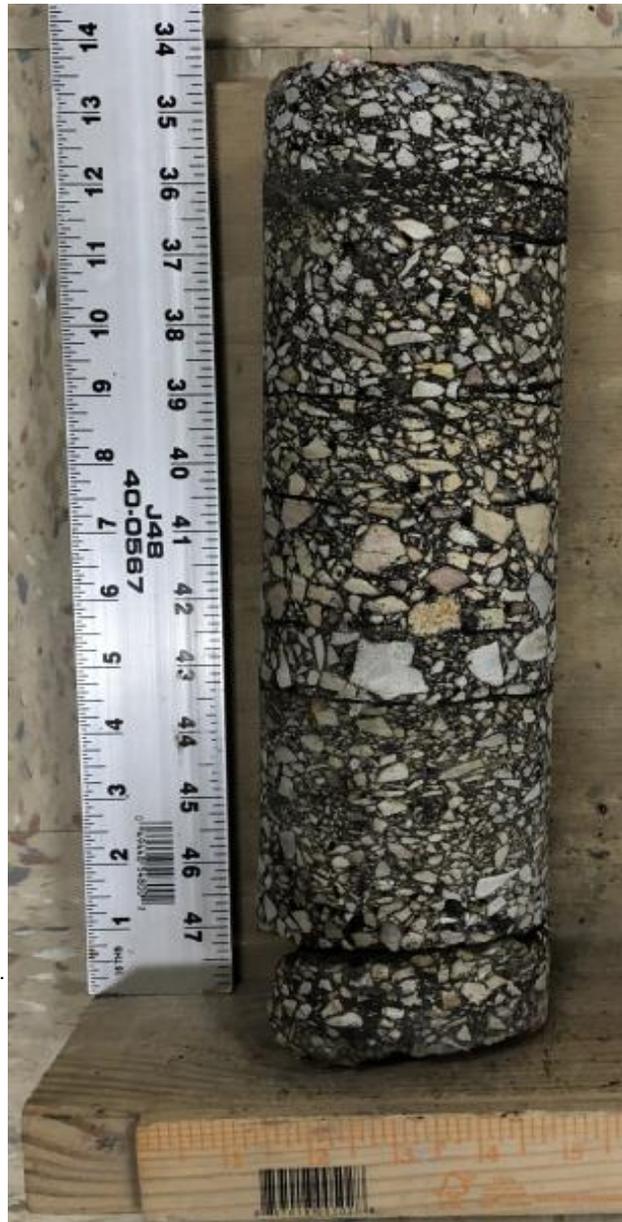
<b>File No.:</b>	9267	<b>Project Name:</b>	9267 - Geotech I-55 Frontage at Cass PTB 196-016 WO 30				
<b>Client:</b>	Infrastructure Engineering						
<b>Core No.:</b>	PC-01	<b>Date Cored:</b>	10/12/2022	<b>Cored By:</b>	Geocon	<b>Measured By:</b>	Sponaugle
<b>Core Location:</b>	Sta # 0+85.3, 18.1' R. See Attached Location Map						
<b>Core Diameter (in):</b>	3.71	<b>Core Height (in):</b>	12.60	<b>Notes:</b>

Separation during recovery.

Asphalt Surface - 1.25"

All measurements are average.

A total of three (3) pavement cores were recovered from I-55 North Frontage Road to determine the existing pavement thickness and condition. The pavement thickness varied between 9.3 inches and 12.6 inches. Pavement core photo logs are presented in Appendix D of this report.

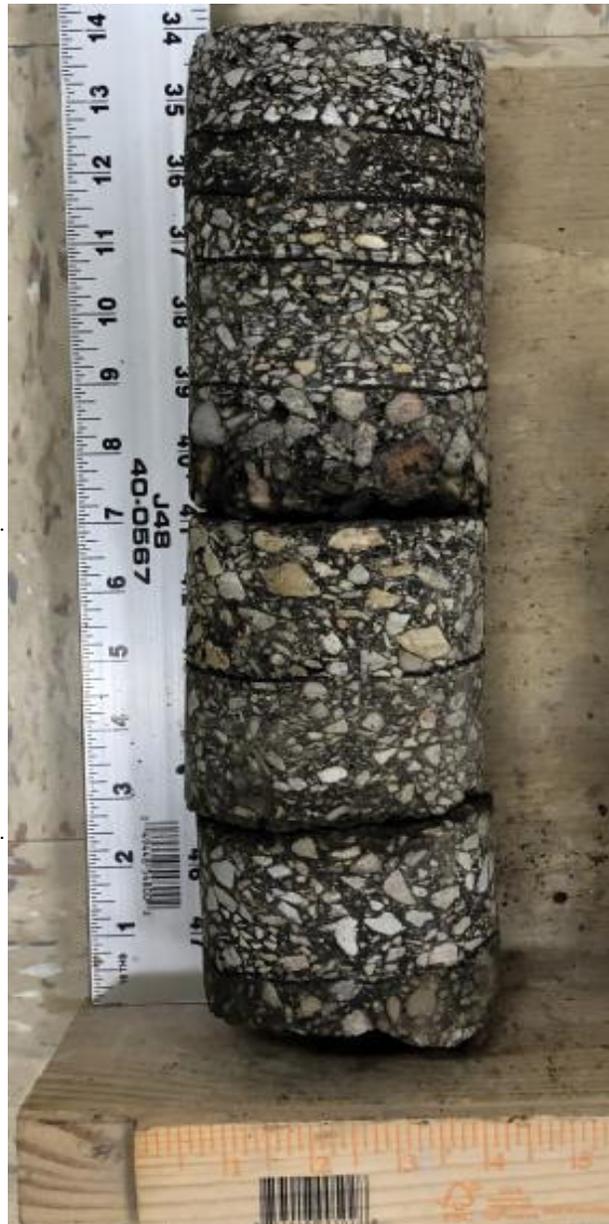
<b>File No.:</b>	9267	<b>Project Name:</b>	9267 - Geotech I-55 Frontage at Cass PTB 196-016 WO 30				
<b>Client:</b>	Infrastructure Engineering						
<b>Core No.:</b>	PC-02	<b>Date Cored:</b>	10/12/2022	<b>Cored By:</b>	Geocon	<b>Measured By:</b>	Sponaugle
<b>Core Location:</b>	Sta # 3+30.1, 1.6' L. See Attached Location Map						
<b>Core Diameter (in):</b>	3.71	<b>Core Height (in):</b>	12.58	<b>Notes:</b>

Separation during recovery.

Advanced split spoon following pavement core.  
14" gravel base course

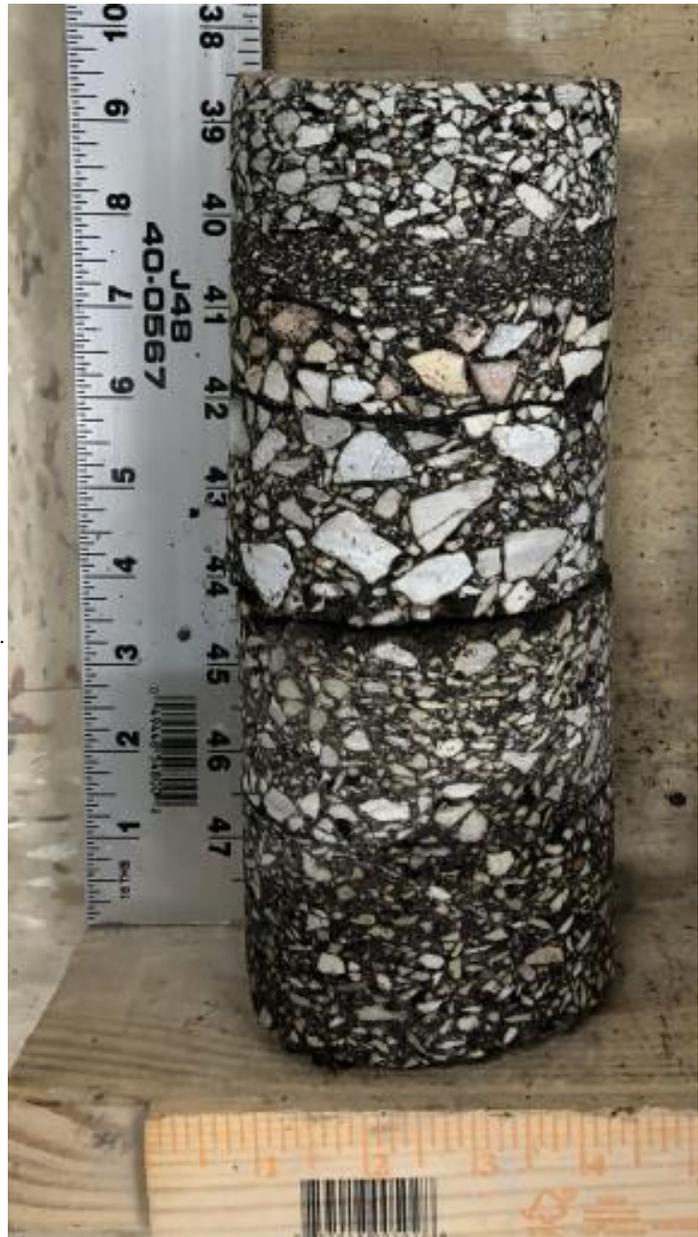
<b>File No.:</b>	9267	<b>Project Name:</b>	9267 - Geotech I-55 Frontage at Cass PTB 196-016 WO 30				
<b>Client:</b>	Infrastructure Engineering						
<b>Core No.</b>	PC-03	<b>Date Cored:</b>	10/12/2022	<b>Cored By:</b>	Geocon	<b>Measured By:</b>	Sponaugle
<b>Core Location:</b>	Sta # 7+69.4, 9.3' R. See Attached Location Map						
<b>Core Diameter (in):</b>	3.71	<b>Core Height (in):</b>	9.29	<b>Notes:</b>

Asphalt Surface - 1.38"

Leveling Binder - 0.83"

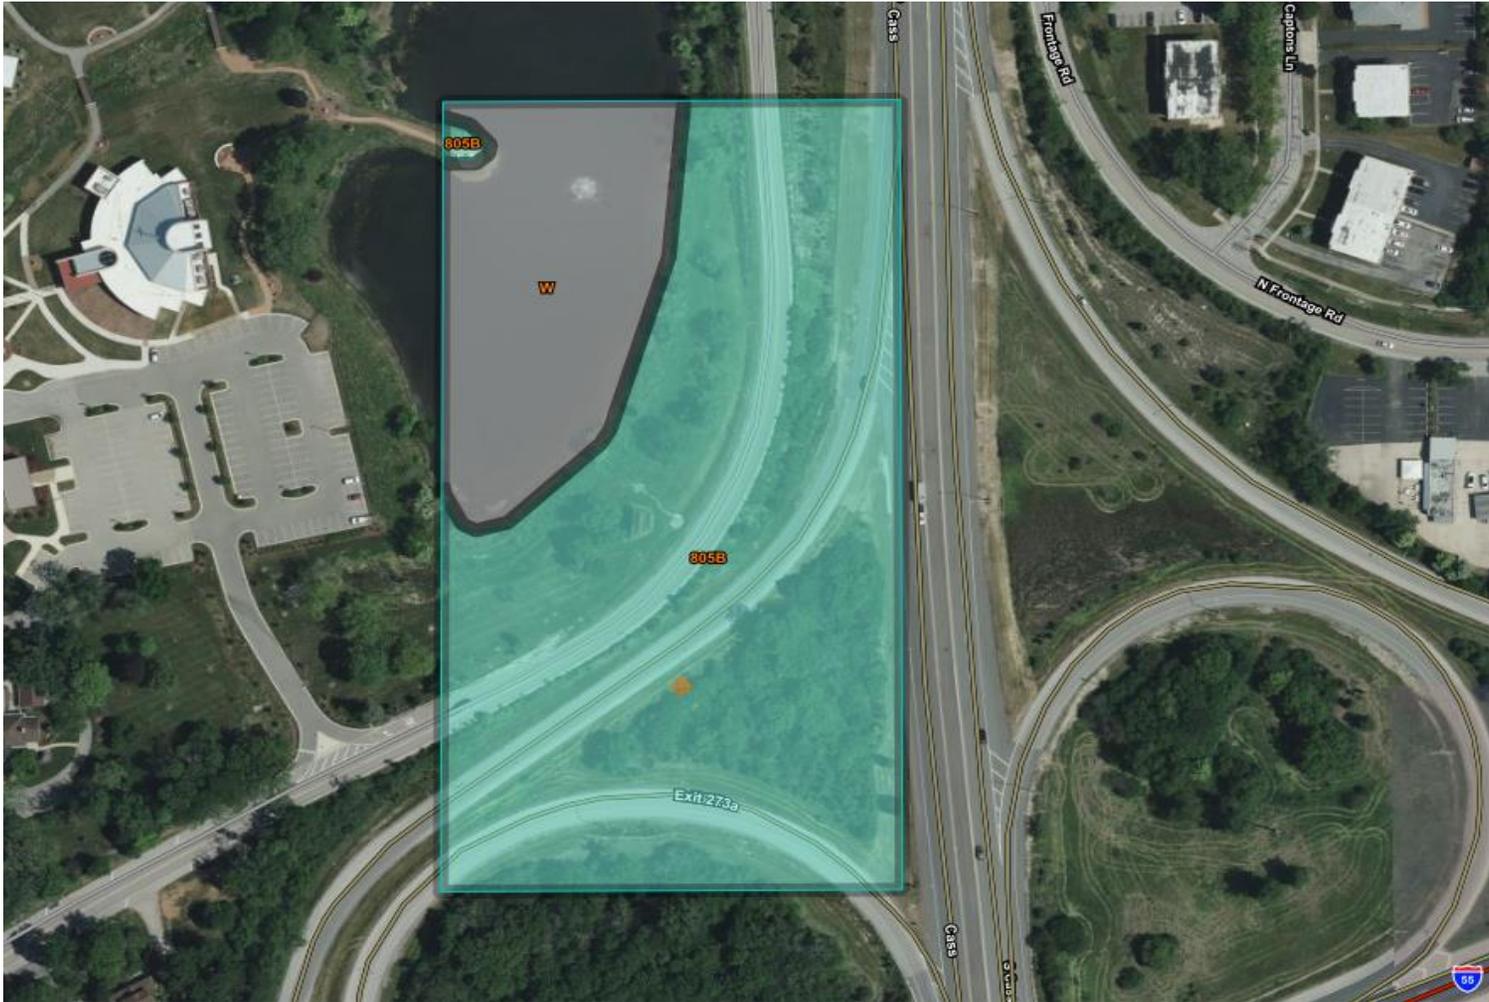
**Soil Types for Erosion Factors and Hazard Rating**

**Hazard Rating and Soil Erosion Factors**

Map Unit Symbol	Map Unit Name	Soil Erosion Factor, k	Hazard Rating
805B	Orthents, clayey, undulating	0.32	Moderate

- If the project will need to apply for a NPDES storm water permit for construction site activities, Soil erosion factors (K factors) and erosion hazard ratings for each of the soil types within the project limits were obtained from NRCS website and presented in Appendix E.
