Re: Asbestos Survey Report
Work Order No: 660
Parcel No. 1JQ0001
Gas Station
Buckley Rd. & Ivanhoe Rd.
Grayslake, IL 60030
PSI Project No. 00474021

ASBESTOS SURVEY REPORT

FAP Route: Route 83
Section: AT Atkinson Road
County: Lake
Parcel No: 1JQ0001
IDOT Job No: R-91-019-12
IDOT Work Order No: 660

Date of Inspection: March 18, 2020

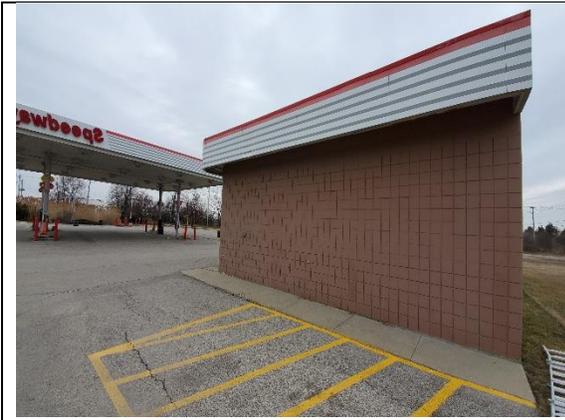
North Face

The facility inspected is an abandoned gas station constructed on concrete foundation, brick fencing on all 4 sides, ceramic floor tile, drywall, vinyl floor tile and ceiling tile. The roof was insulated with non-suspect Styrofoam and rubber sheet.

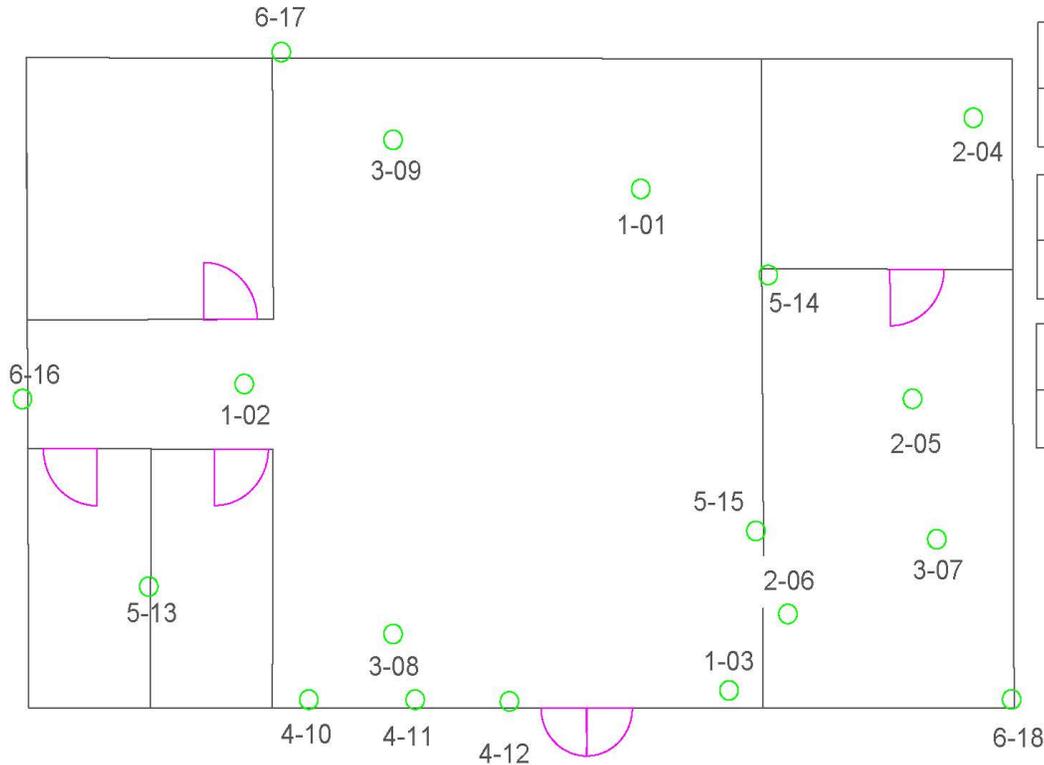
Site Layout Map (not to scale)

1-01 1-02 1-03	ND
8" x 8" Ceramic Floor Tile and Grout Gray

2-04 2-05 2-06	ND
12" x 12" Ceramic Floor Tile and Mastic Beige

3-07 3-08 3-09	ND
2' x 2' Ceiling Tile

4-10 4-11 4-12	ND
Window Caulk

5-13 5-14 5-15	ND
Drywall and Joint Compound

6-16 6-17 6-18	ND
Roof Flashing
