CHRISTIAN-ROGE & ASSOCIATES, INC.	USER NAME = IDGT	DESIGNED - J.C.N./B.H.S./J.W.	REVISED -	STATE OF ILLINOIS DEPARTMENT OF TRANSPORTATION	SILICONE JOINT SEALER DETAILS STRUCTURE NO'S. 099-0008 & 099-0009	F.A.I. RFE	SECTION	COUNTY	TOTAL SHEETS	SHEET NO.
	PLOT SCALE = 5/8" = 1' / DL	CHECKED - B.H.S./J.W.	REVISED -			55	07B, D-BR-1	WILL	106	58
	PLOT DATE = 3/19/2013	DRAWN - F.M.	REVISED -			CONTRACT NO. 60R62				
	DATE - MARCH 20, 2013	REVISED -	ILLINOIS FED. AID PROJECT							
					SHEET NO. 519 OF 560 SHEETS

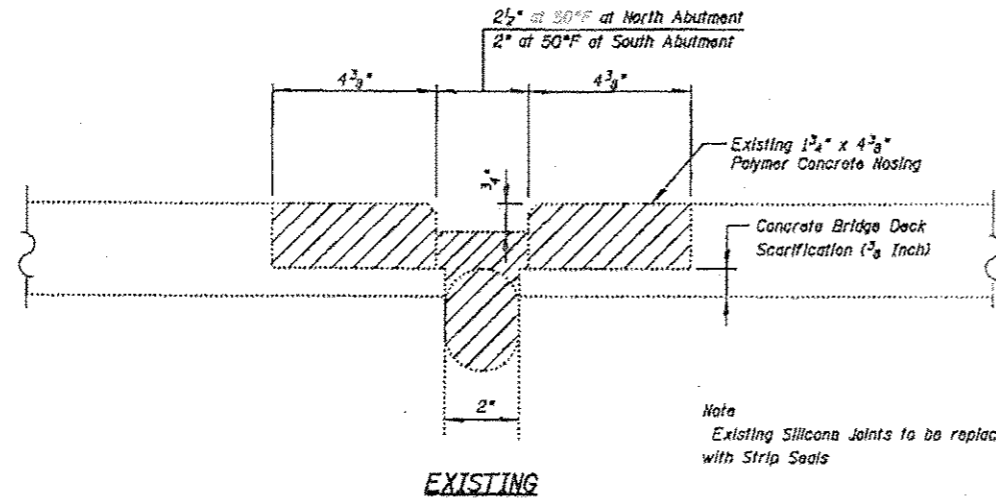
**SILICONE JOINT SEALER
AT NORTH & SOUTH ABUTMENTS**
North Abutment shown
South Abutment similar

Note
Existing Silicone Joints to be replaced
with Strip Seals
