**STATE OF ILLINOIS  
DEPARTMENT OF TRANSPORTATION**

**STRUCTURAL REPAIR - SUBSTRUCTURE & MICROSILICA DETAIL  
SN. 080-0005**

SCALE: NA SHEET NO. 5 OF 13 SHEETS STA. TO STA.

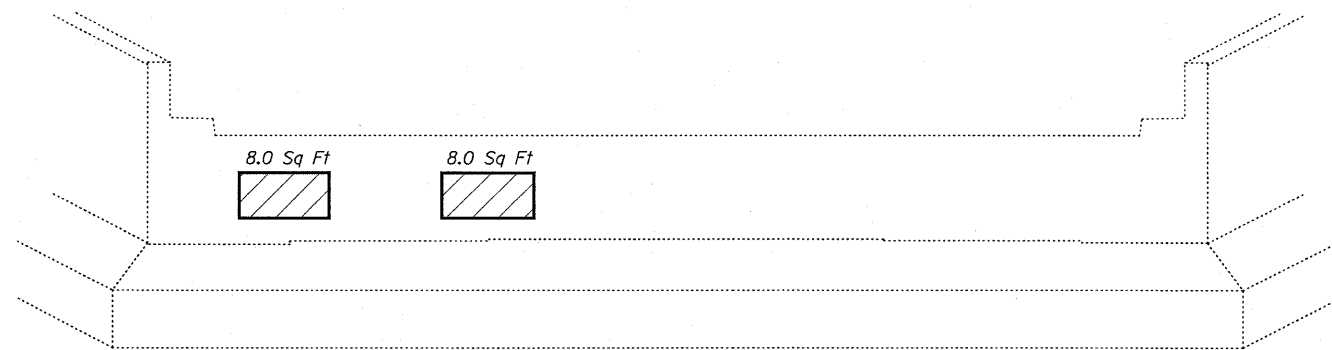
**EAST ABUTMENT**  
(Looking East)

STRUCTURAL REPAIR OF CONCRETE (DEPTH < 5")
