BORING LOG 03-RWB-02

WEI Job No.: 1100-04-01
 Client: AECOM
 Project: Circle Interchange Reconstruction
 Location: Section 17, T39N, R14E of 3rd PM
 Datum: NAVD 88
 Elevation: 593.70 ft
 North: 1898142.33 ft
 East: 1170680.34 ft
 Station: 1839+83.93
 Offset: 38.8940 RT

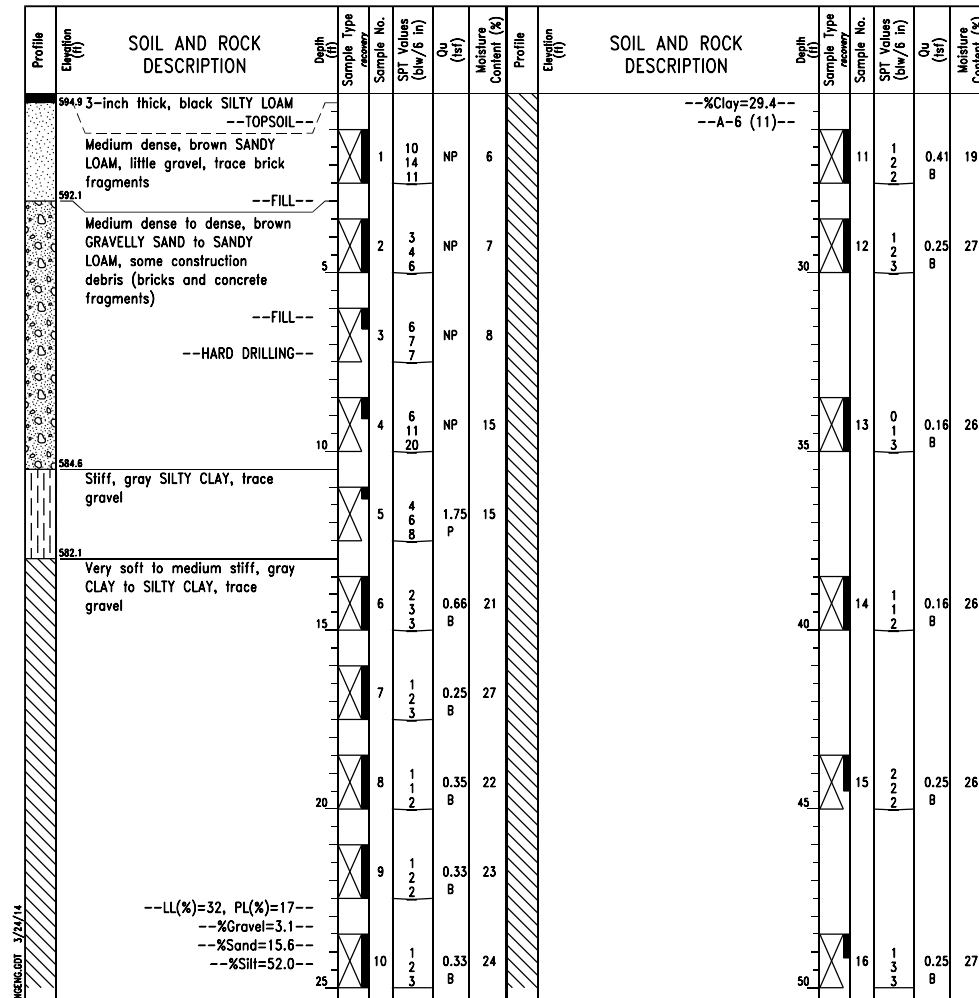
BORING LOG 03-RWB-03

WEI Job No.: 1100-04-01
 Client: AECOM
 Project: Circle Interchange Reconstruction
 Location: Section 17, T39N, R14E of 3rd PM
 Datum: NAVD 88
 Elevation: 595.15 ft
 North: 1898142.41 ft
 East: 1170611.57 ft
 Station: 1840+52.56
 Offset: 43.2853 RT

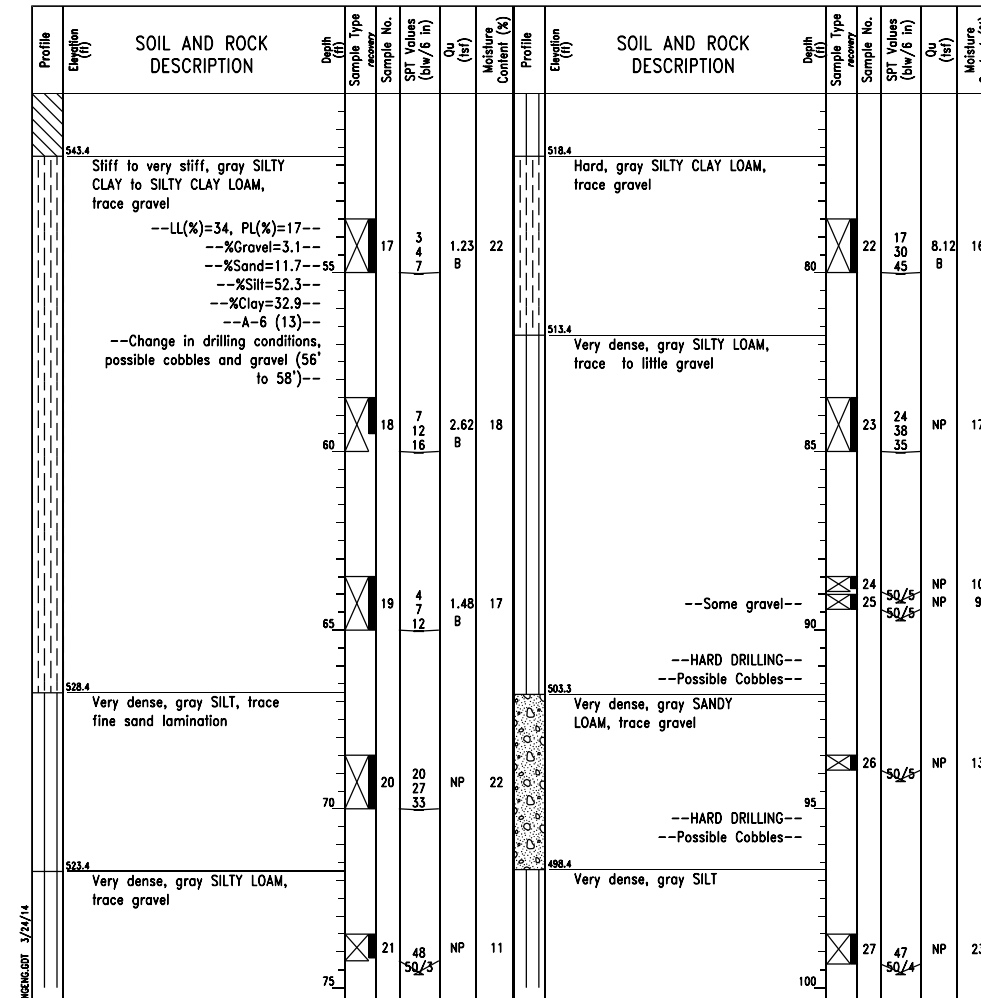
BORING LOG 03-RWB-03

WEI Job No.: 1100-04-01
 Client: AECOM
 Project: Circle Interchange Reconstruction
 Location: Section 17, T39N, R14E of 3rd PM
 Datum: NAVD 88
 Elevation: 595.15 ft
 North: 1898142.41 ft
 East: 1170611.57 ft
 Station: 1840+52.56
 Offset: 43.2853 RT
