# IDOT WORK ORDER 627

Re: Asbestos Survey Report  
**Work Order No: 627**  
Parcel No. 1MF0127  
Single Family Residence  
409 Elm Road  
Barrington, Illinois 60010  
PSI Project No. 00472669

## **ASBESTOS SURVEY REPORT**

Single Family Residence  
409 Elm Road  
Barrington, Illinois 60010

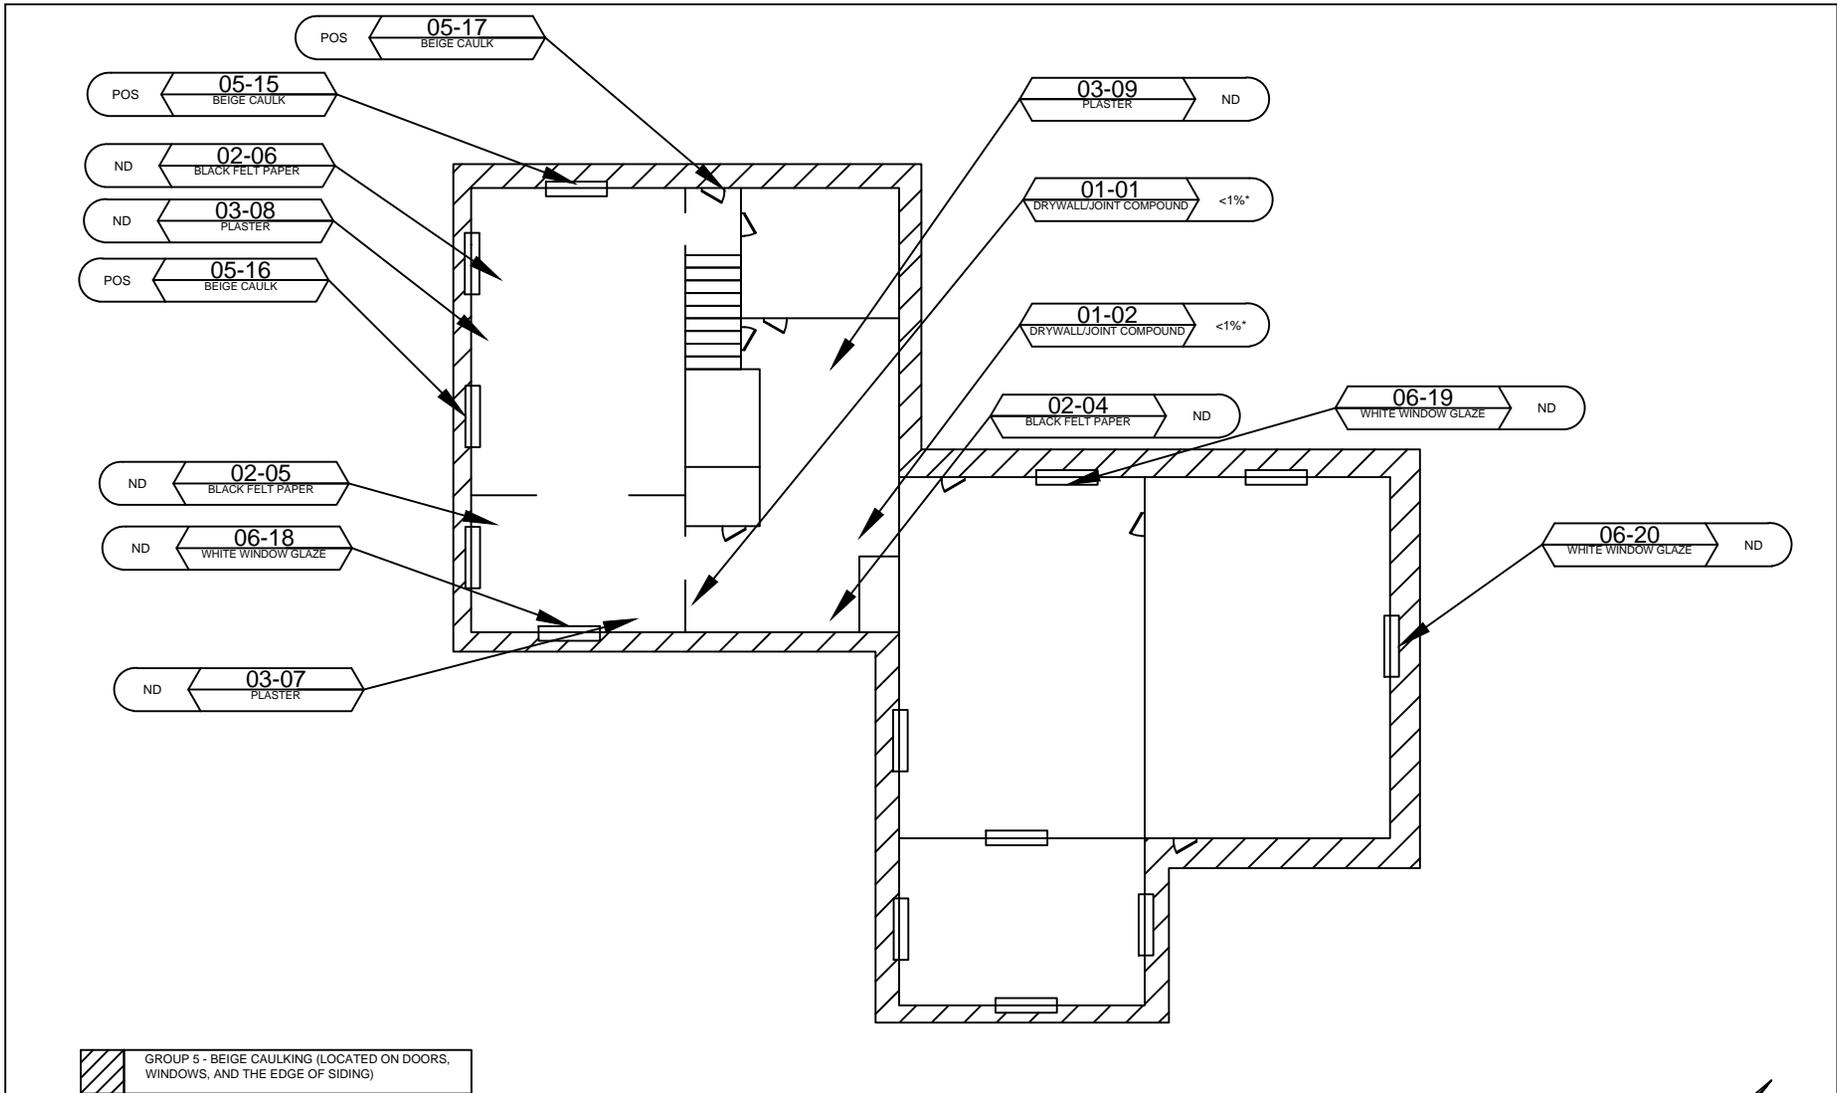
# FIRST FLOOR

<p>4421 W. Harrison St. Hillside, Illinois 60162 (708) 236-0720</p>	<p>ASBESTOS SAMPLE GROUP</p> <p>01-53AV Floor Tile/Mastic</p> <p>MATERIAL DESCRIPTION</p>	<p>SAMPLE NUMBER</p> <p>N/TR</p>	<p><b>SAMPLE LEGEND</b></p> <p>NA = NOT ANALYZED N or ND = NONE DETECTED P or POS = POSITIVE TR = TRACE * = POINT COUNT ANALYSIS</p>		<p>PARCEL NO. 1MF0127 409 ELM ROAD BARRINGTON, ILLINOIS 60010</p>	<p>DRAWN: SJL</p>	<p>CHECKED: JC</p>	<p>DATE: 4-23-18</p>	<p>FIGURE: 1</p>
					<p>ILLINOIS DEPARTMENT OF TRANSPORTATION 2300 SOUTH DIRKSEN PARKWAY SPRINGFIELD, ILLINOIS 62764</p>	<p>PROJECT NO: 00472669</p>	<p>SCALE: NTS</p>	<p>WO # 627</p>

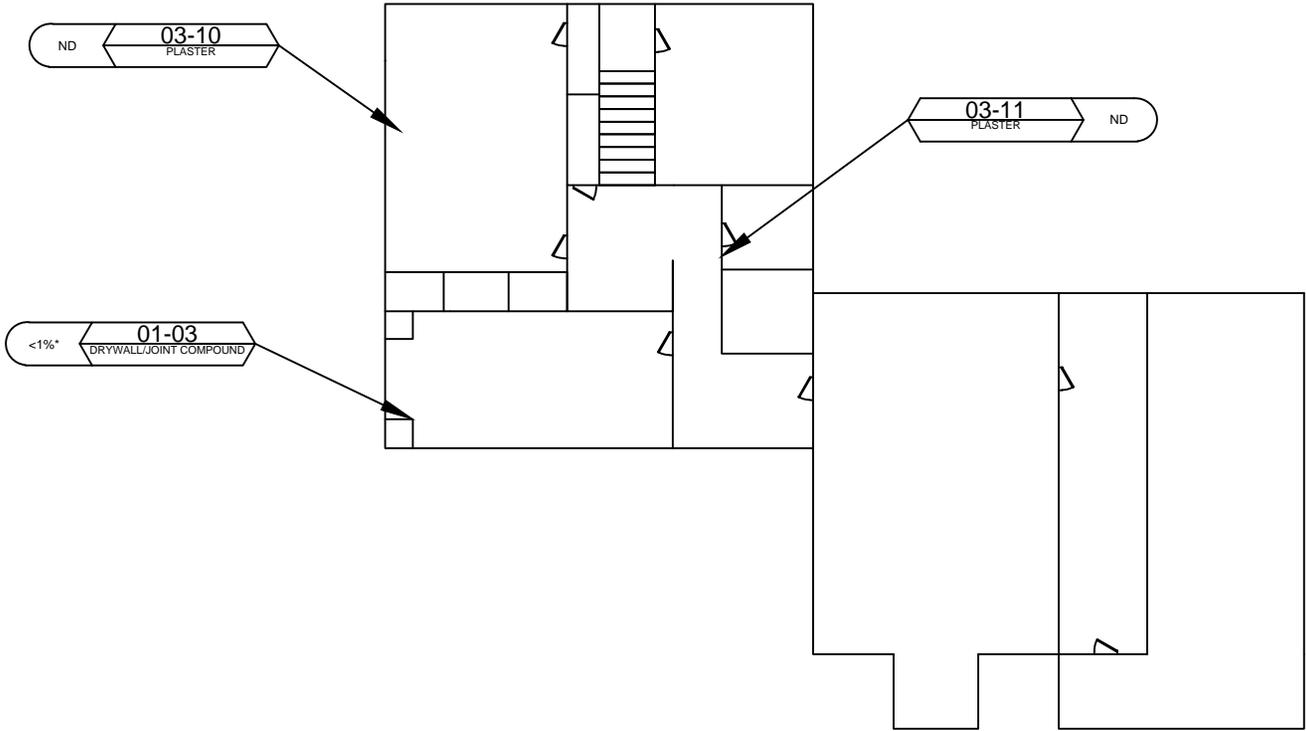
**SECOND FLOOR**

<p>4421 W. Harrison St. Hillside, Illinois 60162 (708) 236-0720</p>	<p>ASBESTOS</p> <p>SAMPLE GROUP</p> <p>01-53AV</p> <p>Floor Tile/Mastic</p> <p>N/TR</p> <p>MATERIAL DESCRIPTION</p> <p>SAMPLE RESULT</p>	<p><b>SAMPLE LEGEND</b></p> <p>NA = NOT ANALYZED</p> <p>N or ND = NONE DETECTED</p> <p>P or POS = POSITIVE</p> <p>TR = TRACE</p> <p>* = POINT COUNT ANALYSIS</p>		<p>PARCEL NO. 1MF0127</p> <p>409 ELM ROAD</p> <p>BARRINGTON, ILLINOIS 60010</p>	<p>DRAWN: SJL</p>	<p>CHECKED: JC</p>	<p>DATE: 4-23-18</p>	<p>FIGURE: 2</p>
				<p>ILLINOIS DEPARTMENT OF TRANSPORTATION</p> <p>2300 SOUTH DIRKSEN PARKWAY</p> <p>SPRINGFIELD, ILLINOIS 62764</p>	<p>PROJECT NO: 00472669</p>	<p>SCALE: NTS</p>	<p>WO # 627</p>

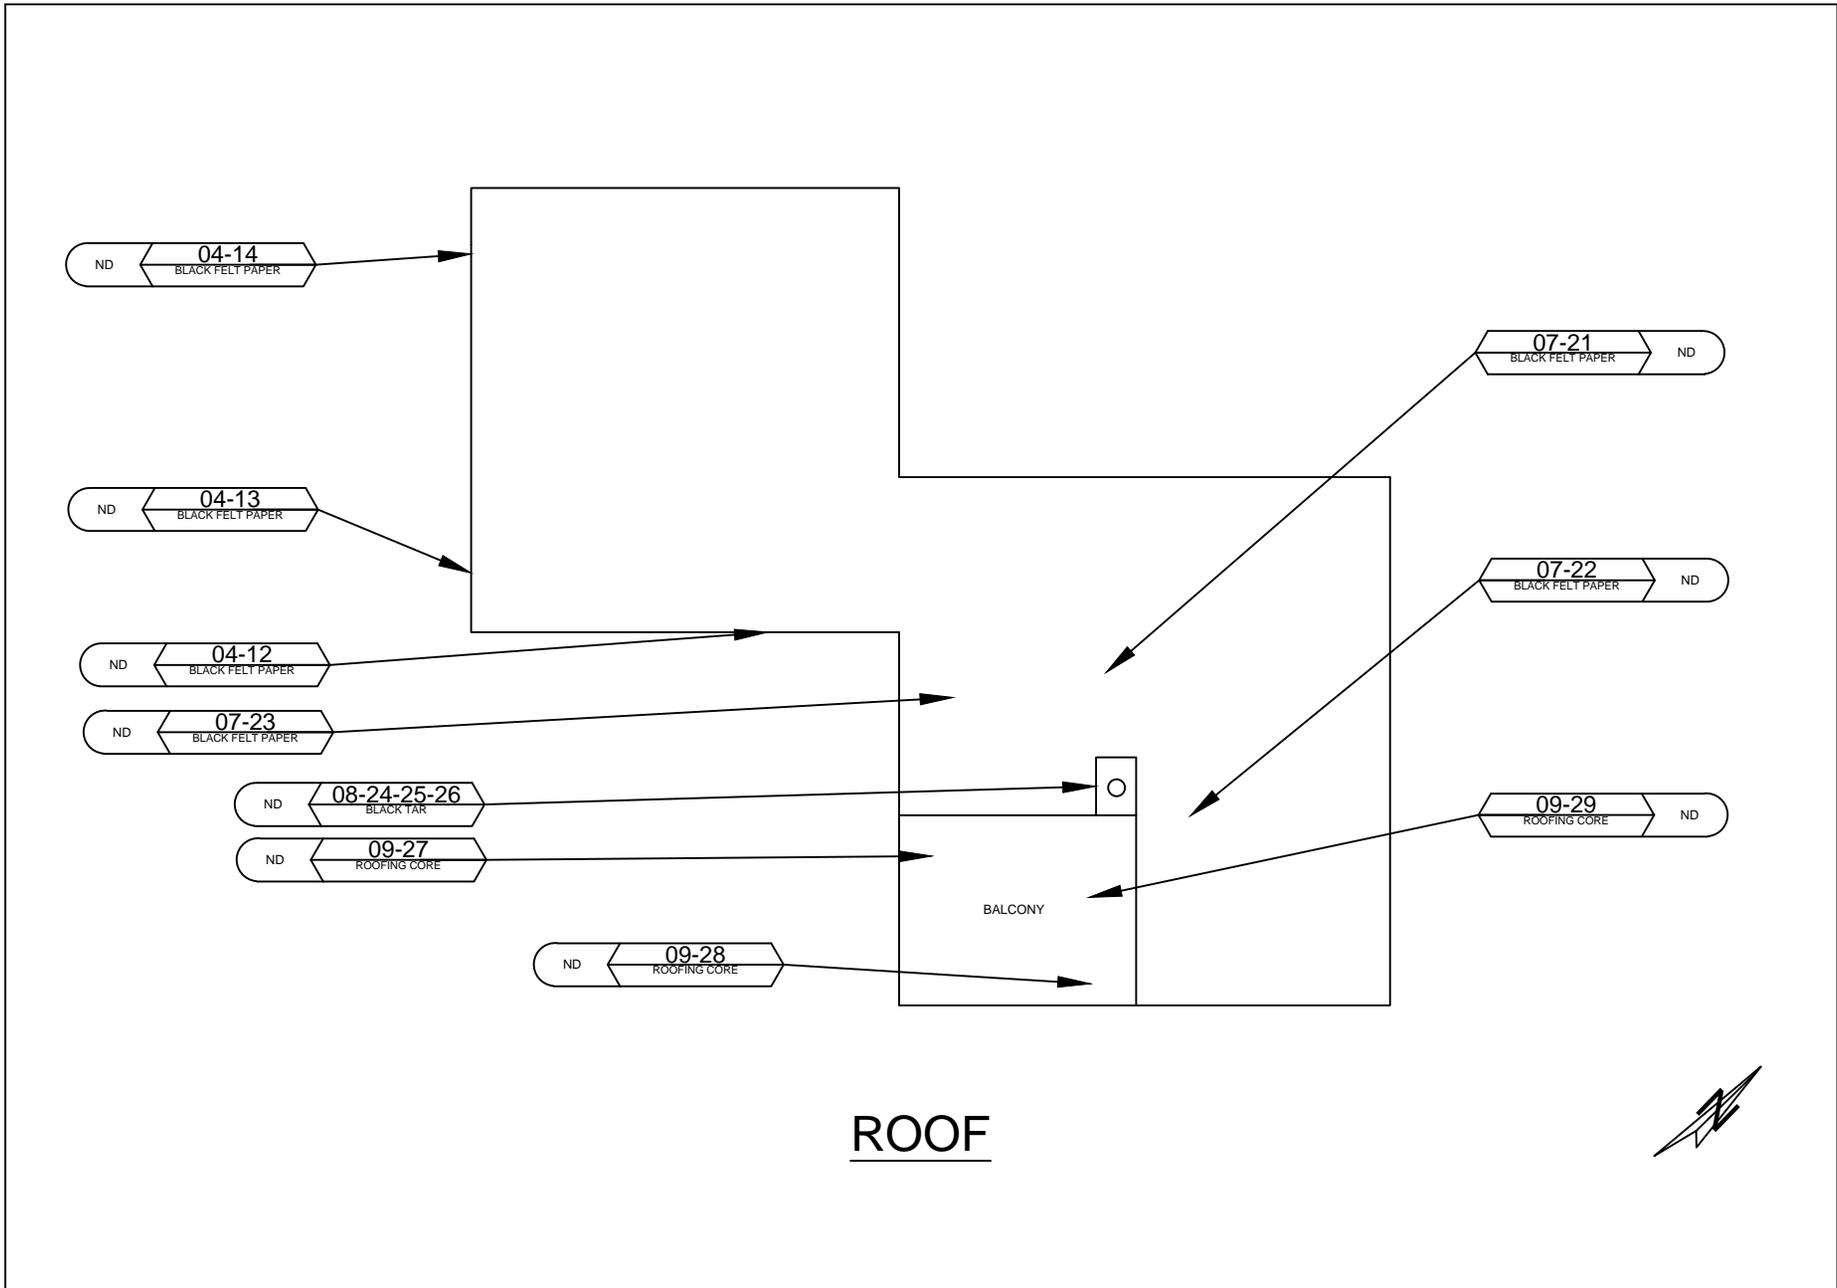
# ROOF

<p>4421 W. Harrison St. Hillside, Illinois 60162 (708) 236-0720</p>	<p>ASBESTOS</p> <p>SAMPLE GROUP</p> <p>01-53AV</p> <p>Floor Tile/Mastic</p> <p>N/TR</p> <p>MATERIAL DESCRIPTION</p> <p>SAMPLE RESULT</p>	<p><b>SAMPLE LEGEND</b></p> <p>NA = NOT ANALYZED</p> <p>N or ND = NONE DETECTED</p> <p>P or POS = POSITIVE</p> <p>TR = TRACE</p> <p>* = POINT COUNT ANALYSIS</p>		<p>PARCEL NO. 1MF0127</p> <p>409 ELM ROAD</p> <p>BARRINGTON, ILLINOIS 60010</p>	<p>DRAWN: SJL</p>	<p>CHECKED: JC</p>	<p>DATE: 4-23-18</p>	<p>FIGURE:</p>
				<p>ILLINOIS DEPARTMENT OF TRANSPORTATION</p> <p>2300 SOUTH DIRKSEN PARKWAY</p> <p>SPRINGFIELD, ILLINOIS 62764</p>	<p>PROJECT NO: 00472669</p>	<p>SCALE: NTS</p>	<p>WO # 627</p>	<p><b>3</b></p>

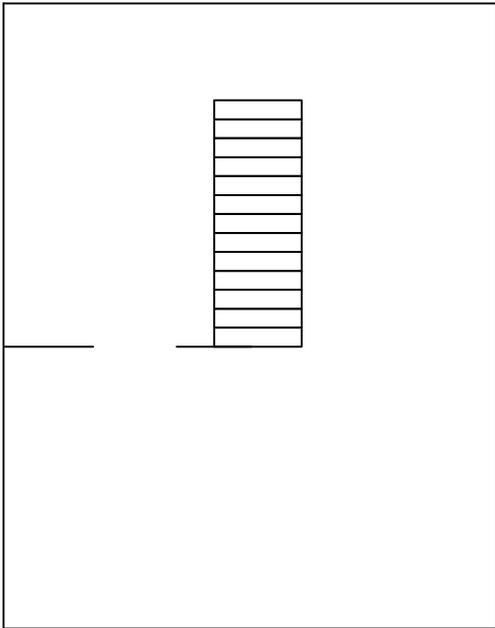
BASEMENT

NO SUSPECT MATERIAL
