# PRELIMINARY SITE INVESTIGATION REPORT

FAP 873 (IL 149)

WEST FRANKFORT, FRANKLIN COUNTY,  
ILLINOIS

MAY 01, 2023

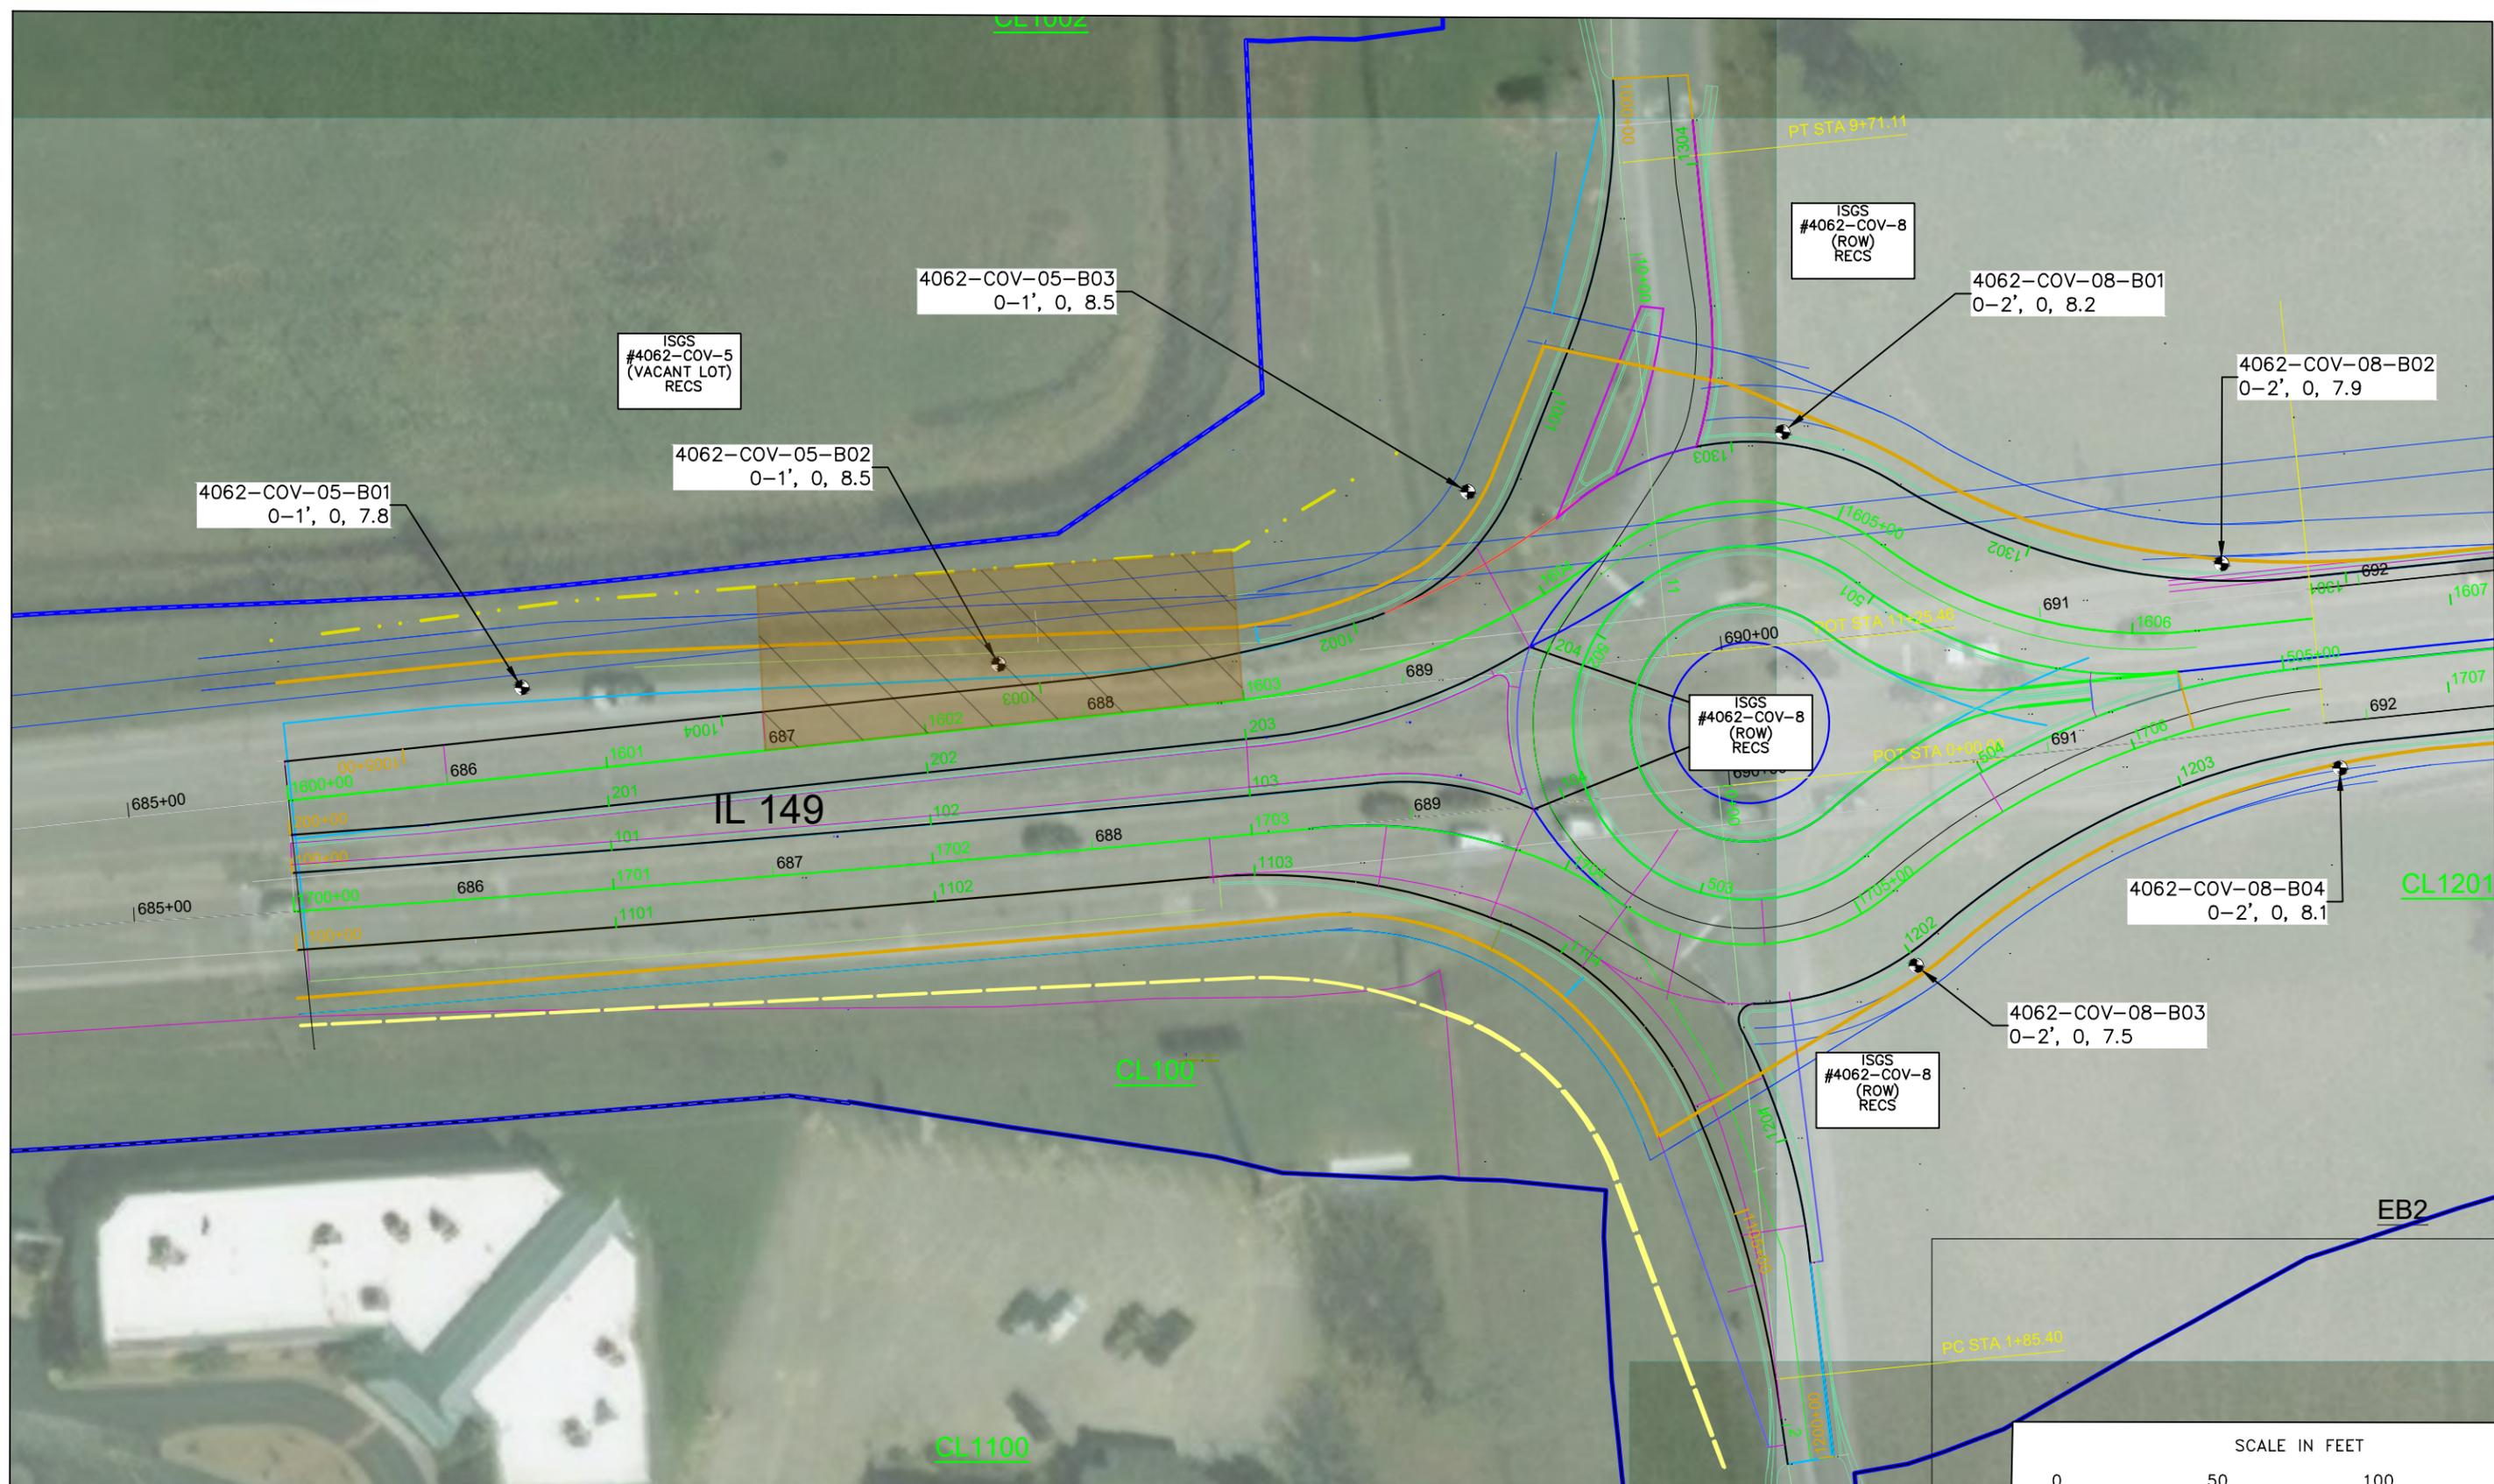
NOTE: SEE FIGURE 4-4 FOR CONTAMINANTS OF CONCERN

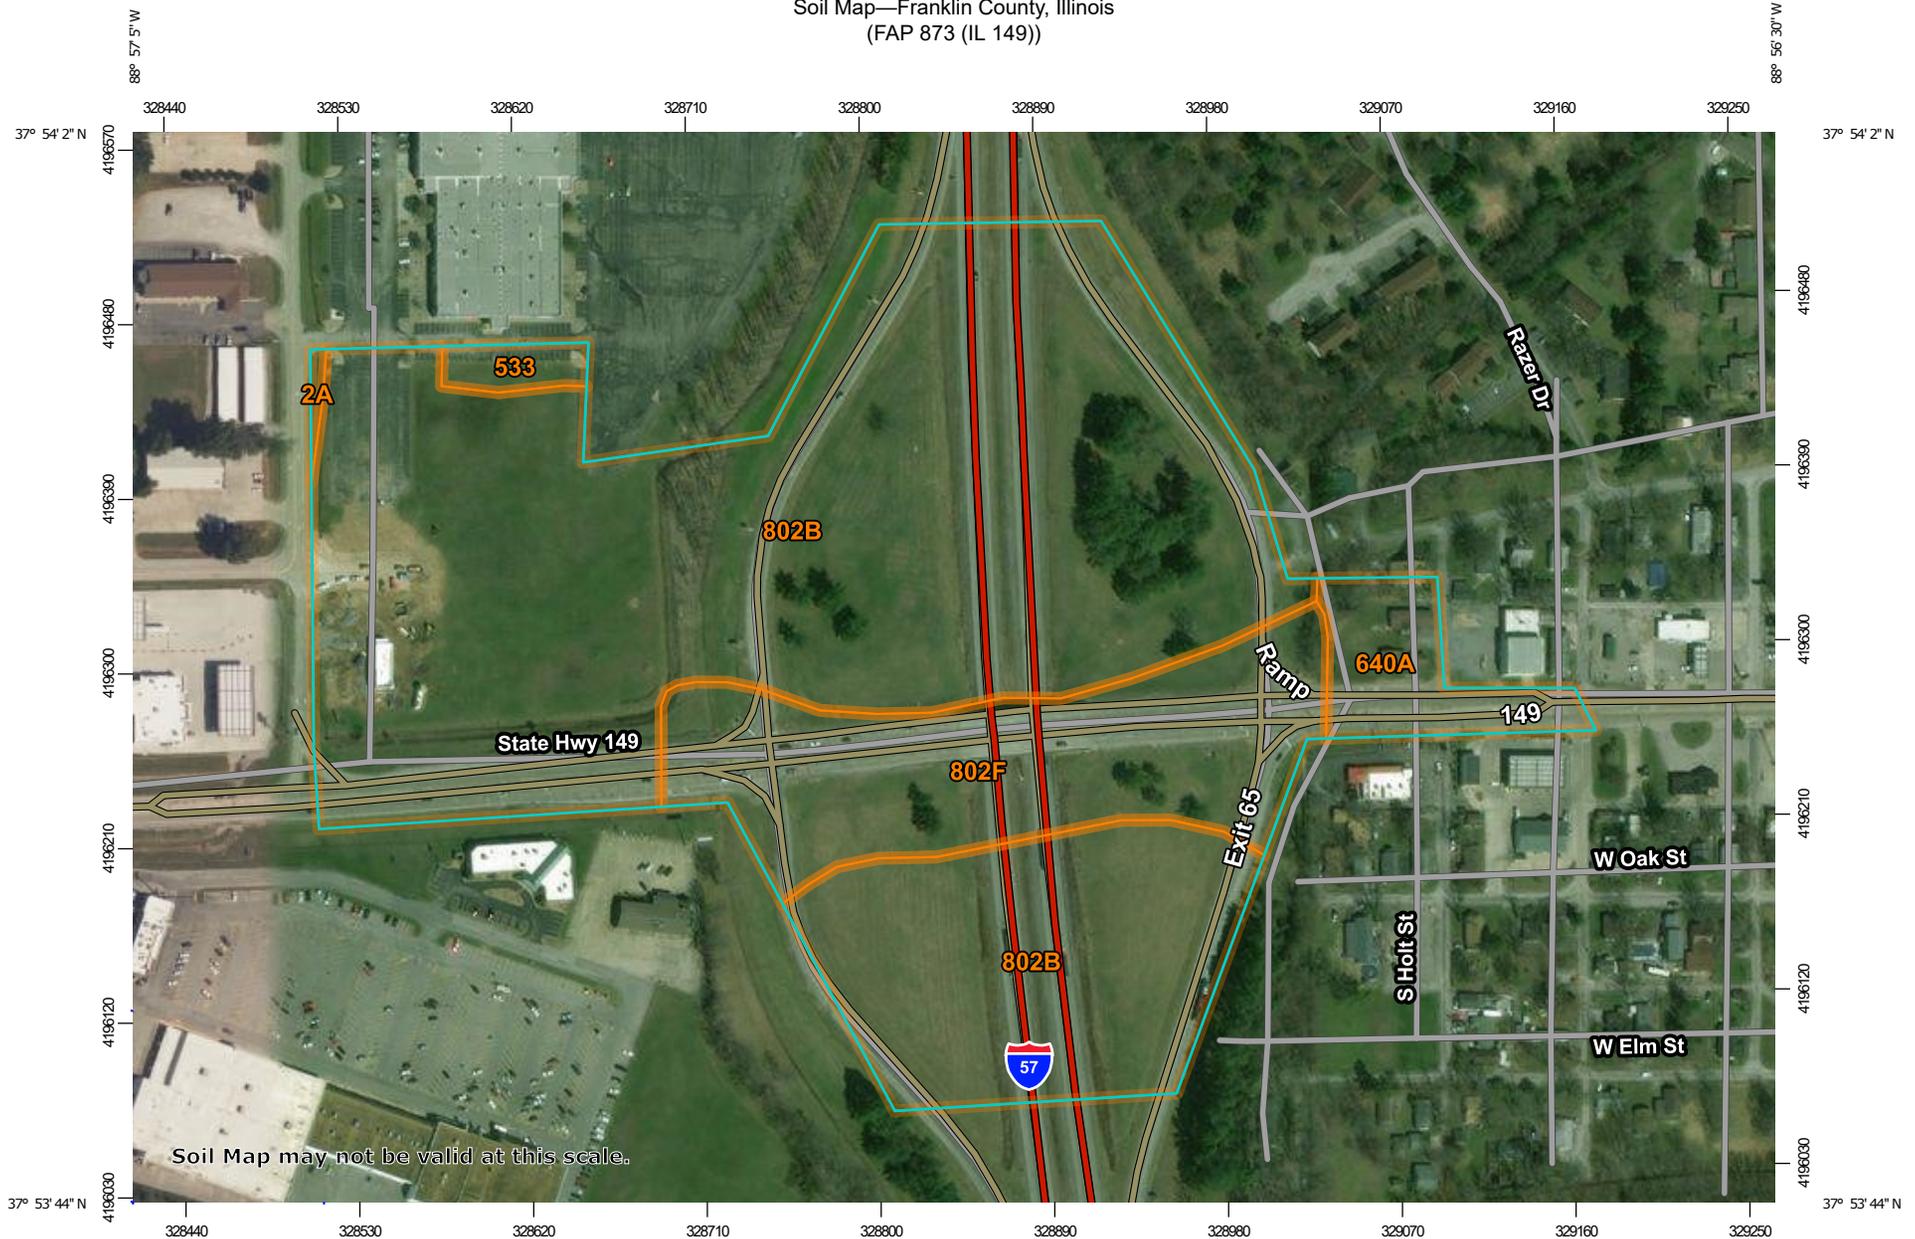
Soil Map—Franklin County, Illinois  
(FAP 873 (IL 149))

Map Scale: 1:3,890 if printed on A landscape (11" x 8.5") sheet.

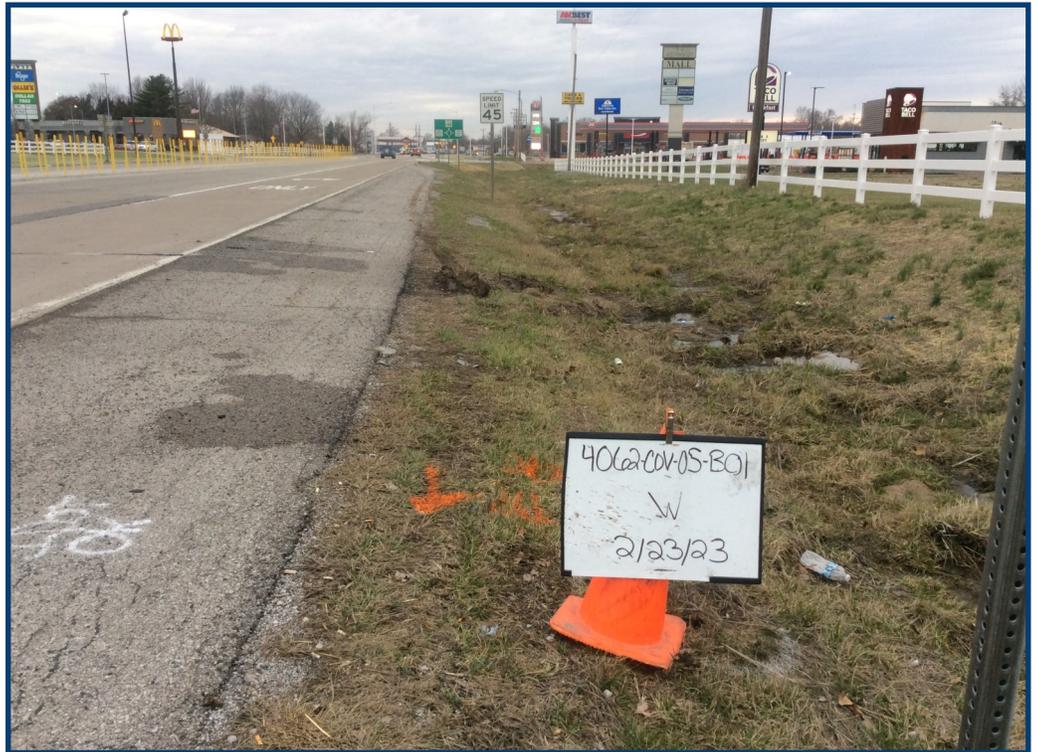
Site: ISGS #4062-COV-05  
(Vacant Lot)  
Date: 2/23/2023  
Direction: West  
Time: 1551

Description: Orange cone and placard indicate location of boring ISGS #4062-COV-05-B01

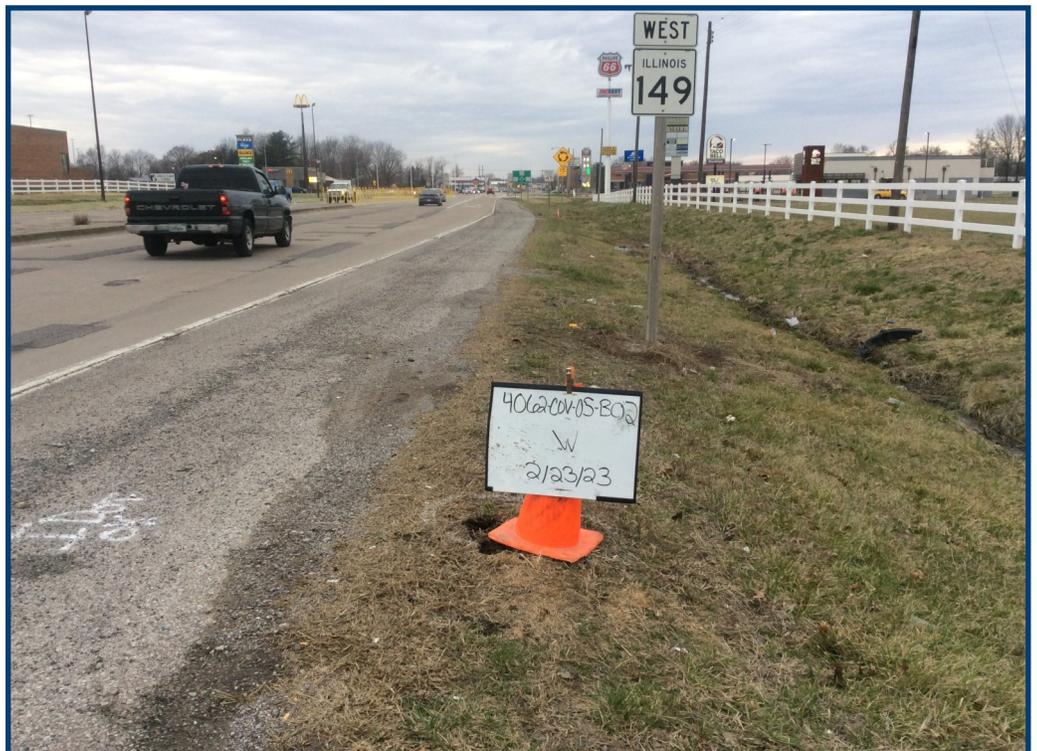
Site: ISGS #4062-COV-05  
(Vacant Lot)  
Date: 2/23/2023  
Direction: West  
Time: 1550

Description: Orange cone and placard indicate location of boring ISGS #4062-COV-05-B02

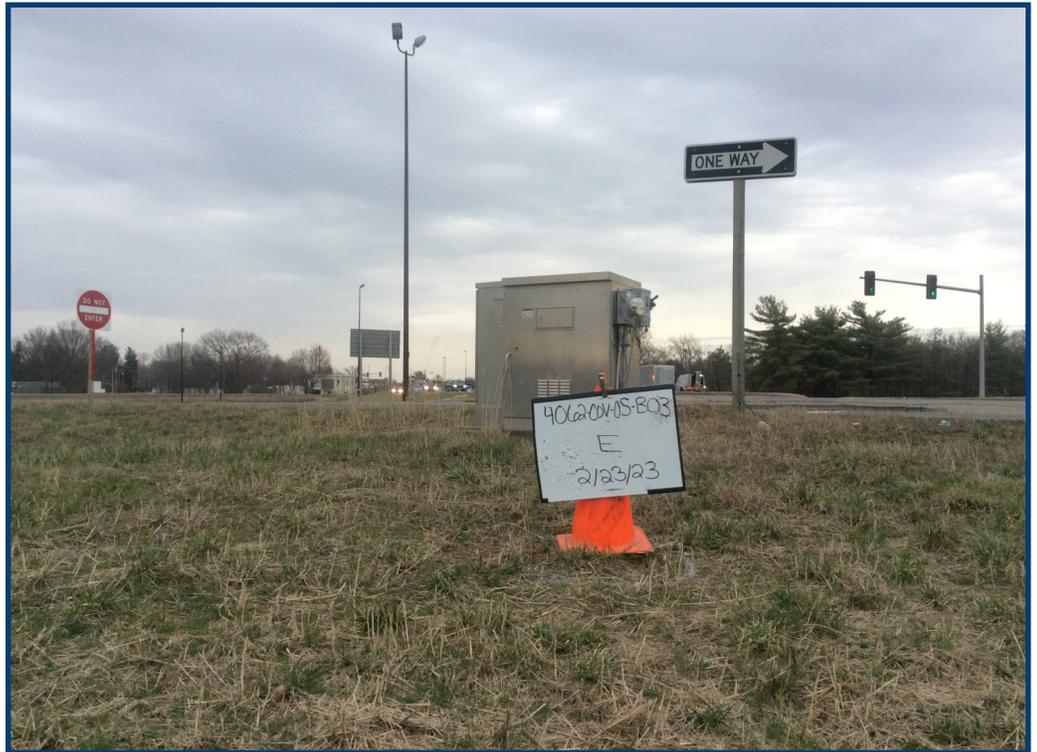
Site: ISGS #4062-COV-05  
(Vacant Lot)  
Date: 2/23/2023  
Direction: East  
Time: 1548

Description: Orange cone and placard indicate location of boring  
ISGS #4062-COV-05-B03

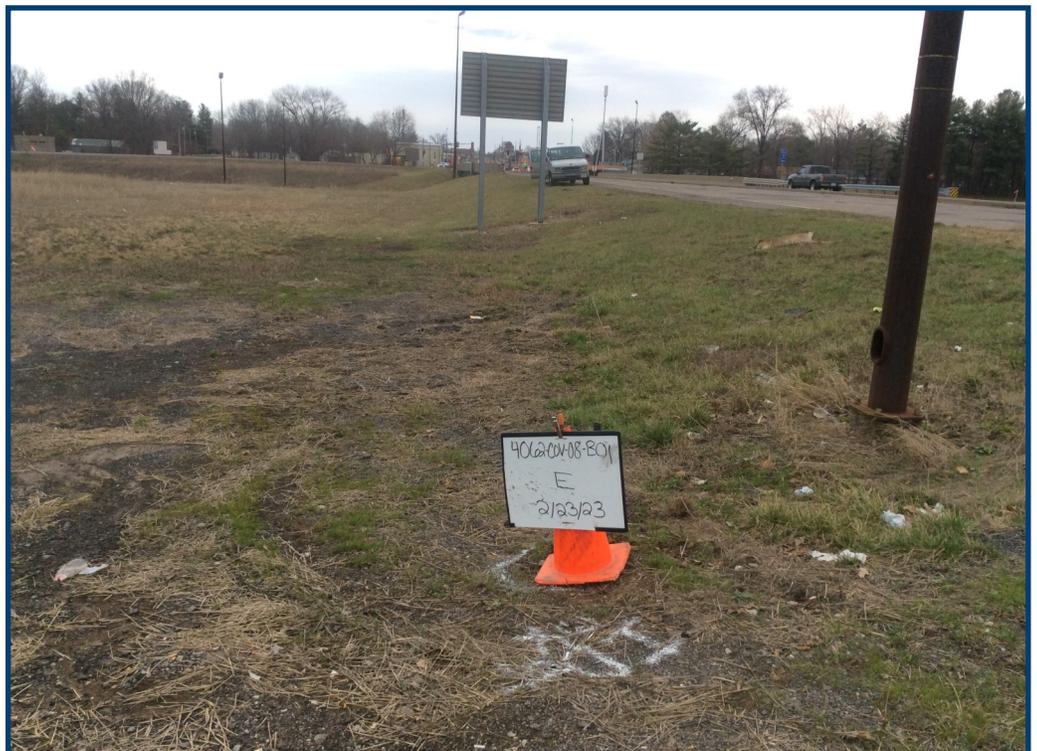
Site: ISGS #4062-COV-08  
(ROW)  
Date: 2/23/2023  
Direction: East  
Time: 1516

Description: Orange cone and placard indicate location of boring  
ISGS #4062-COV-08-B01

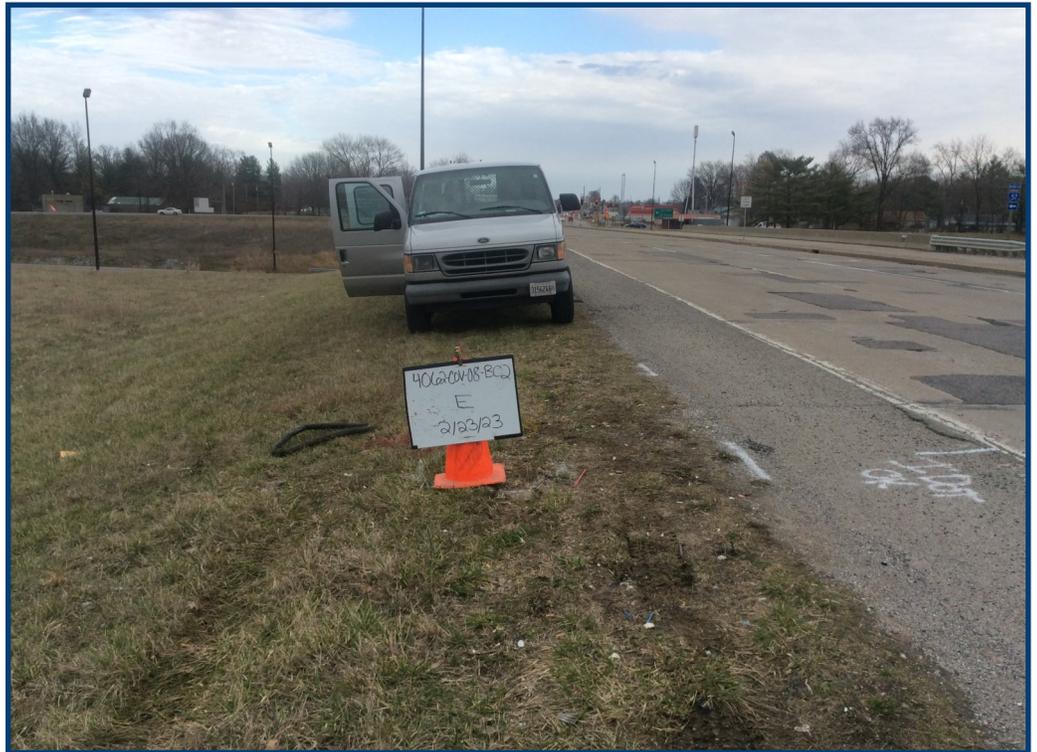
Site: ISGS #4062-COV-08  
(ROW)  
Date: 2/23/2023  
Direction: East  
Time: 1515

Description: Orange cone and placard indicate location of boring ISGS #4062-COV-08-B02

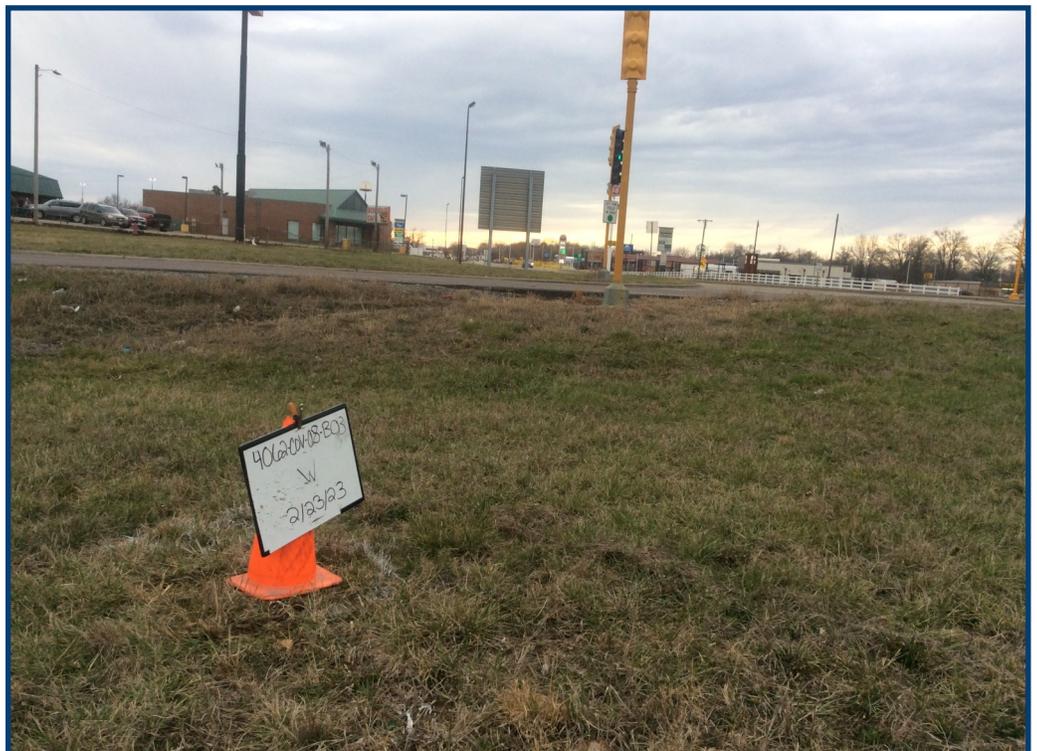
Site: ISGS #4062-COV-08  
(ROW)  
Date: 2/23/2023  
Direction: West  
Time: 1615

Description: Orange cone and placard indicate location of boring ISGS #4062-COV-08-B03

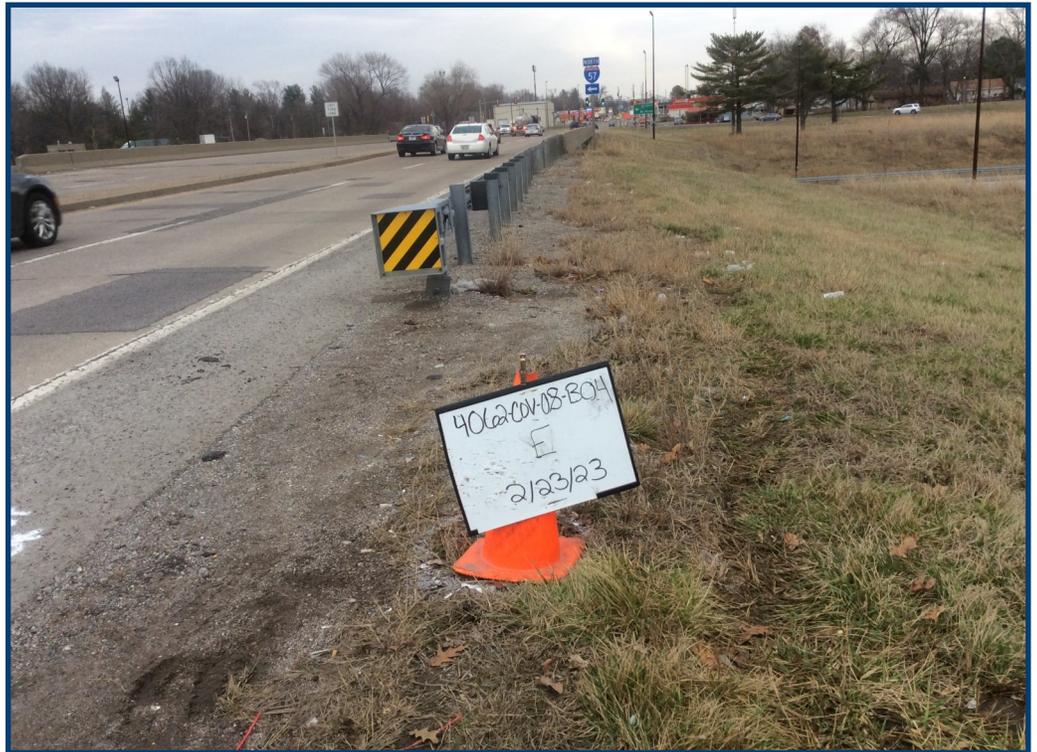
Site: ISGS #4062-COV-08  
(ROW)  
Date: 2/23/2023  
Direction: East  
Time: 1616

Description: Orange cone and placard indicate location of boring  
ISGS #4062-COV-08-B04

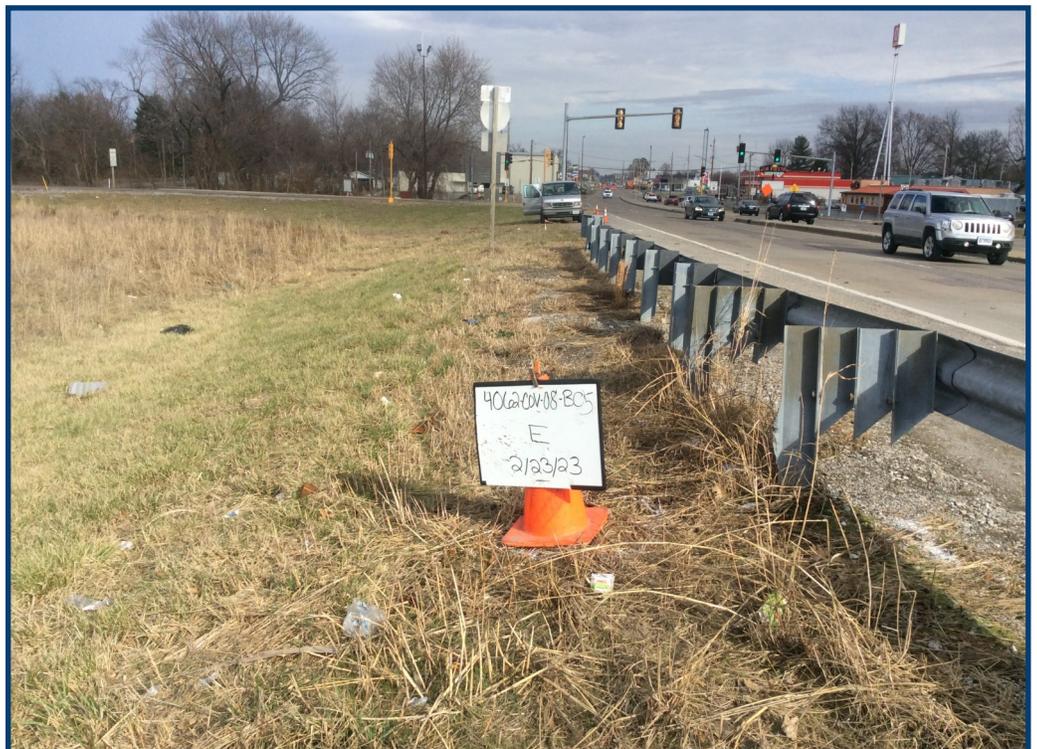
Site: ISGS #4062-COV-08  
(ROW)  
Date: 2/23/2023  
Direction: East  
Time: 1453

Description: Orange cone and placard indicate location of boring  
ISGS #4062-COV-08-B05

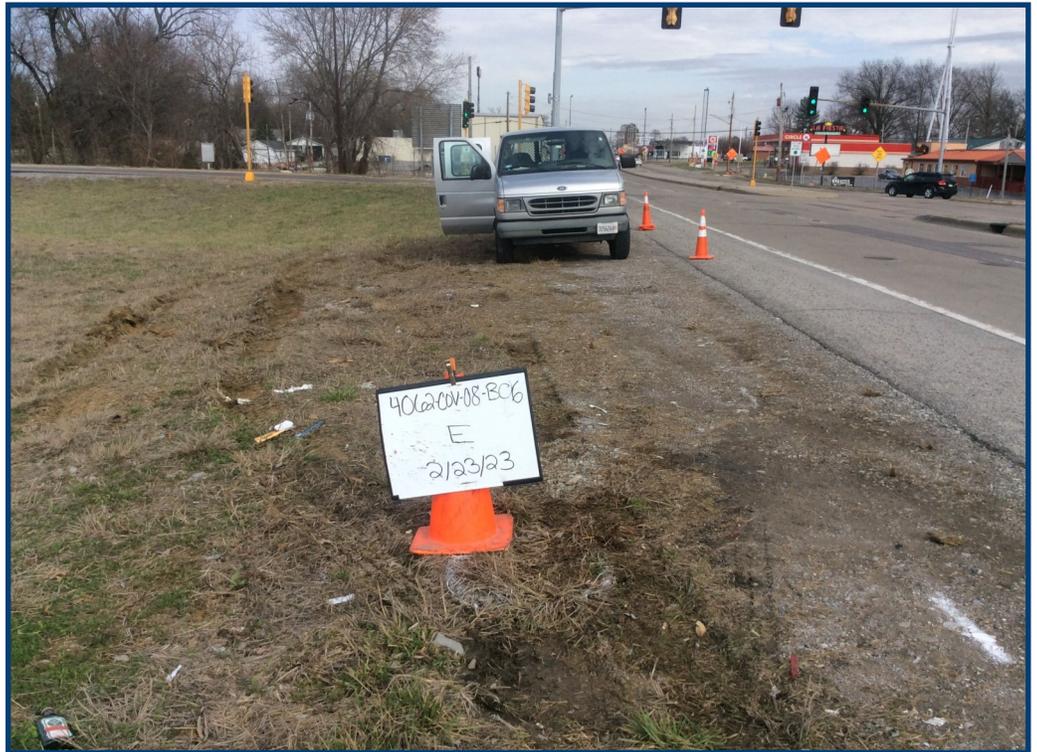
Site: ISGS #4062-COV-08  
(ROW)  
Date: 2/23/2023  
Direction: East  
Time: 1453

Description: Orange cone and placard indicate location of boring  
ISGS #4062-COV-08-B06

Soil associated with boring 4062-COV-08-B06 (manganese, benzo(a)pyrene) may be managed on-site as fill. If soil cannot be used on-site as fill, it must be managed off-site as non-special waste, providing that a non-special waste certification is submitted by the generator according to the conditions set forth in 415 ILCS 5/22.48 and 415 ILCS 5/3.475. Site background information and the results of the PSI indicate that a non-special waste certification may be completed for soil associated with the boring.

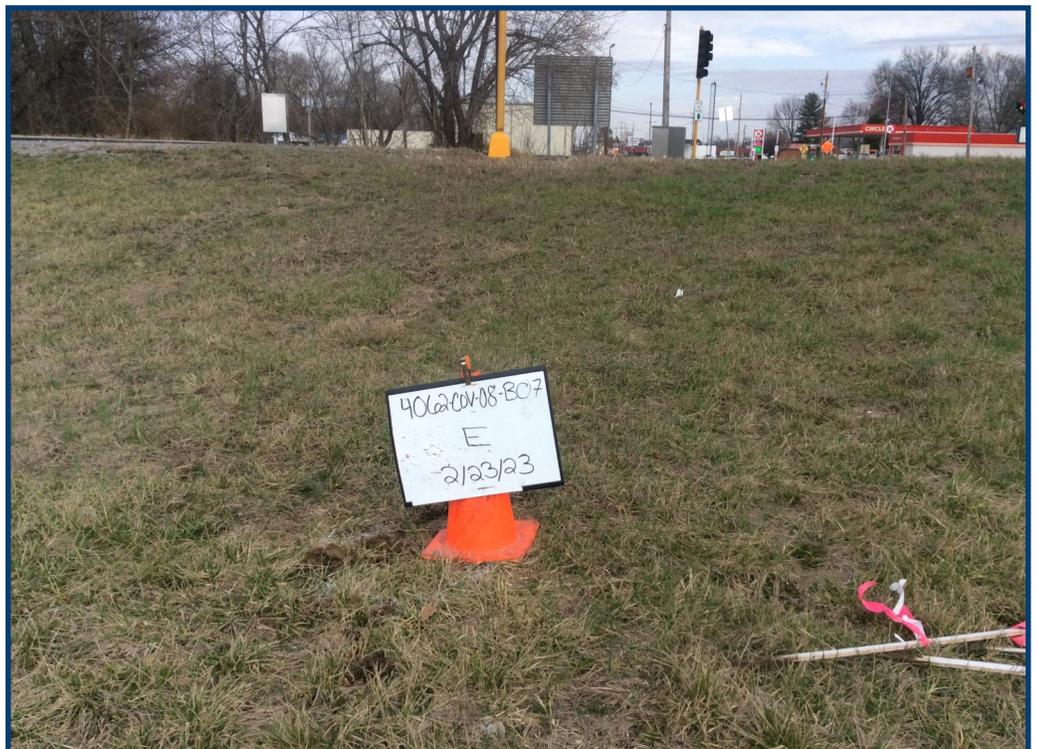
Site: ISGS #4062-COV-08  
(ROW)  
Date: 2/23/2023  
Direction: East  
Time: 1451

Description: Orange cone and placard indicate location of boring  
ISGS #4062-COV-08-B07

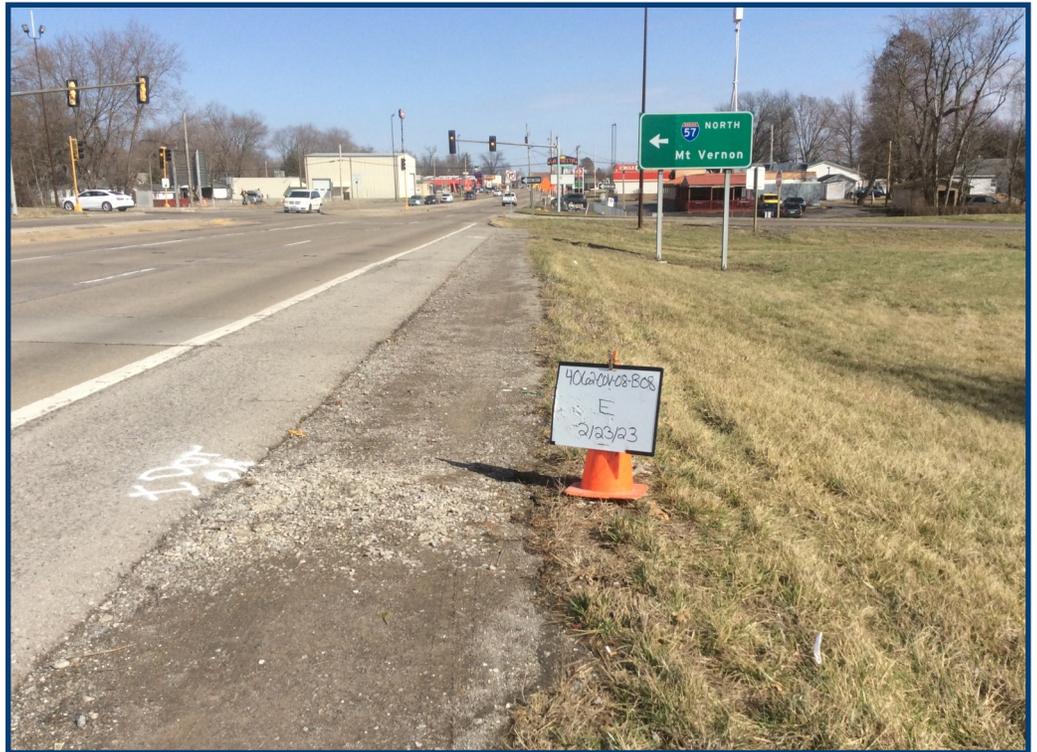
Site: ISGS #4062-COV-08  
(ROW)  
Date: 2/23/2023  
Direction: East  
Time: 1351

Description: Orange cone and placard indicate location of boring ISGS #4062-COV-08-B08

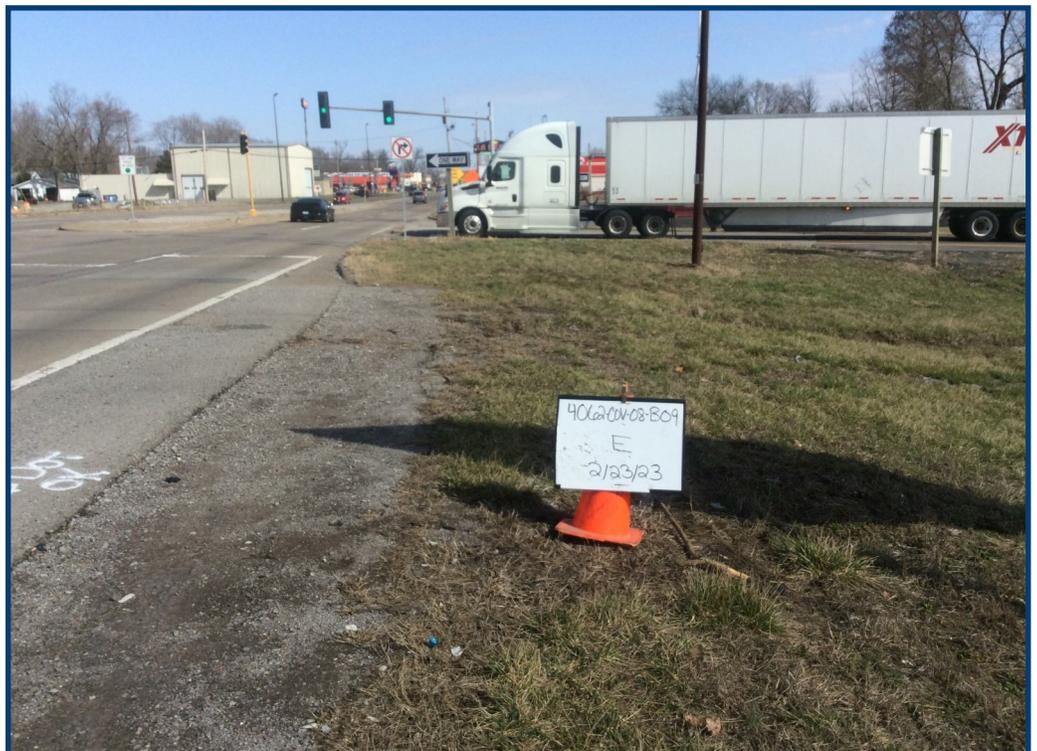
Site: ISGS #4062-COV-08  
(ROW)  
Date: 2/23/2023  
Direction: East  
Time: 1352

Description: Orange cone and placard indicate location of boring ISGS #4062-COV-08-B09

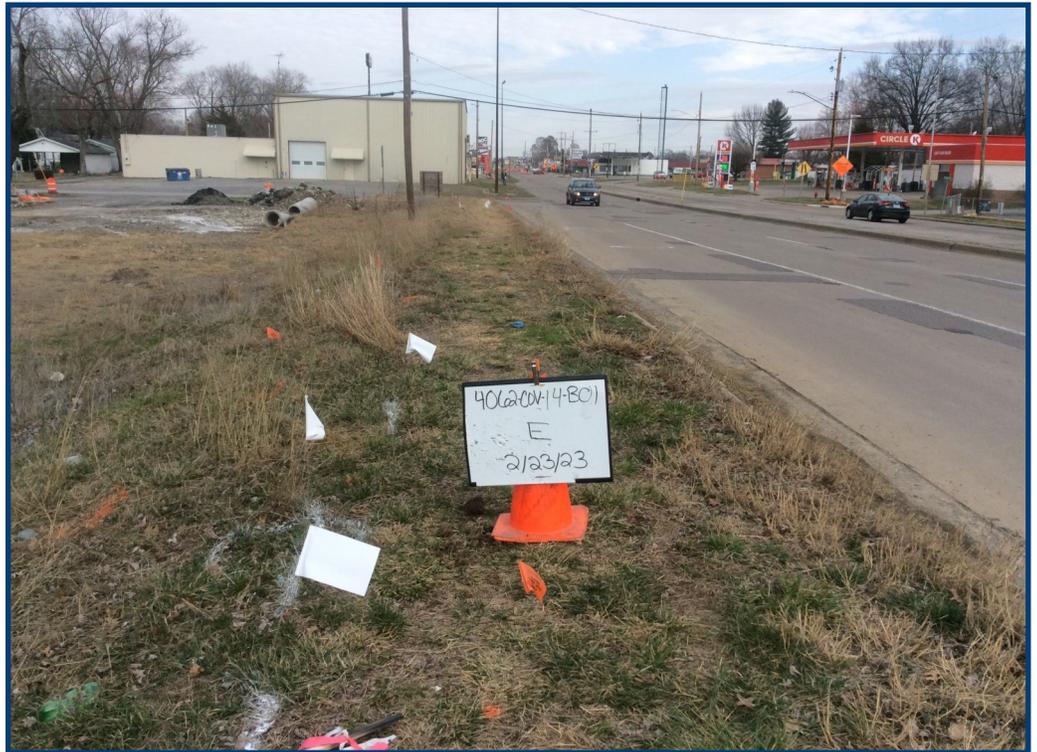
Site: ISGS #4062-COV-14  
(Residential)  
Date: 2/23/2023  
Direction: East  
Time: 1447

Description: Orange cone and placard indicate location of boring  
ISGS #4062-COV-14-B01

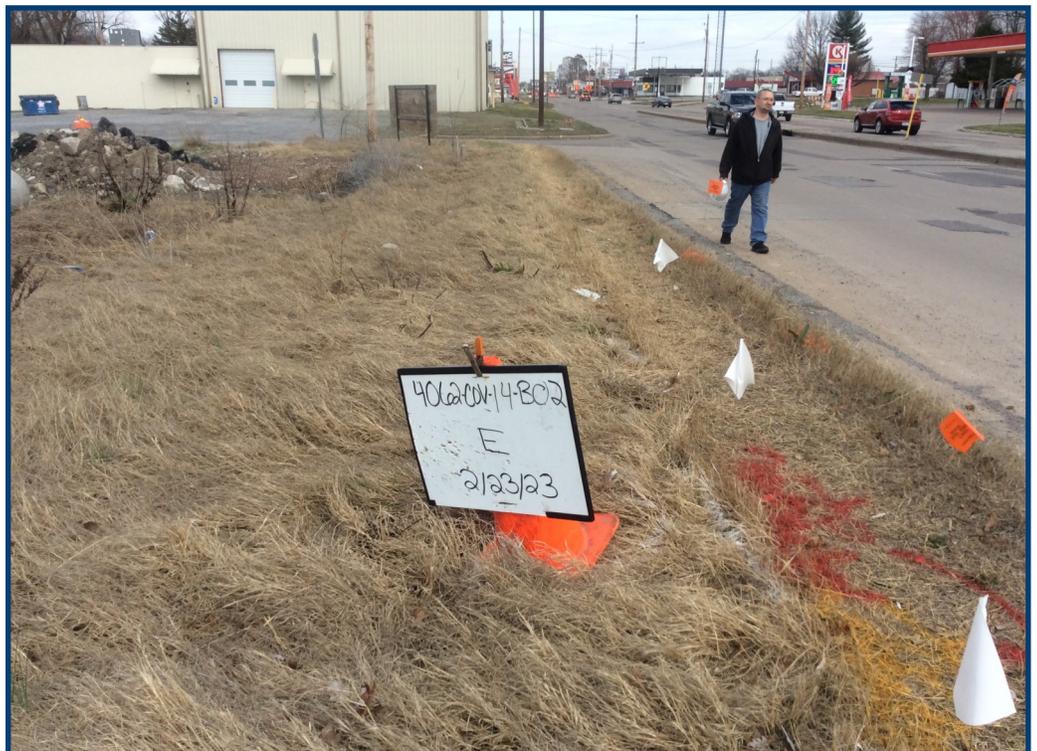
Site: ISGS #4062-COV-14  
(Residential)  
Date: 2/23/2023  
Direction: East  
Time: 1448

Description: Orange cone and placard indicate location of boring  
ISGS #4062-COV-14-B02
