Structure Geotechnical Report

**FAP631 (IL 102)
Section 110BR
Kankakee County
IL 102 over Rock Creek,
6.7 miles west of US 52
SN 046-0065(Existing)
SN 046-0149 (Proposed)
P93-048-04
Contract #66B55
PTB 133/10**

Prepared By: Terrence McCleary
Geotechnical Engineer
McCleary Engineering
terry@mcclearyengineering.com
(815) 442-8495

Date: August 16, 2011(Revised July 5, 2012)

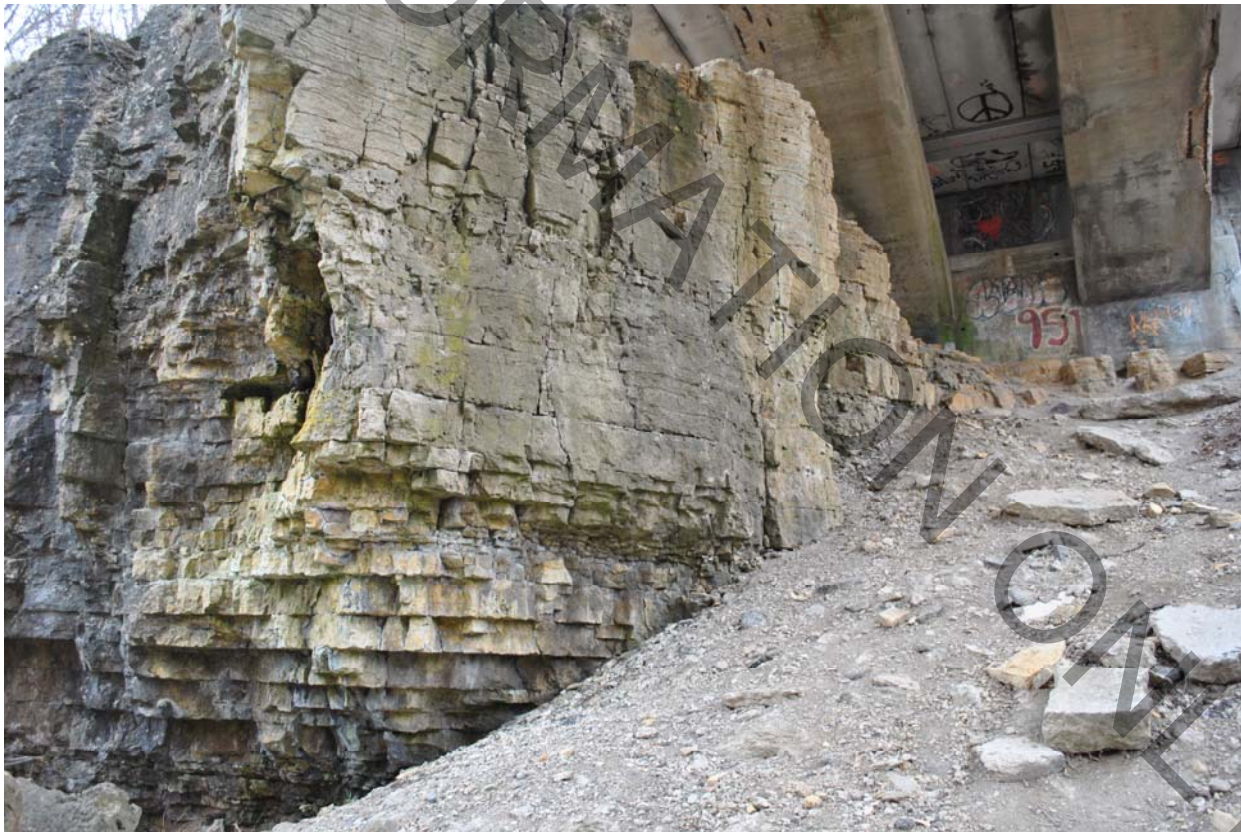
Figure 3: Picture of the rock formation in front of the east abutment of SN046-0065.

The picture above shows the bedding planes to have a horizontal physical expression in two directions. In this picture the rock face shown in the left $\frac{1}{4}$ of the picture is

approximately 70° from the direction of the rock face toward the center of the picture. The vertical and near vertical jointing in the picture shows no relative movement and provides evidence of why this structure rock face has existed harmoniously for so many years.

The vertical rock walls are made of horizontal bedding planes of varying thickness ranging from 3 inches to 12 inches. According to the rock cores taken April 6 and July 13, 2011, the material between the bedding planes appears to be silt and clay shale. The orientation of the joints and cracks are shown in the picture below.

With the orientation of the bedding planes and the joint sets as shown in the picture on the previous page, there is little concern for short term stability. Over time, many years, the rock has eroded near the stream surface. Care should be taken to properly drain the roadway storm water away from the face of the rock. Normal sheet flow does not appear to be greatly affecting the rock face. A concern that the roadway ditches are concentrating the flow of water for some distance may have been the reason for the retaining structure in the NW quadrant of the west abutment.

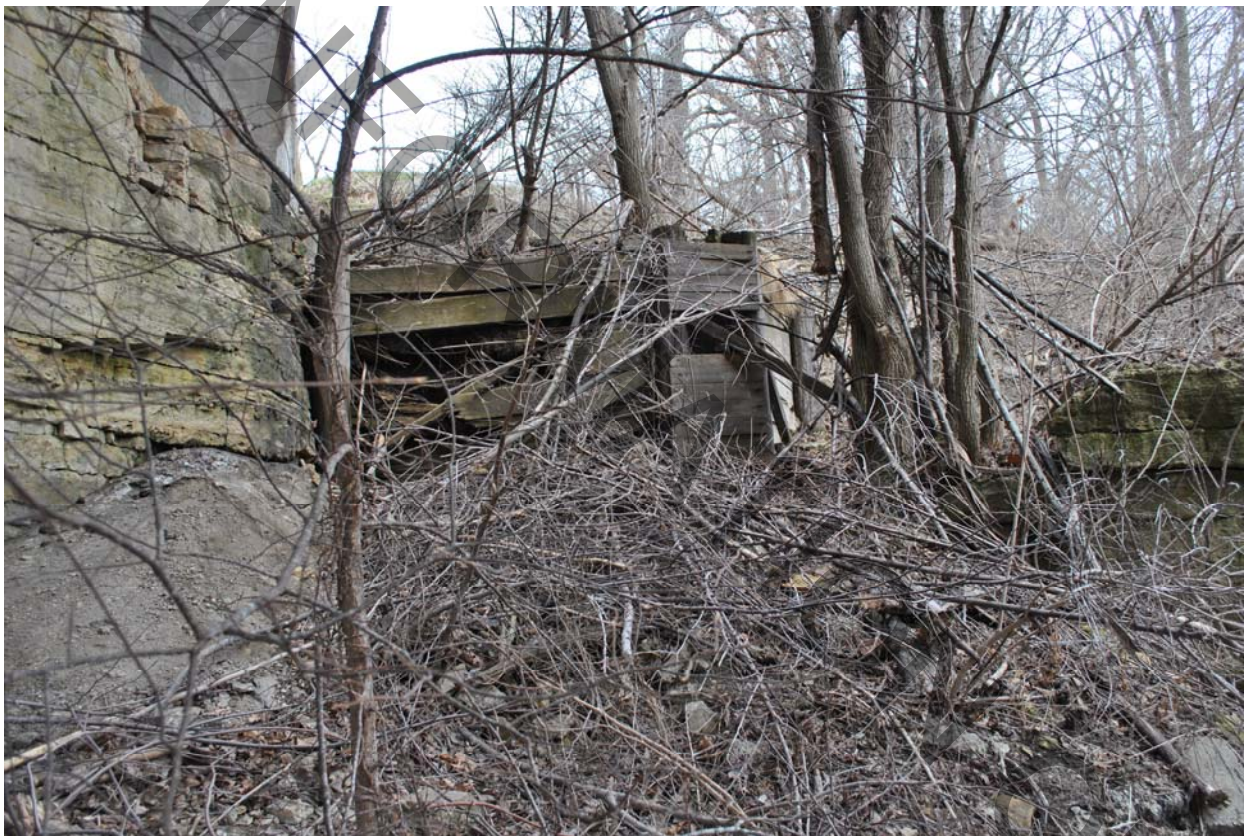
Figure 4: Picture of wooden retaining structure in the NW quadrant of the west abutment.

It is possible this wall is constructed in a crevice filled with sediment or the rock in this area had eroded. The appearance of stability would be improved if the new abutments were placed behind the existing abutments and the existing abutments staying in place up to a point where they would not interfere with the new structure.

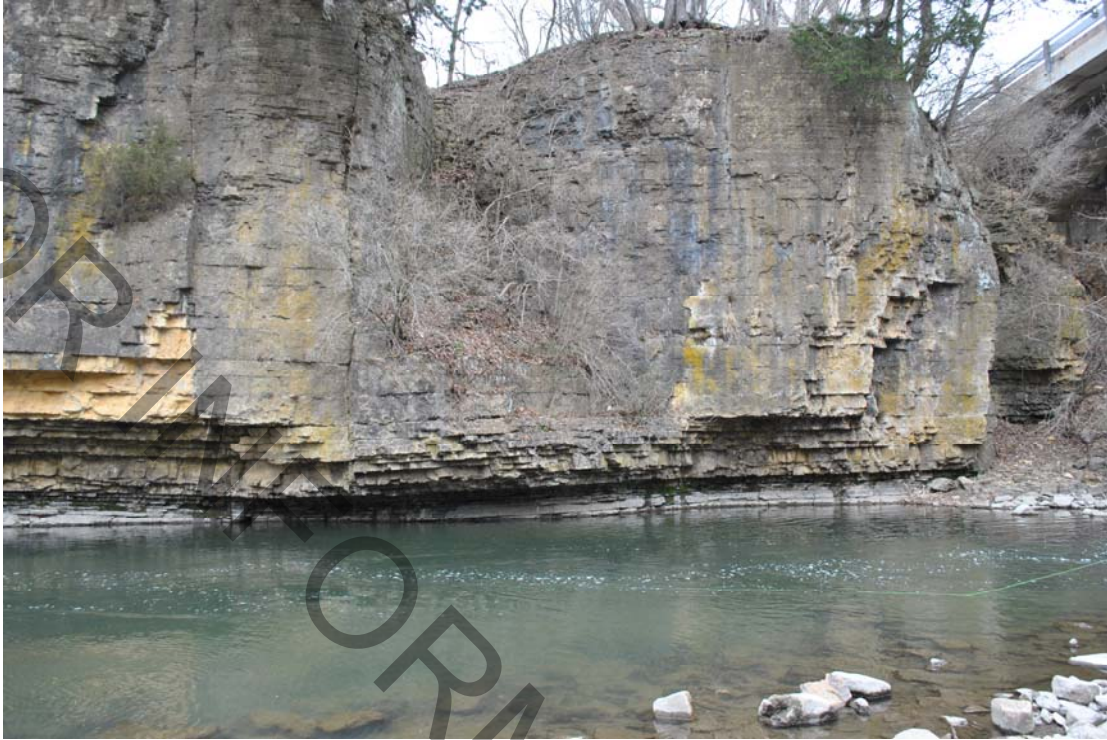
Figure 4: Image of layers and jointing of the rock formation along the west side of Rock Creek.

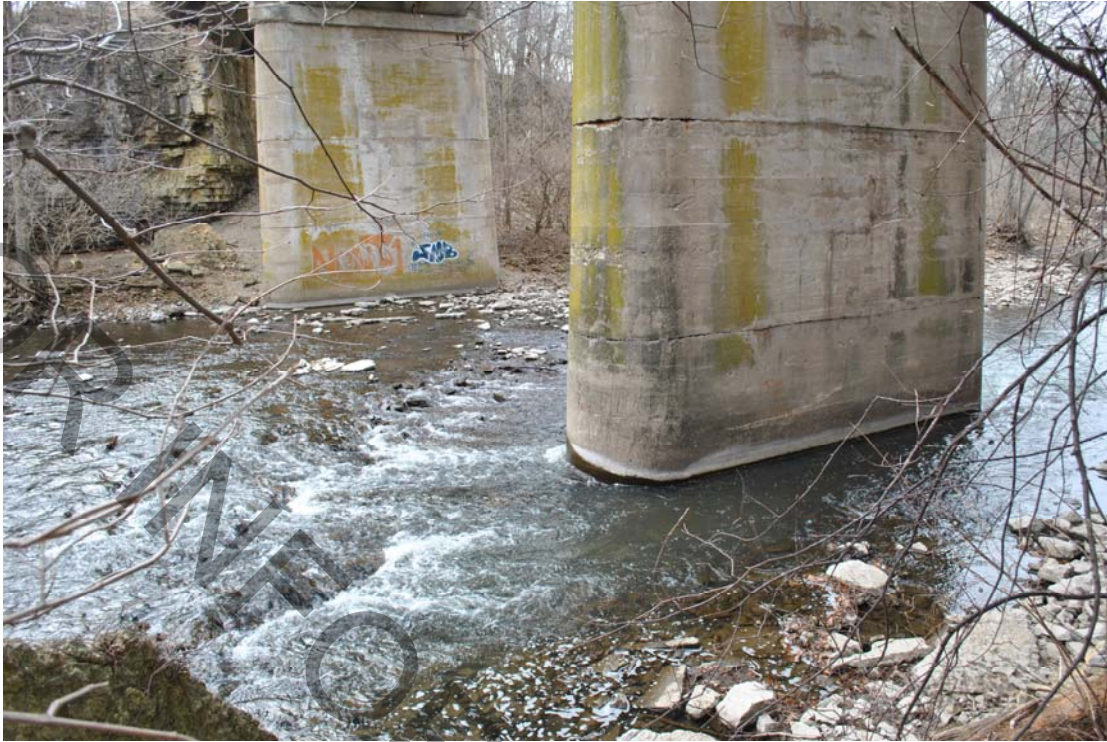
Figure 6: Image of creek bottom at IL 102 Bridge SN 046-0065

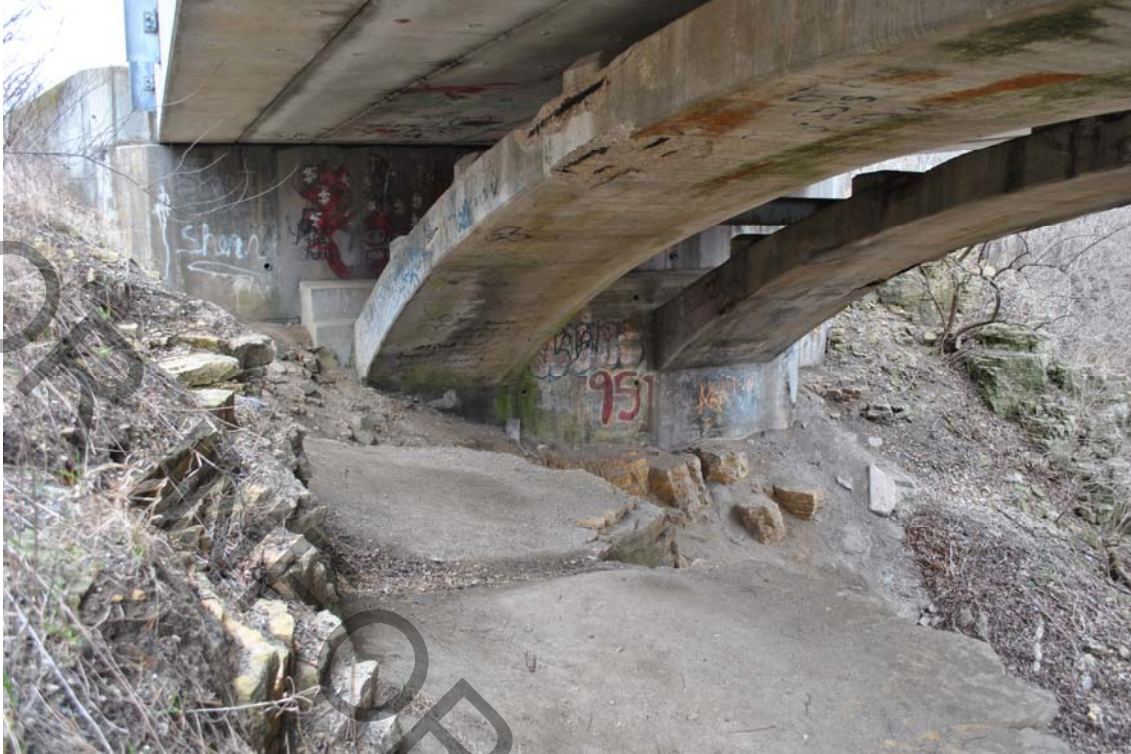
Figure 8: Existing east abutment.

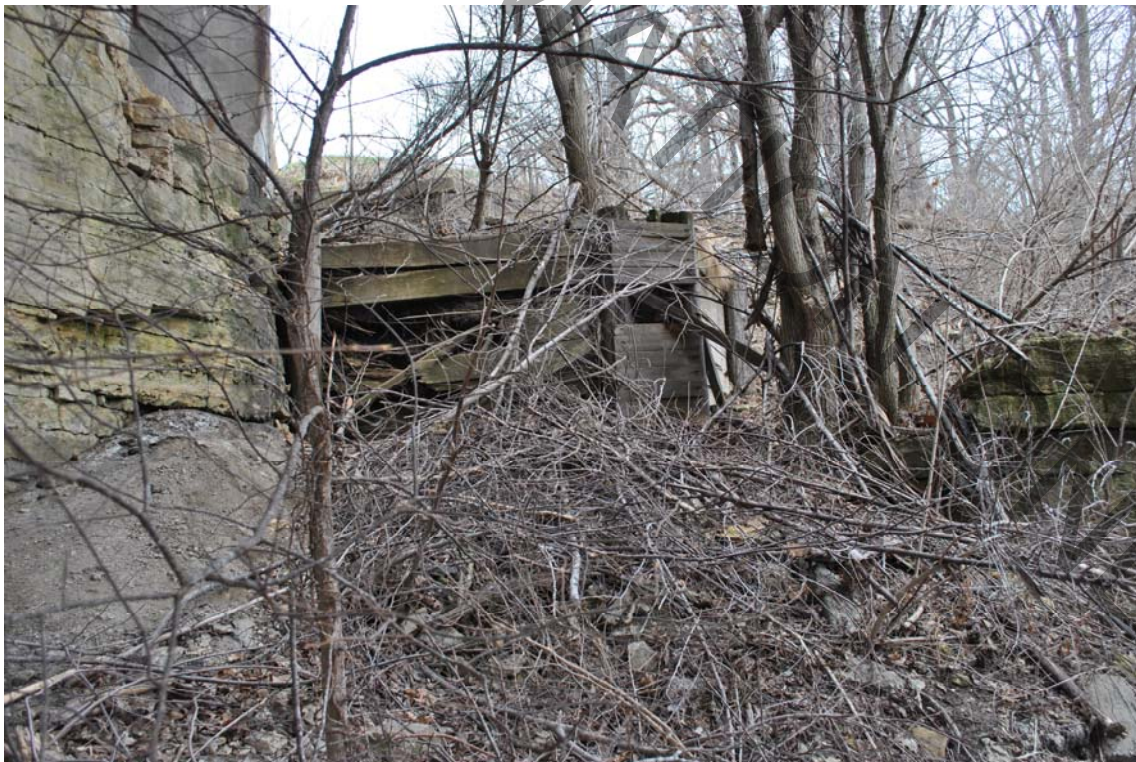
Figure 9: Failing wood retaining wall immediately north of west abutment.
