Pre-Bid Meeting

Contract 66A55

November 6, 2015 Letting

IL 102 over Rock Creek

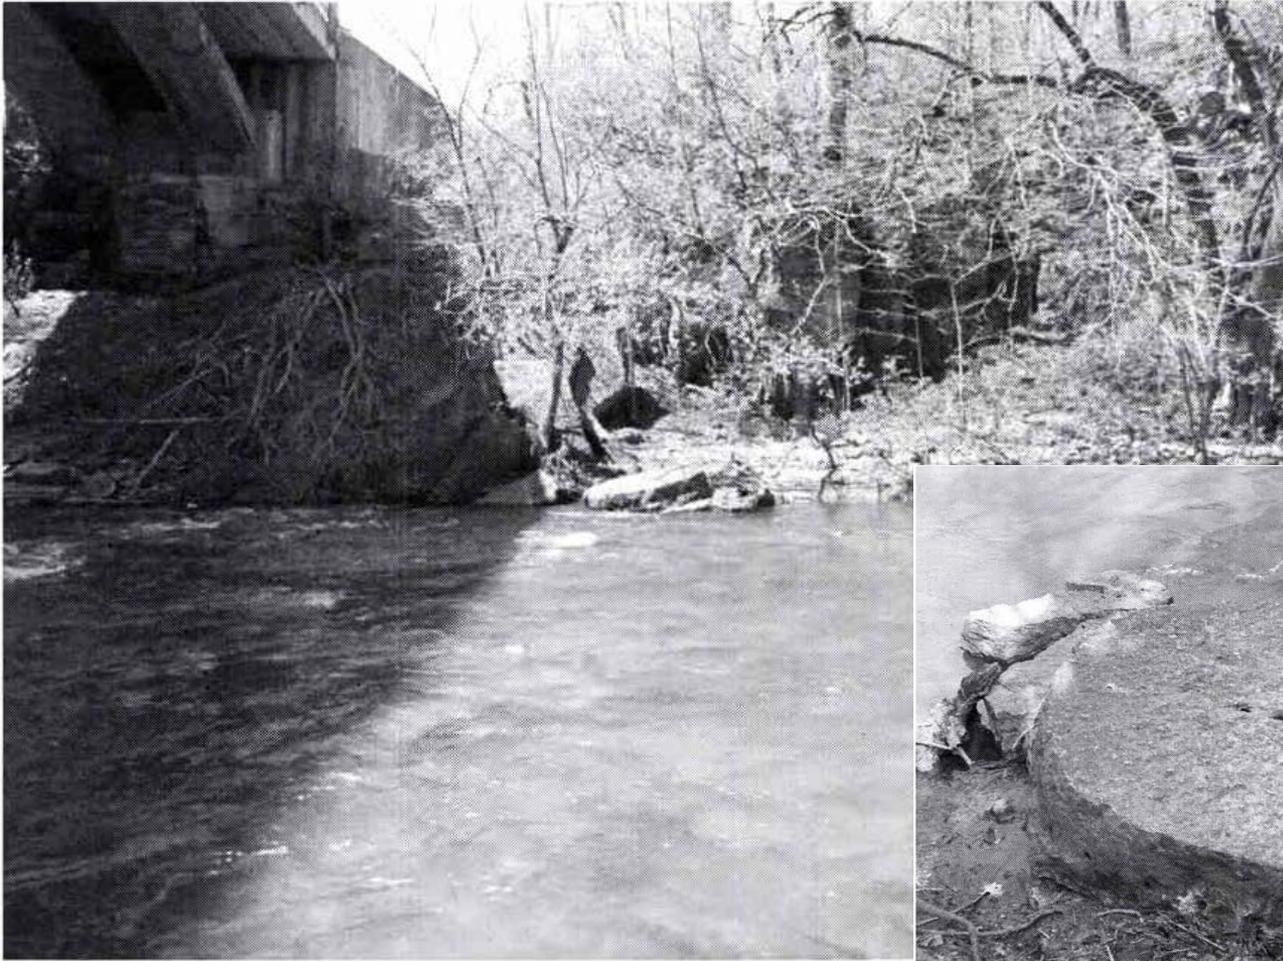
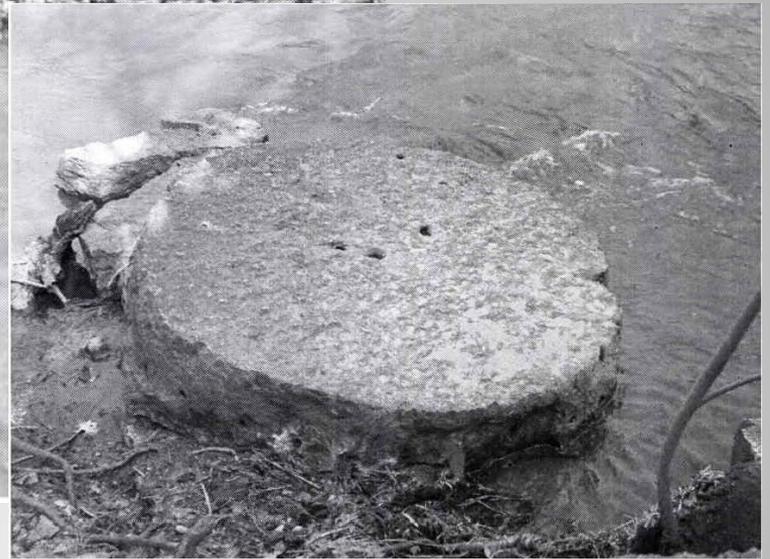
- Protection of Millstone.
- In-stream work restrictions.
- Tree protection/clearing restrictions.
- Temporary Occupancy Permit.

Millstone Protection

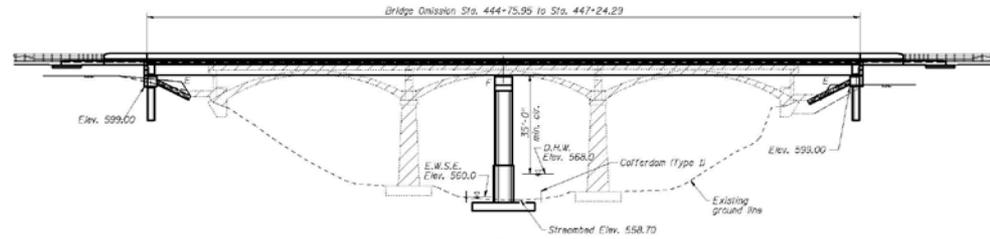
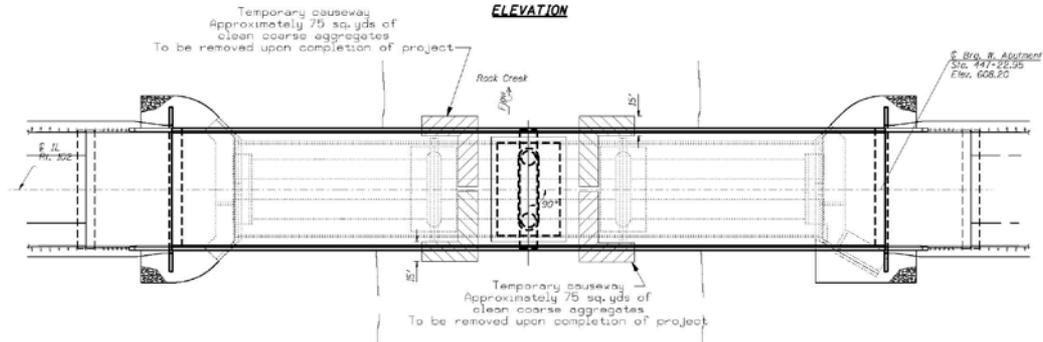
EXHIBIT

ELEVATION

PLAN

**GENERAL PLAN
IL 102 OVER ROCK CREEK
FAP ROUTE 631 - SECTION (110)BR
KANKAKEE COUNTY
STATION 445+00.12
EXISTING STRUCTURE NO. 046-0065
PROPOSED STRUCTURE NO. 046-0149**

INDR 404 Permit - Causeway

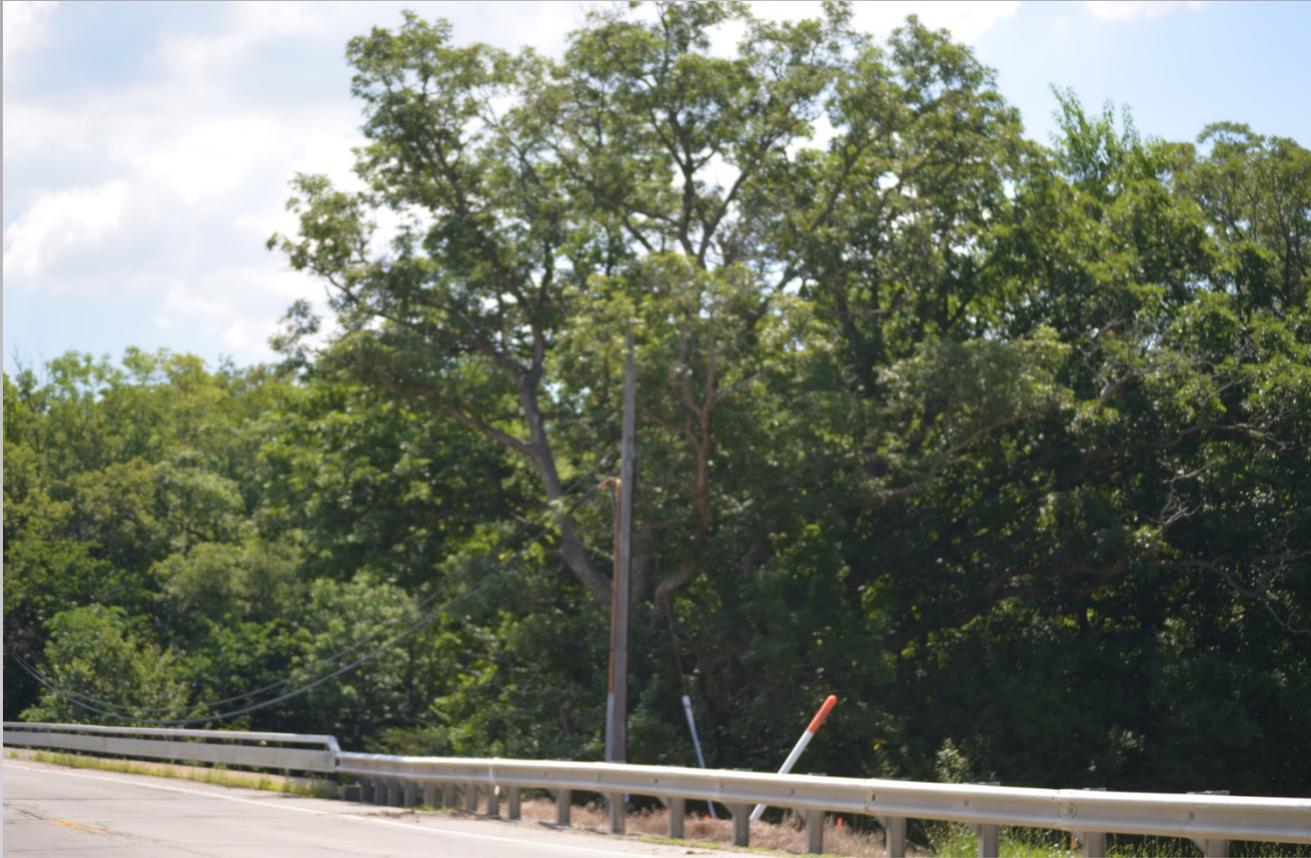
Oak Trees SW Quadrant

Two oak trees in the southwest quadrant shall be protected from damage. Trimming allowed if required, but must be coordinated with the Park Superintendent.

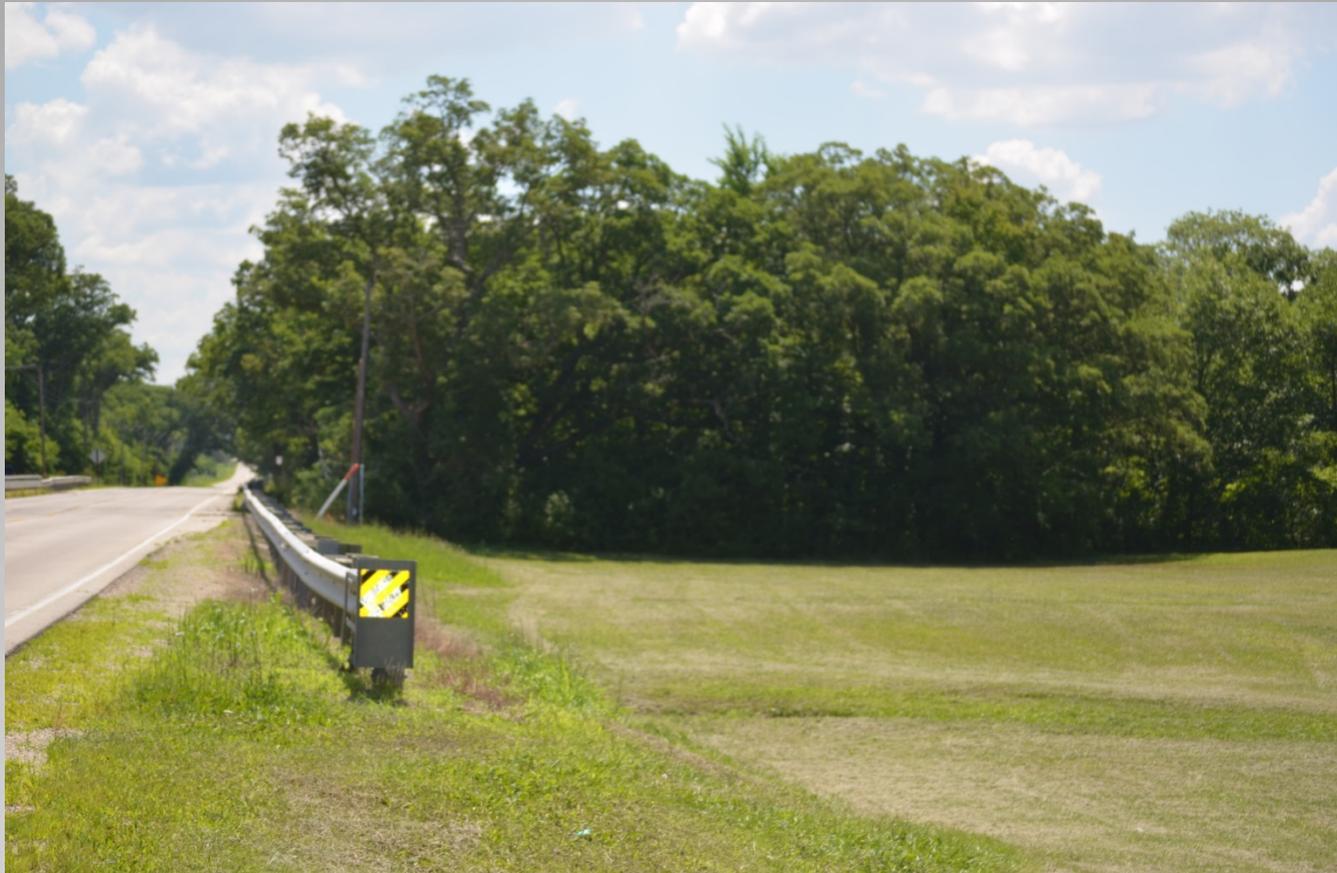
- Intent of the permit is to provide area for use as access/laydown area for the project work due to restricted existing right of way.
- All proposed maintenance activities / improvements in these areas must be approved by the Park Site Superintendent.

**Temporary Occupancy Permit Area
South Side of IL 102**

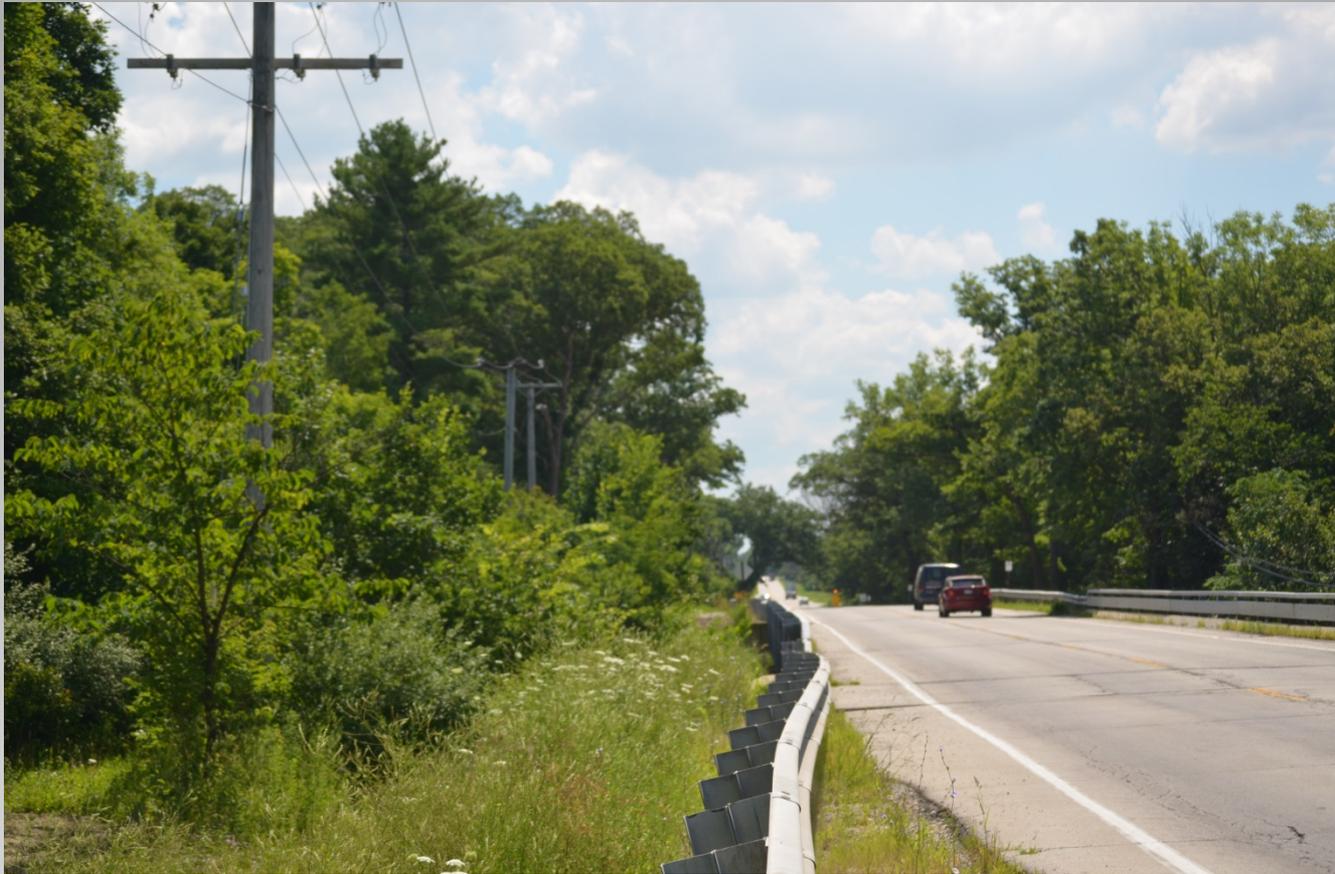
Temporary Occupancy – NW Quadrant

- Access to the jobsite is limited to the existing right of way, and the Temporary Occupancy Permit area. (Special Provision for Contractor Access).
- The Kankakee River State Park Site Superintendent does not have sole authority to authorize access from other locations within the park.
- Project site topography will make access to the creek bed challenging. Pictures of the project in the following slides.

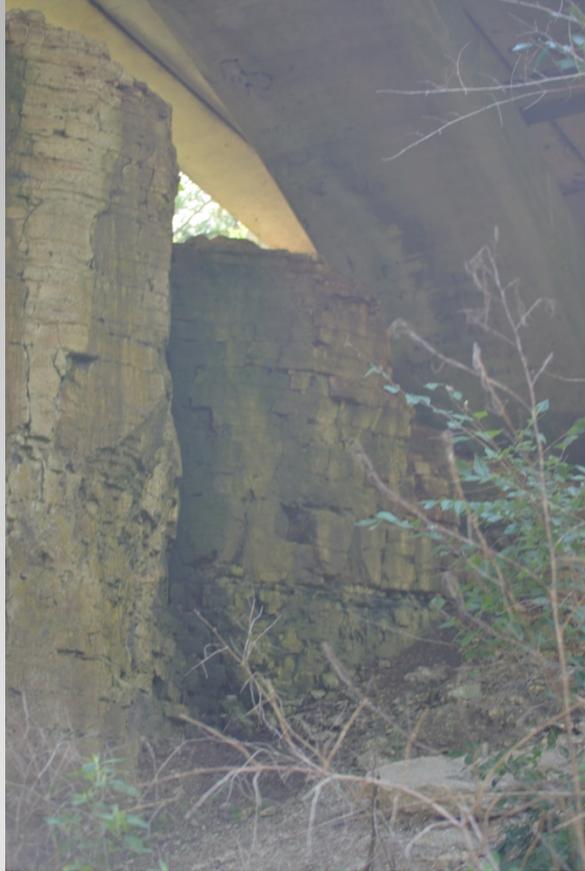
NE Abutment – Rock Outcrop
