# ASBESTOS SURVEY REPORT

**PTB 196-032**

**Asbestos Survey for Building Demolition (I-80)**

**230 Duncan Street, Joliet, Illinois**

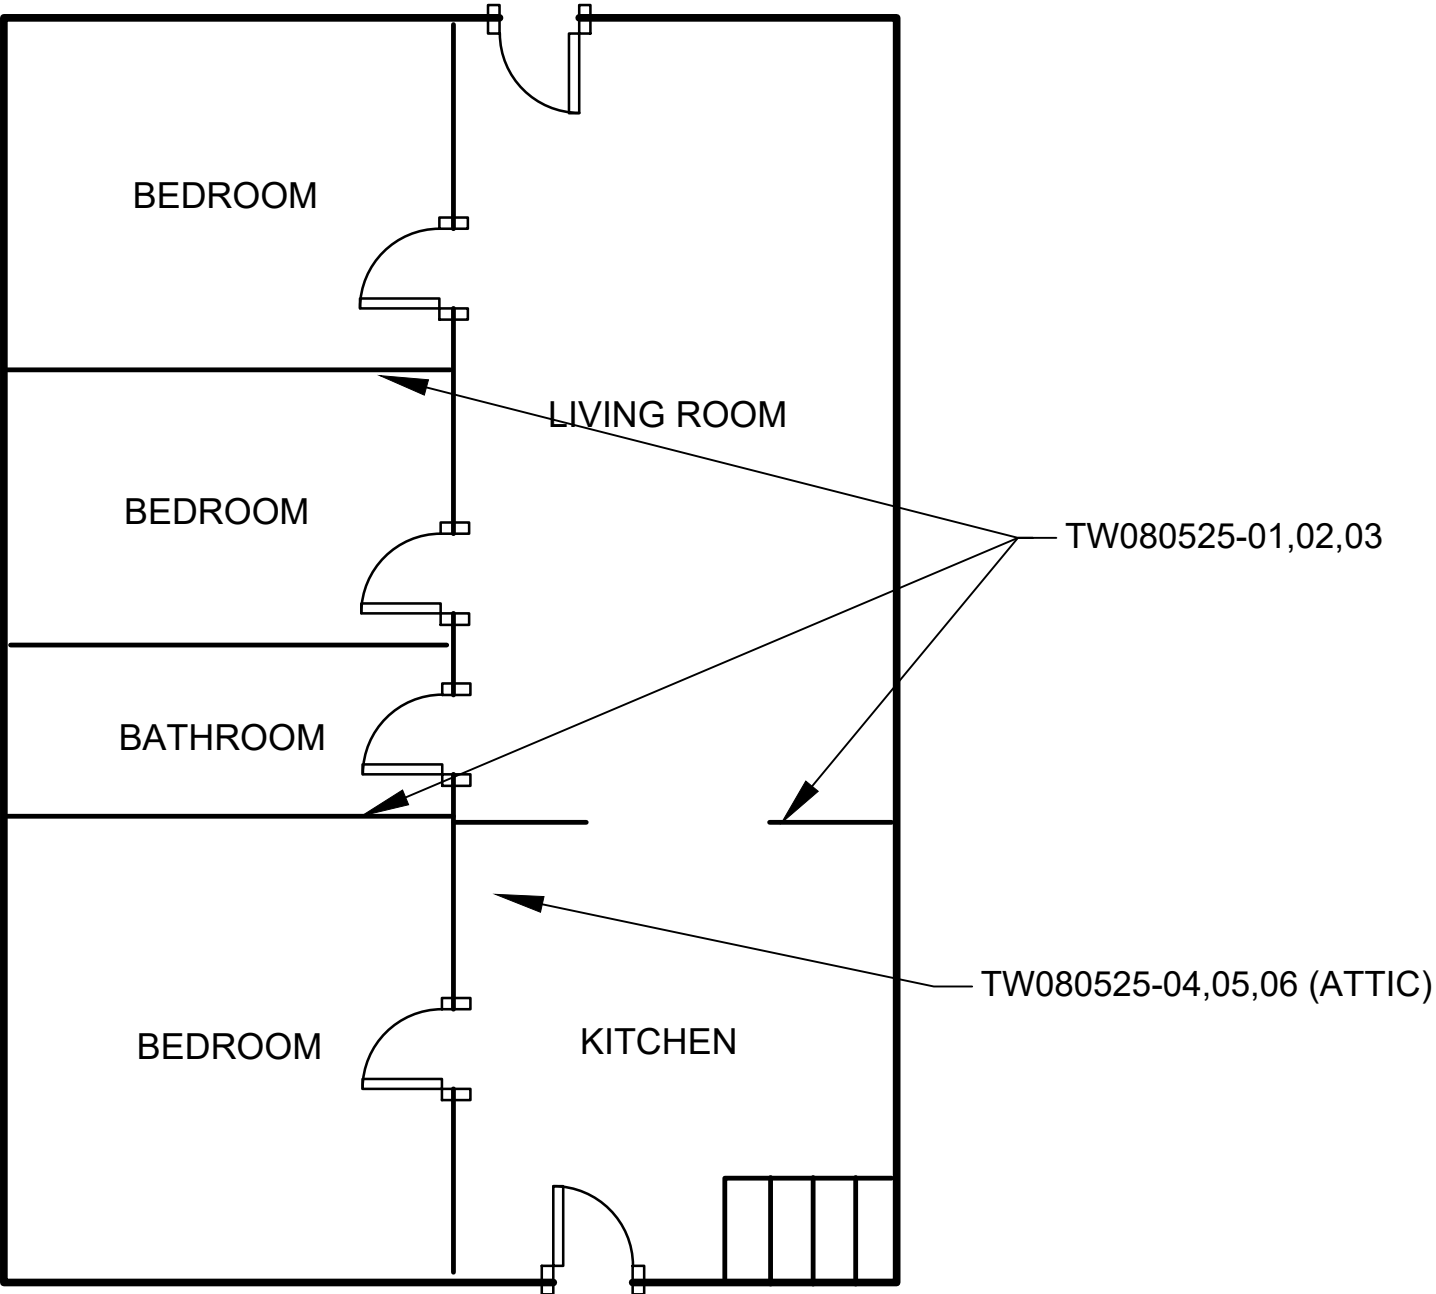
SL-2

FIRST FLOOR  
SCALE = N.T.S.

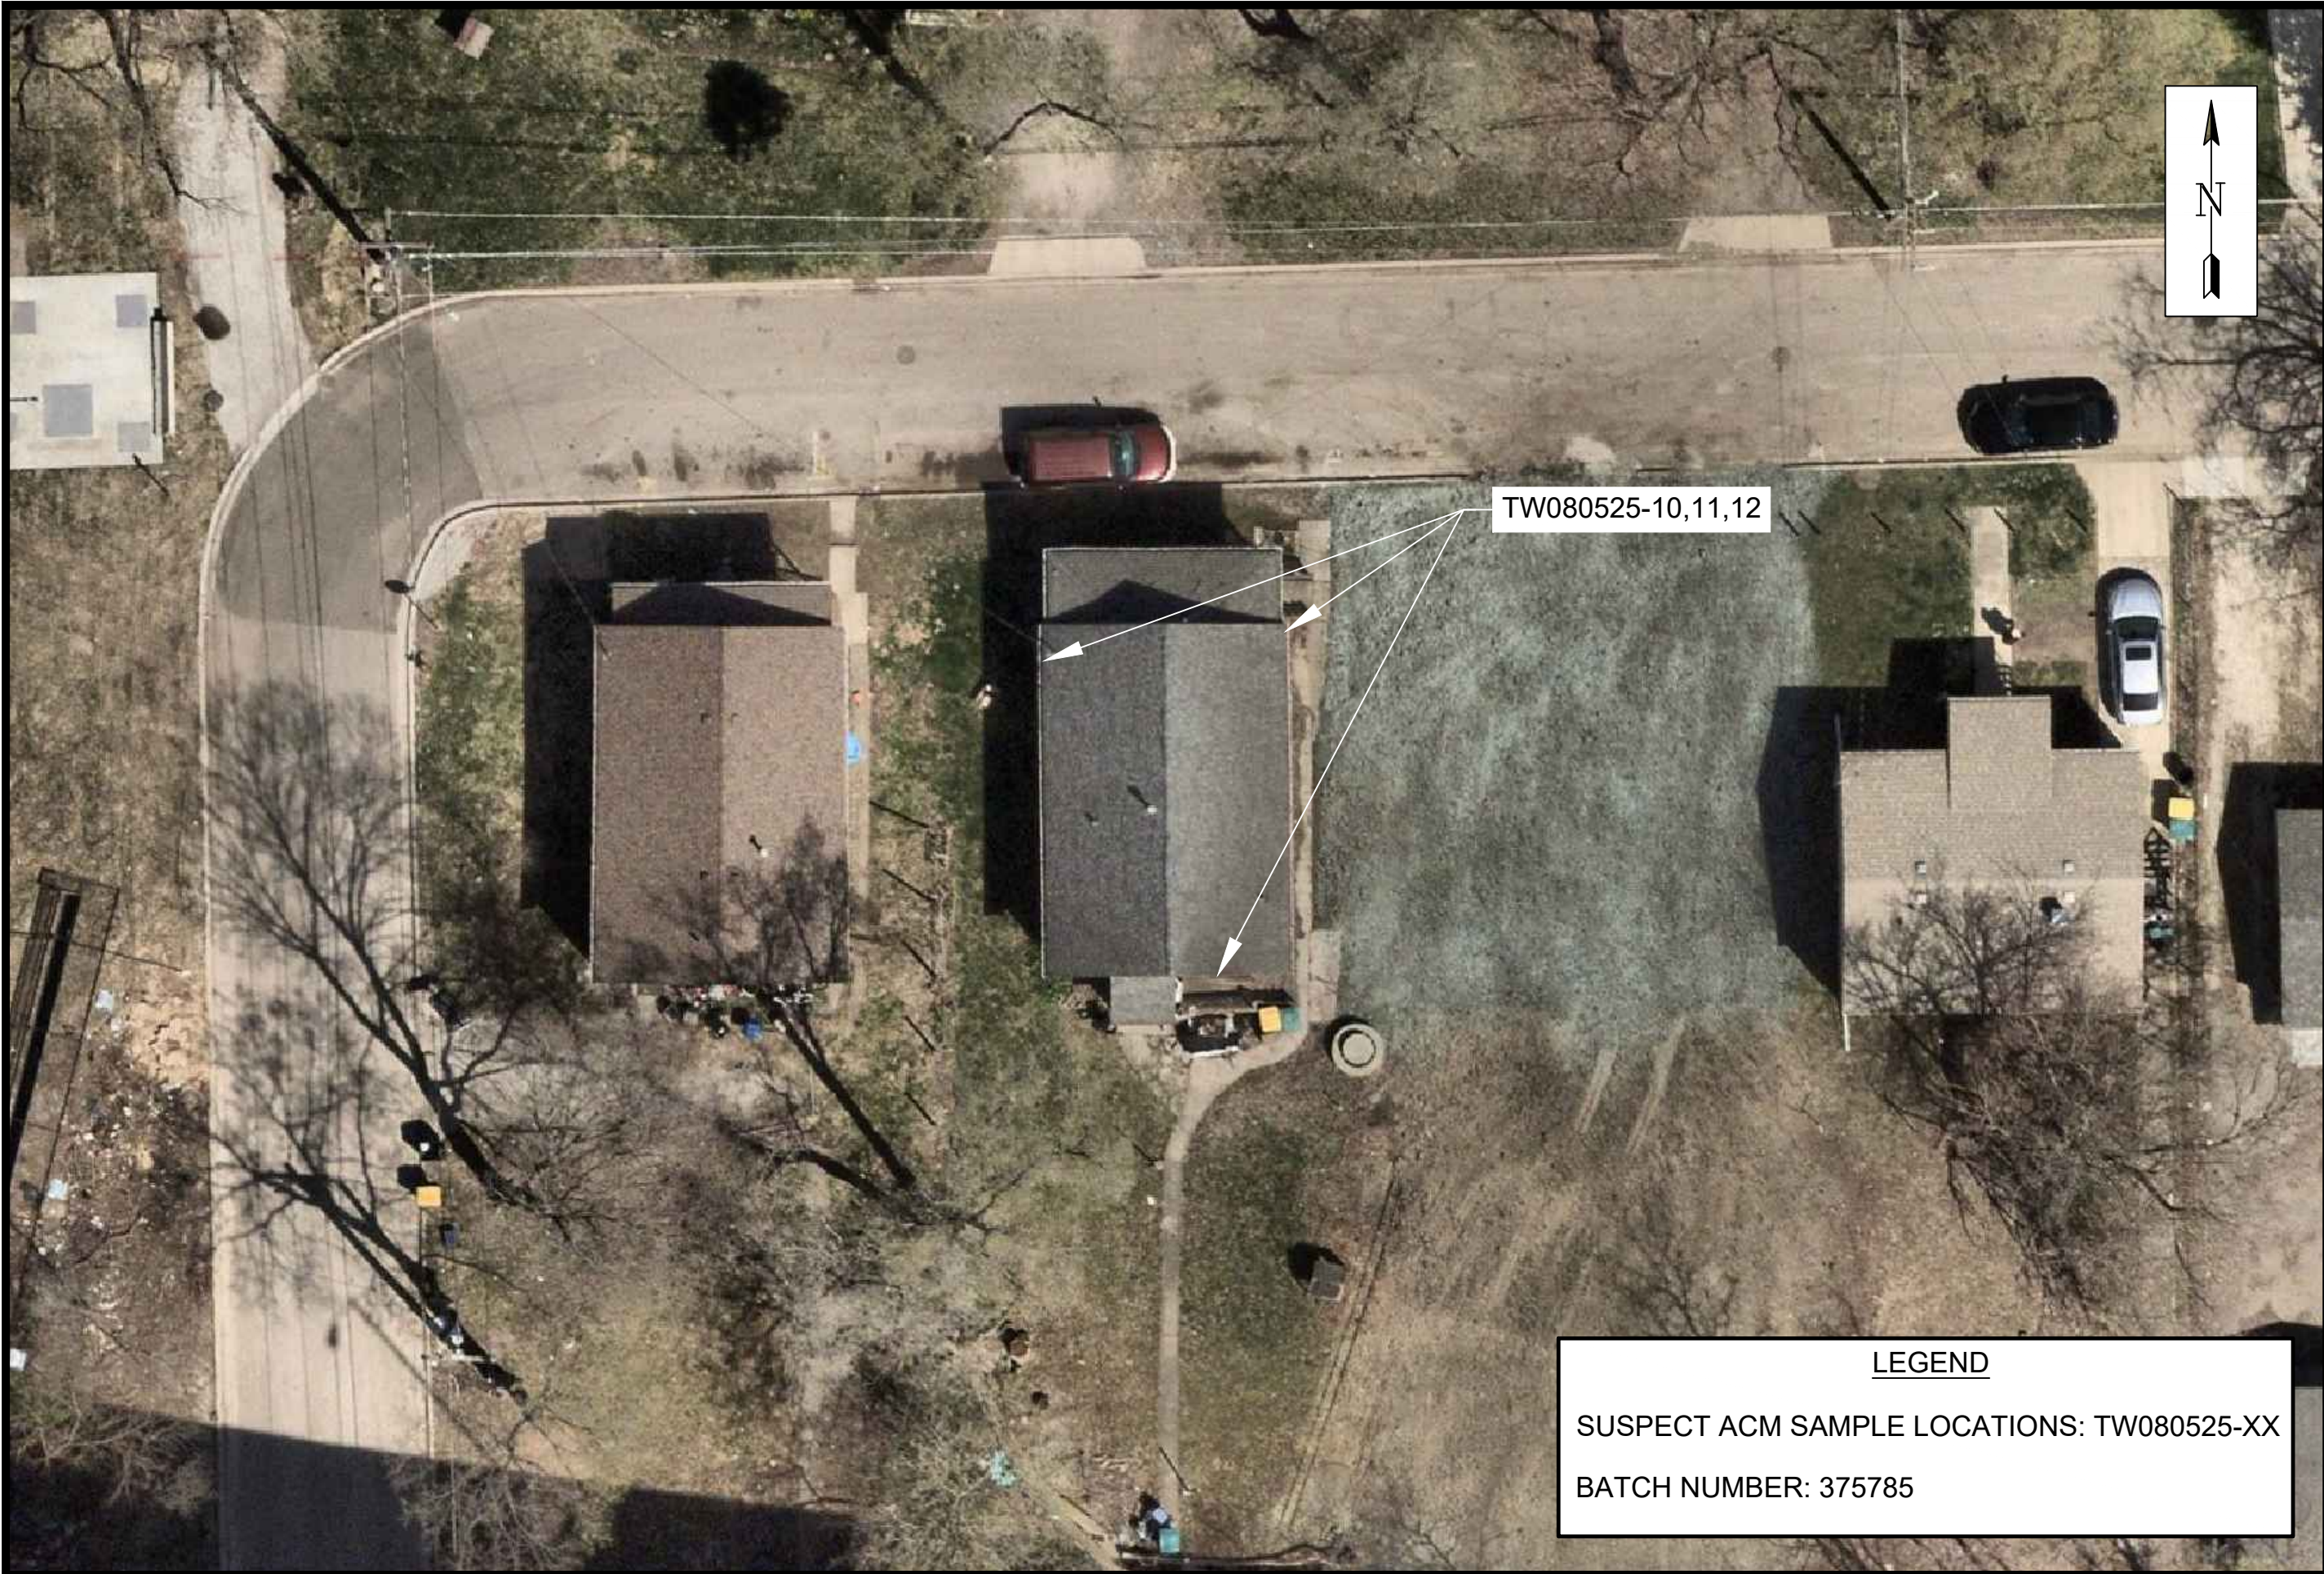
**SL-3**

SUSPECT ASBESTOS-CONTAINING MATERIALS SAMPLE LOCATION PLAN

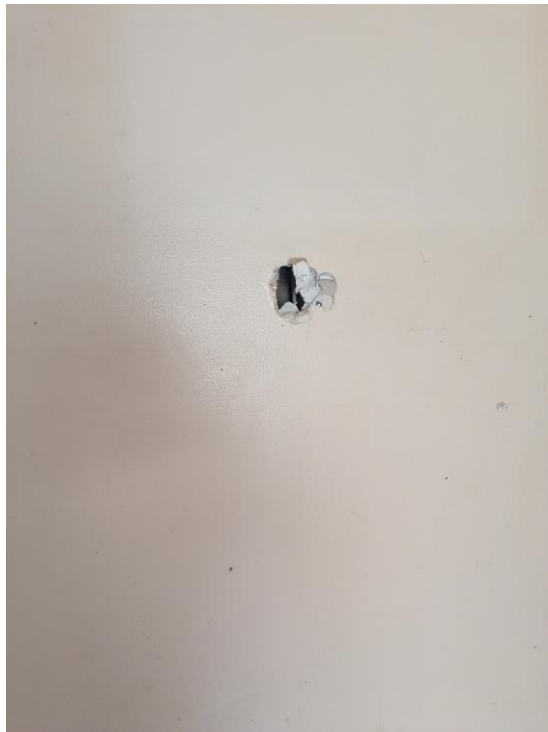
**Photo Location:**  
Living Room

| HA No. | Material Description | Location | Type <sup>(1)</sup> | Condition | Friable | % Asbestos* | # of Samples | Estimated Quantity <sup>(2)</sup> |
|---|---|---|---|---|---|---|---|---|
| 1 | Drywall System | Throughout | Misc. | Good | No | ND | 3 | N/A |

**Material Description:**  
Suspect ACM Drywall  
System

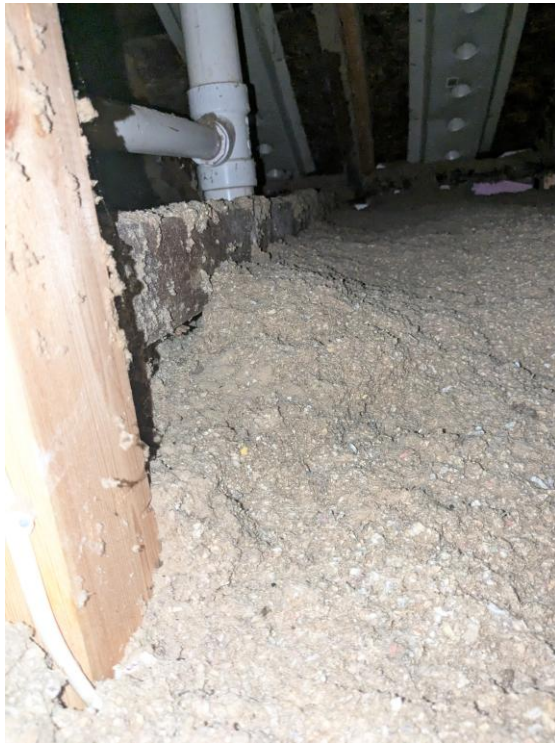
**Photo Location:**  
Attic

| HA No. | Material Description | Location | Type <sup>(1)</sup> | Condition | Friable | % Asbestos* | # of Samples | Estimated Quantity <sup>(2)</sup> |
|---|---|---|---|---|---|---|---|---|
| 2 | Attic Insulation | Attic | TSI | Good | No | ND | 3 | N/A |

**Material Description:**  
Suspect ACM Attic  
Insulation

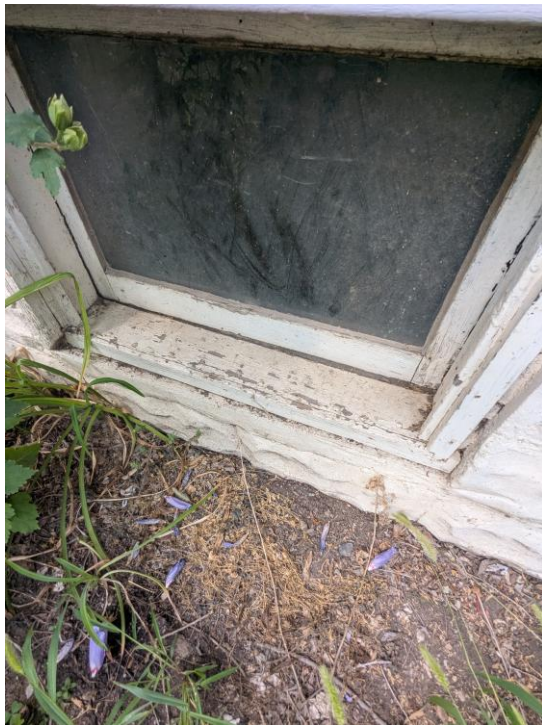
**Photo Location:**  
Basement Windows

| HA No. | Material Description | Location | Type <sup>(1)</sup> | Condition | Friable | % Asbestos* | # of Samples | Estimated Quantity <sup>(2)</sup> |
|---|---|---|---|---|---|---|---|---|
| 3 | Window Glazing | Basement | Misc. | Good | No | ND | 3 | N/A |

**Material Description:**  
Suspect ACM Window  
Glazing

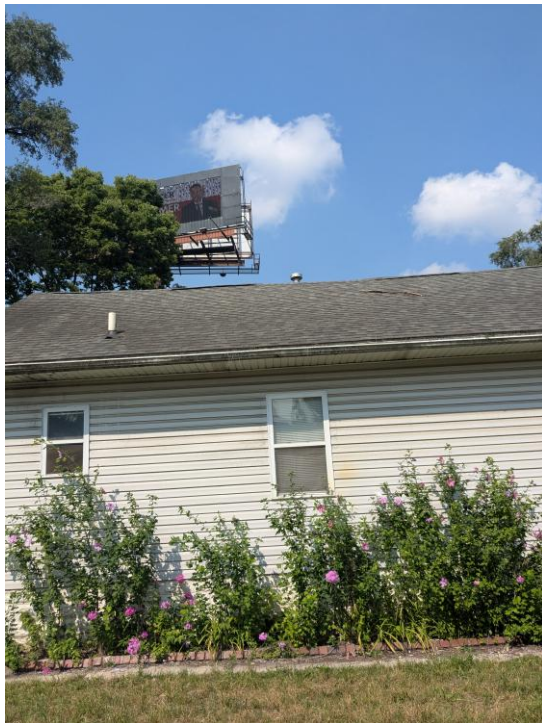
**Photo Location:**  
Roof

| HA No. | Material Description | Location | Type <sup>(1)</sup> | Condition | Friable | % Asbestos* | # of Samples | Estimated Quantity <sup>(2)</sup> |
|---|---|---|---|---|---|---|---|---|
| 4 | Roofing Material (3 Layers) | Roof | Misc. | Good | No | ND | 3 | N/A |

**Material Description:**  
Suspect ACM Roofing  
Material (3 Layers)
