# ASBESTOS SURVEY REPORT

**PTB 196-032**

**Asbestos Survey for Building Demolition (I-80)**

**607 Keip Avenue, Joliet, Illinois**

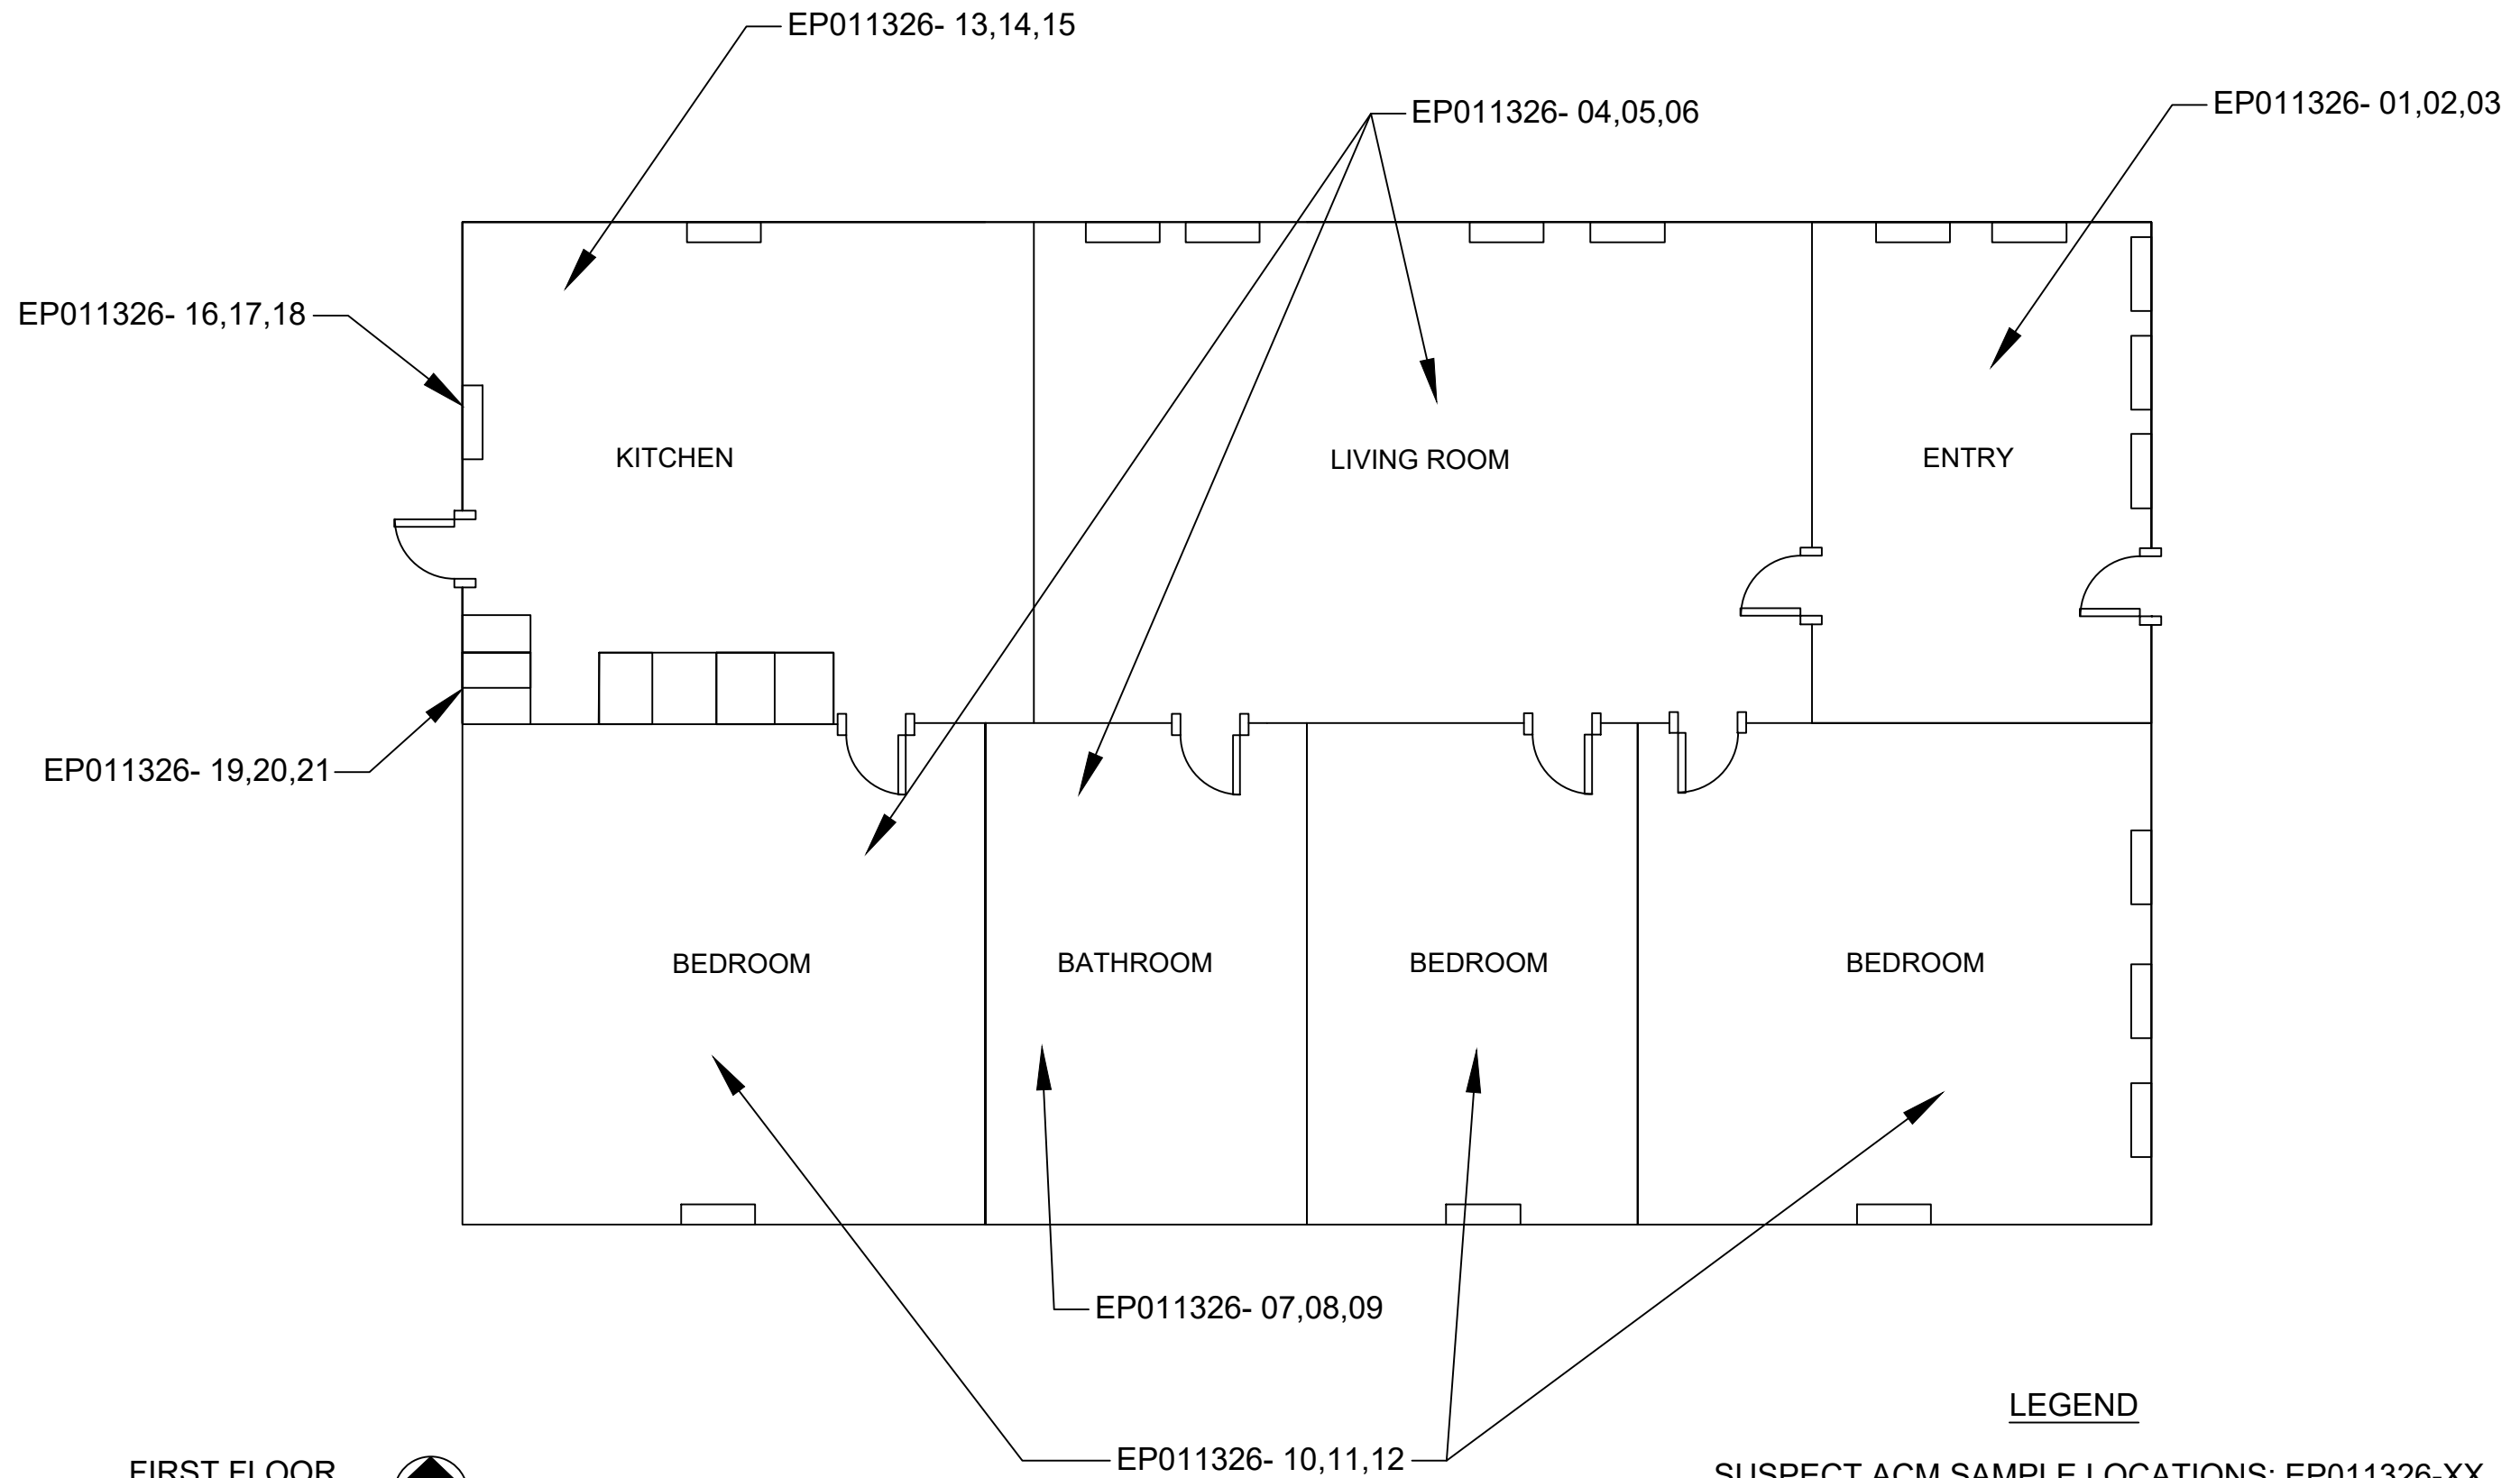
**SL-2**

FIRST FLOOR  
SCALE = N.T.S.

SUSPECT ACM SAMPLE LOCATIONS: EP011326-XX  
BATCH NUMBER: 377356

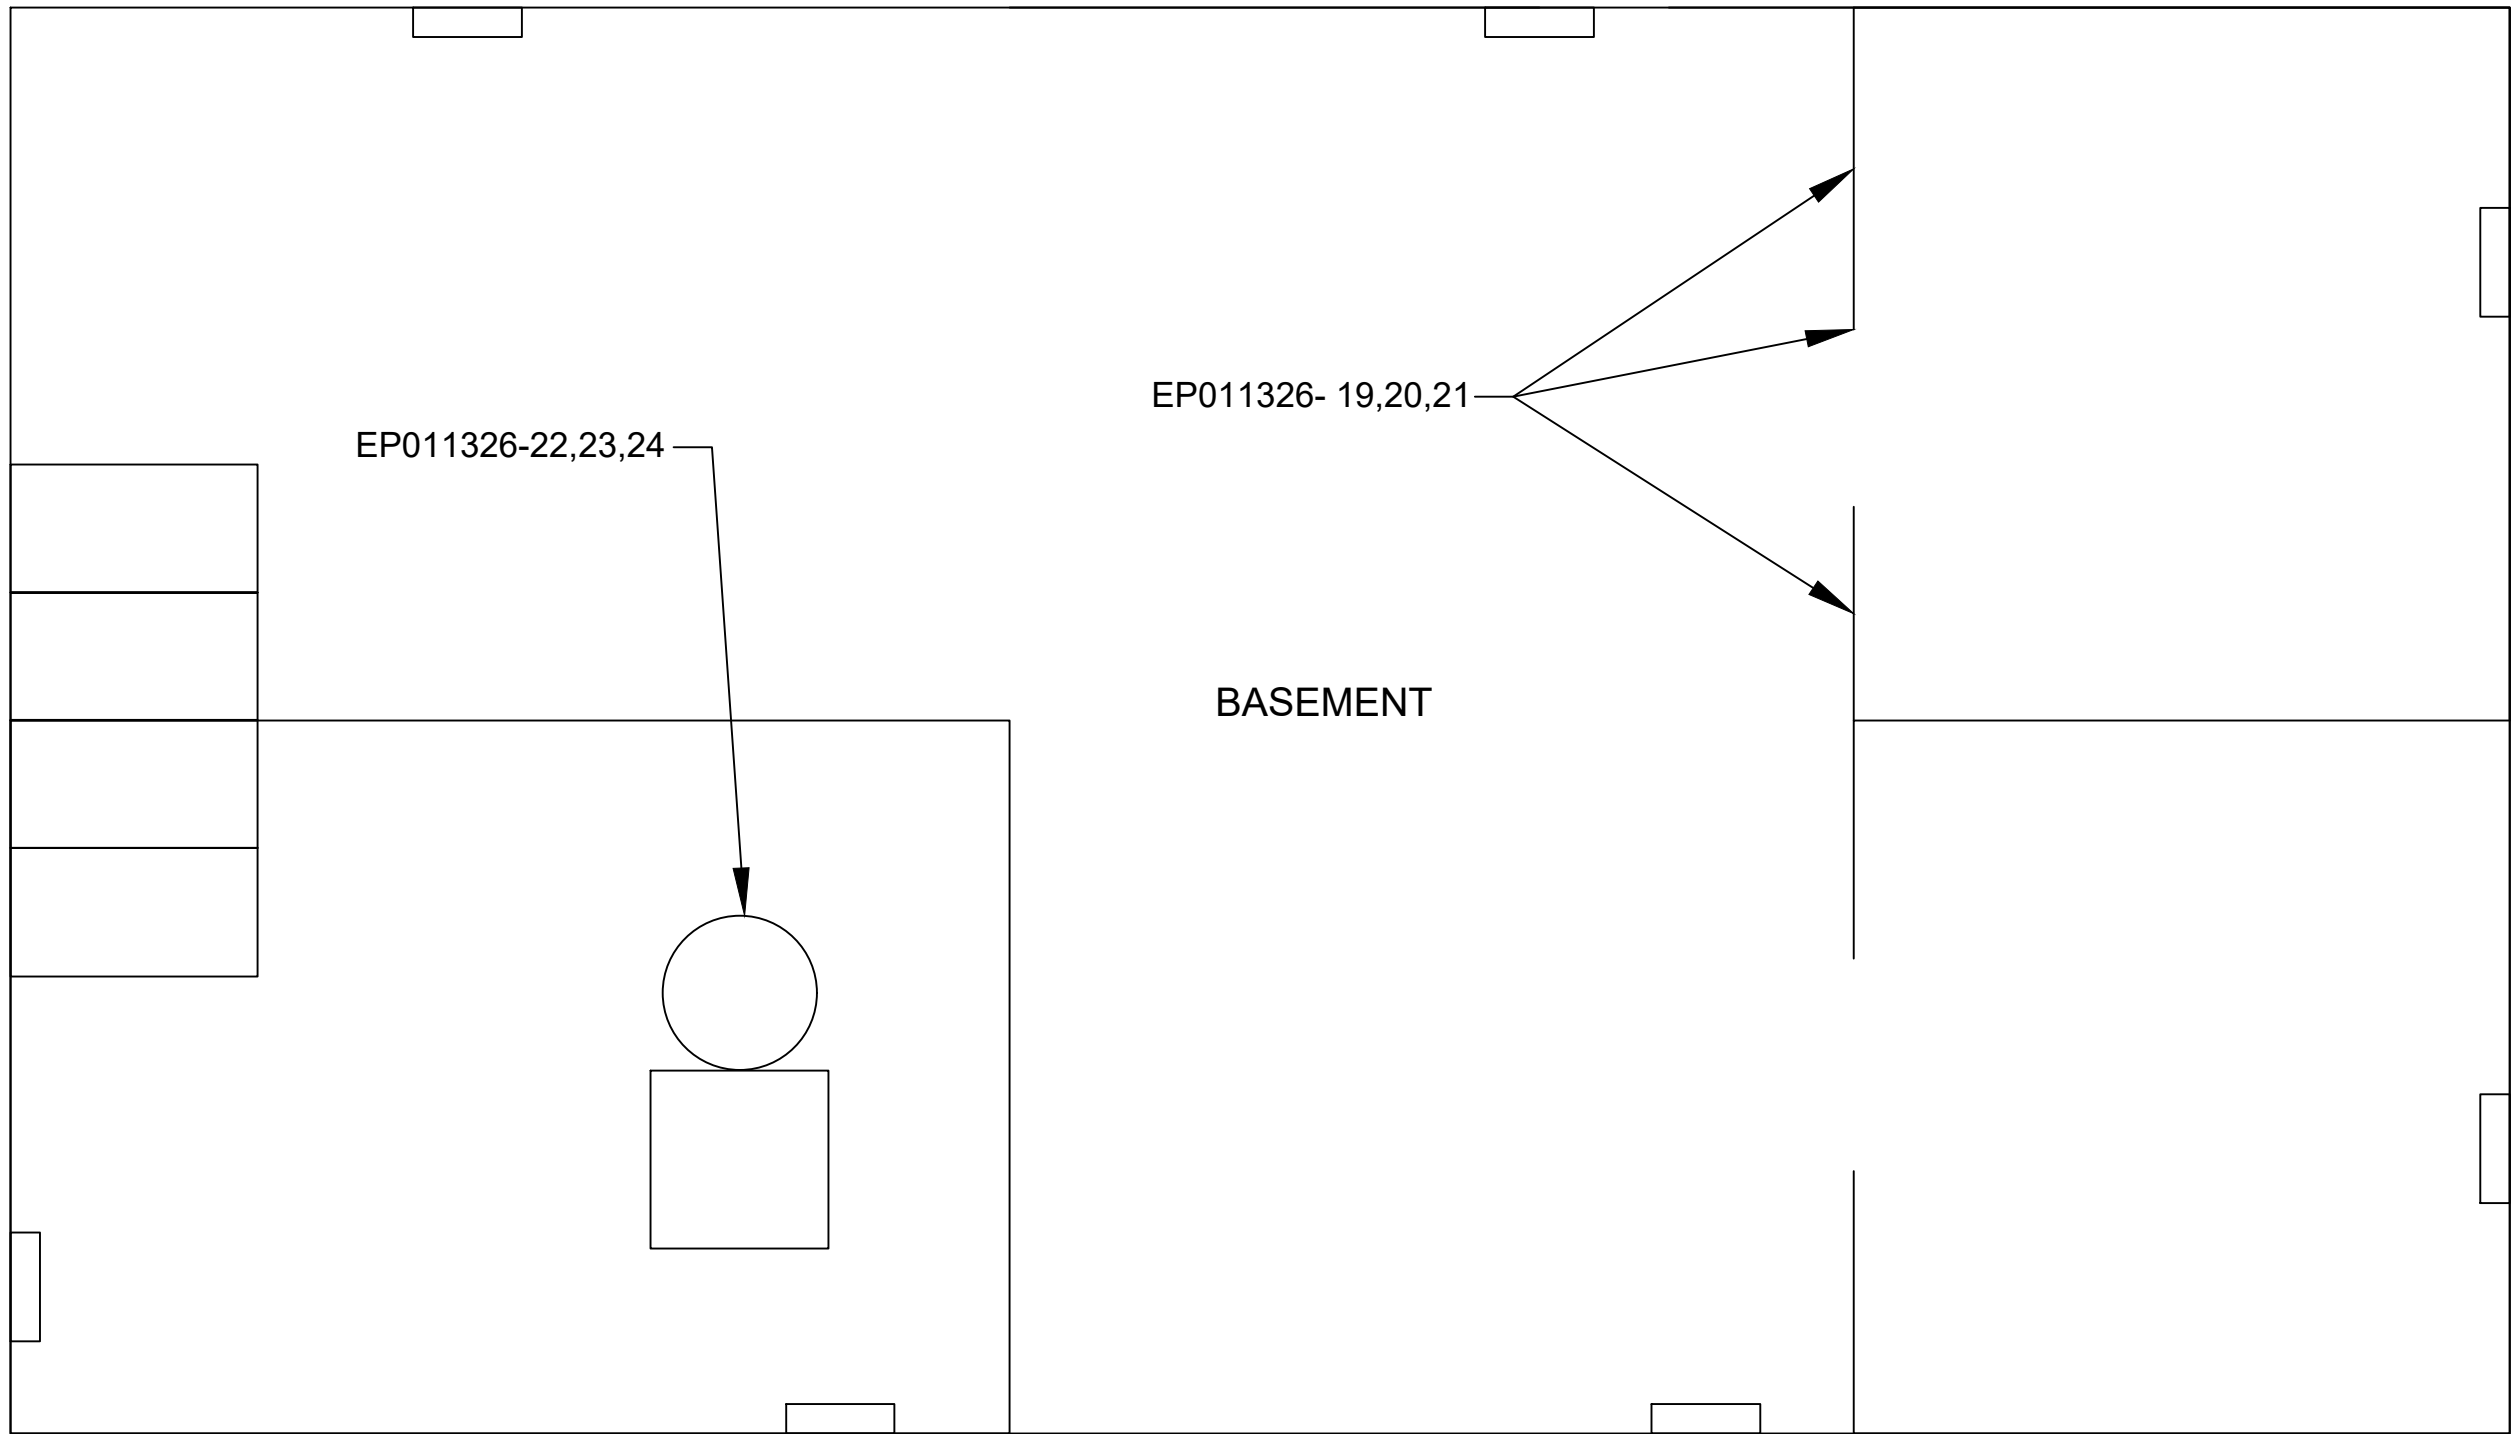
**SL-3**

BASEMENT  
SCALE = N.T.S.

SUSPECT ACM SAMPLE LOCATIONS: EP011326-XX  
BATCH NUMBER: 377356

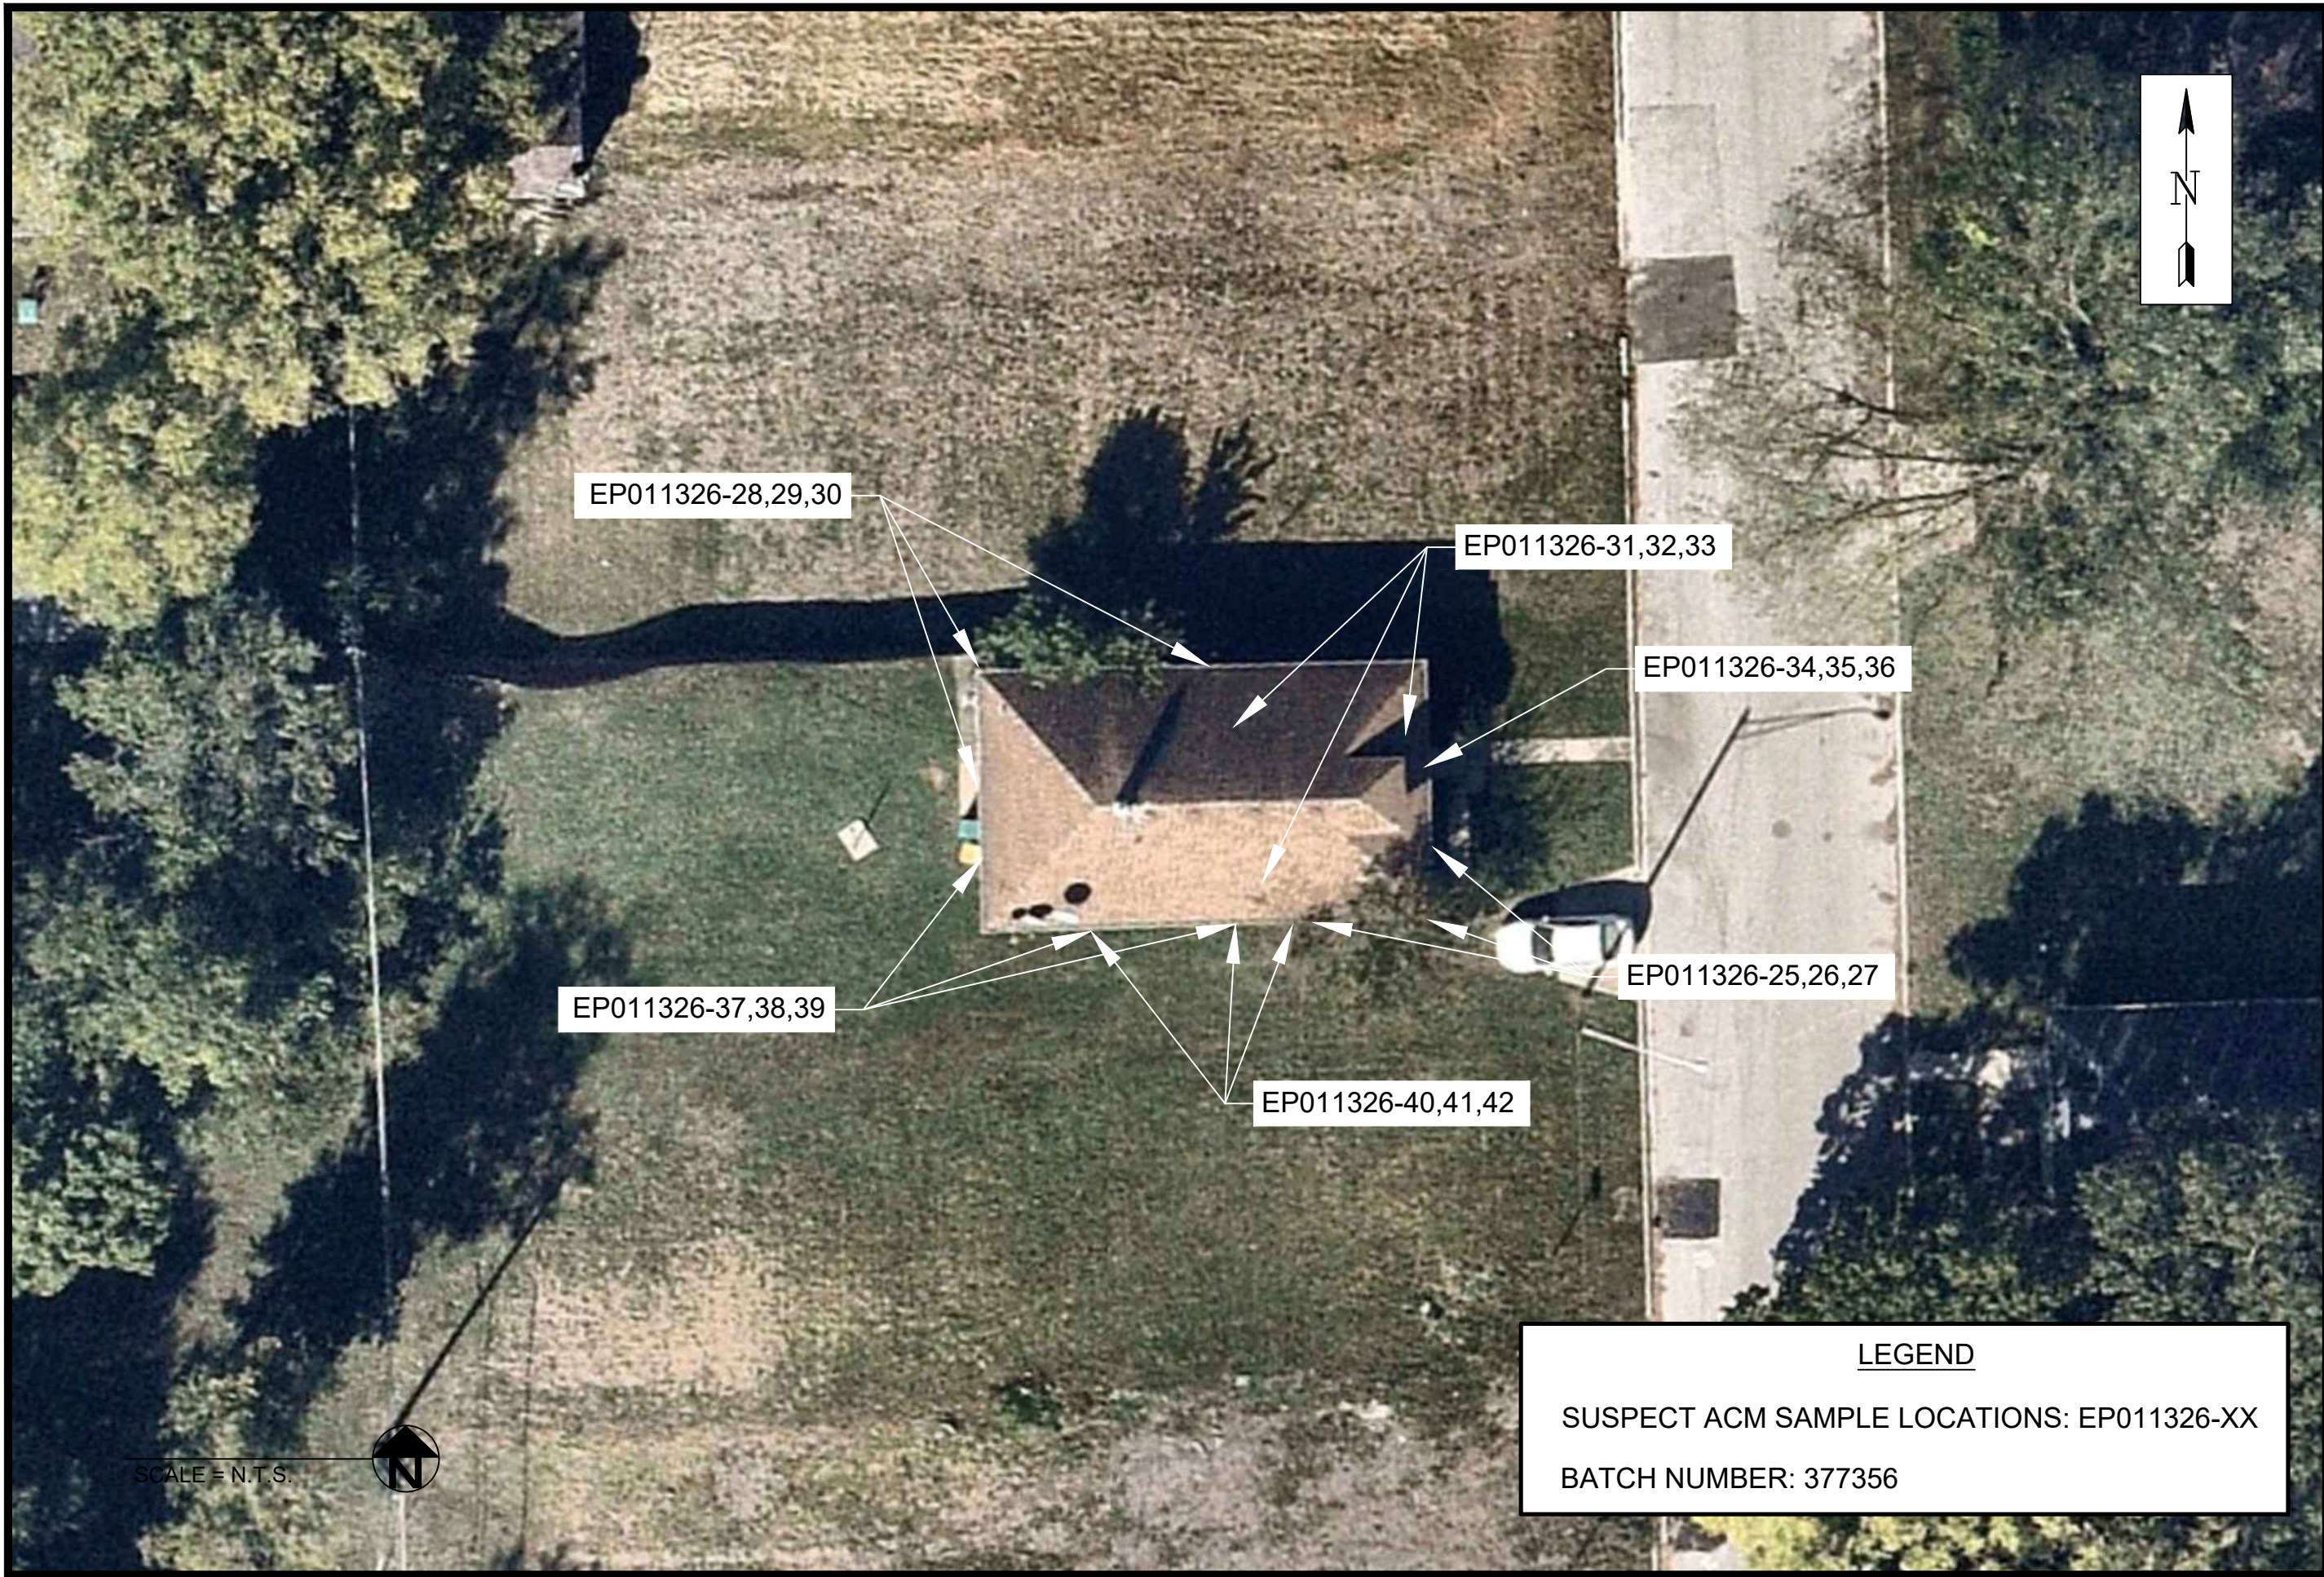
| <b>SL-4</b> | |

**LEGEND**  
SUSPECT ACM SAMPLE LOCATIONS: EP011326-XX  
BATCH NUMBER: 377356

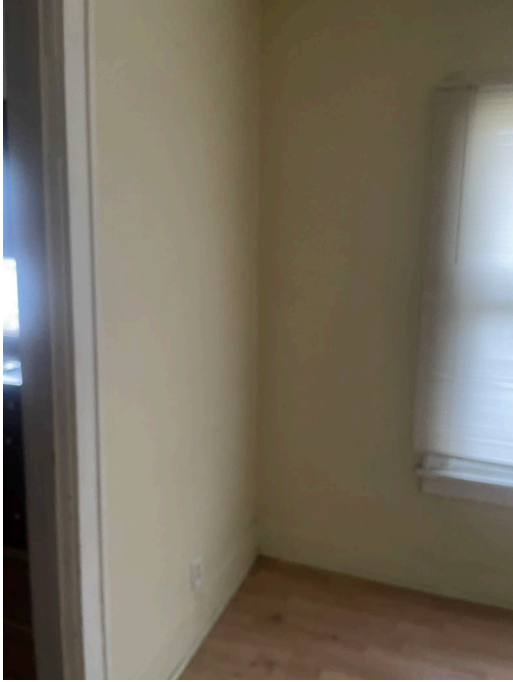
| | <b>Photo Location:</b><br>Living Room |

| HA No. | Material Description | Location | Type <sup>(1)</sup> | Condition | Friable | % Asbestos* | # of Samples | Estimated Quantity <sup>(2)</sup> |
|---|---|---|---|---|---|---|---|---|
| 2 | Plaster | Throughout | Surf. | Good | No | Asbestos Not Detected | 3 | N/A |

| | <b>Material Description:</b><br>Plaster |

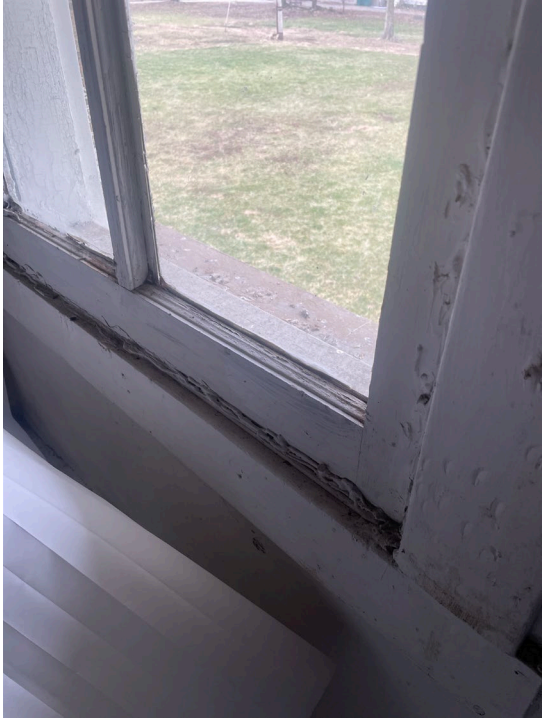
| | <b>Photo Location:</b><br>Back Entrance |

| HA No. | Material Description | Location | Type <sup>(1)</sup> | Condition | Friable | % Asbestos* | # of Samples | Estimated Quantity <sup>(2)</sup> |
|---|---|---|---|---|---|---|---|---|
| 6 | White Interior Caulk | Back Window | Misc. | Good | No | Asbestos Not Detected | 3 | N/A |

| | <b>Material Description:</b><br>Interior Window Caulk |

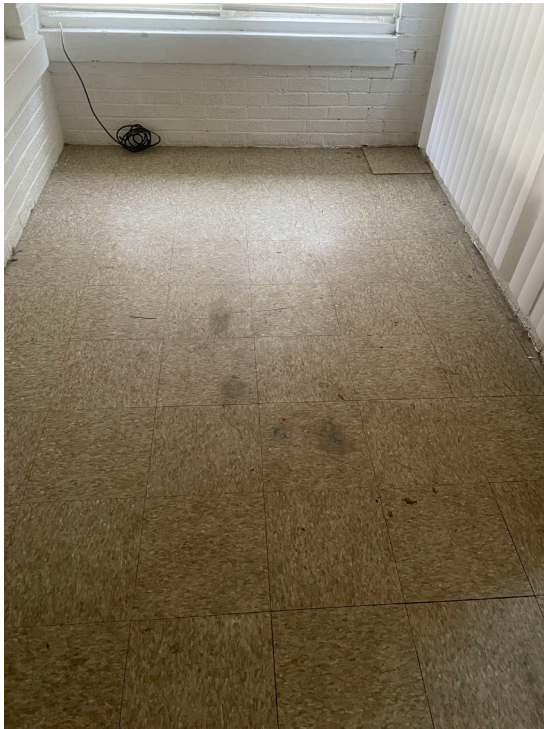
| | <b>Photo Location:</b><br>Entry | |

| HA No. | Material Description | Location | Type <sup>(1)</sup> | Condition | Friable | % Asbestos* | # of Samples | Estimated Quantity <sup>(2)</sup> |
|---|---|---|---|---|---|---|---|---|
| 1 | 12"x12" Beige Self-Stick Floor Tile & Mastic | Entryway | Misc. | Good | No | Asbestos Not Detected | 3 | N/A |

| | <b>Material Description:</b><br>12"X12" Beige Floor Tile &<br>Mastic | |

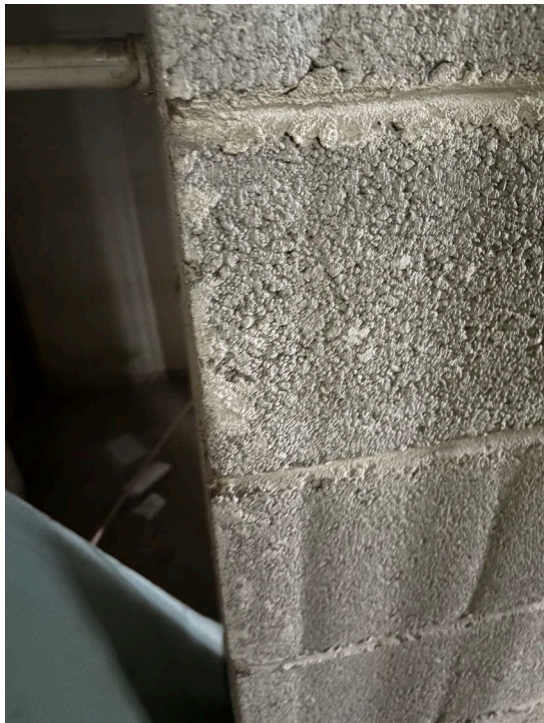
| | <b>Photo Location:</b><br>Basement | |

| HA No. | Material Description | Location | Type <sup>(1)</sup> | Condition | Friable | % Asbestos* | # of Samples | Estimated Quantity <sup>(2)</sup> |
|---|---|---|---|---|---|---|---|---|
| 8 | Chimney Brick | Basement | Misc. | Good | No | Asbestos Not Detected | 3 | N/A |

| | <b>Material Description:</b><br>Chimney Brick | |

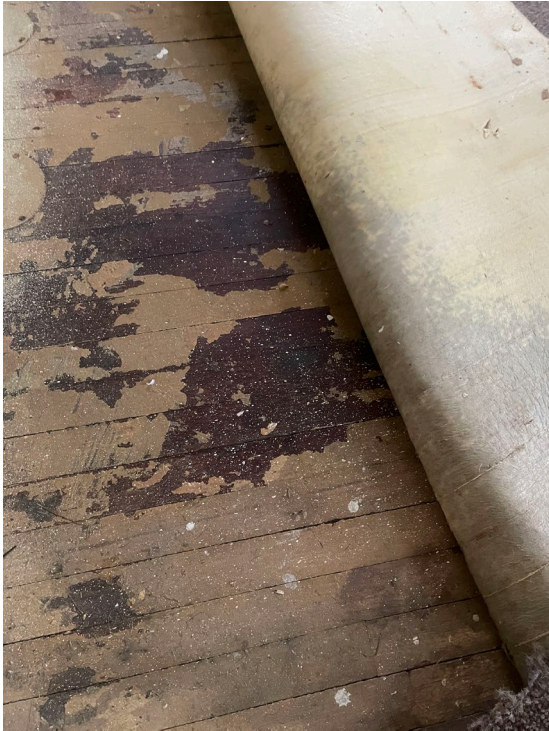
| | <b>Photo Location:</b><br>Bedroom | |

| HA No. | Material Description | Location | Type <sup>(1)</sup> | Condition | Friable | % Asbestos* | # of Samples | Estimated Quantity <sup>(2)</sup> |
|---|---|---|---|---|---|---|---|---|
| 4 | Carpet Mastic | South East Bedroom, Center Bedroom, & South West Bedroom | Misc. | Good | No | Asbestos Not Detected | 3 | N/A |

| | <b>Material Description:</b><br>Carpet Mastic | |

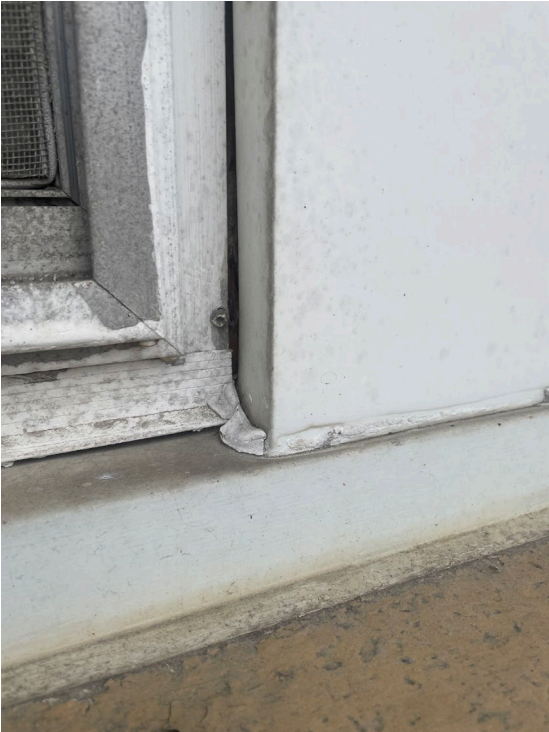
| | <b>Photo Location:</b><br>Exterior | |

| | <b>Material Description:</b><br>Exterior Window Caulk | |

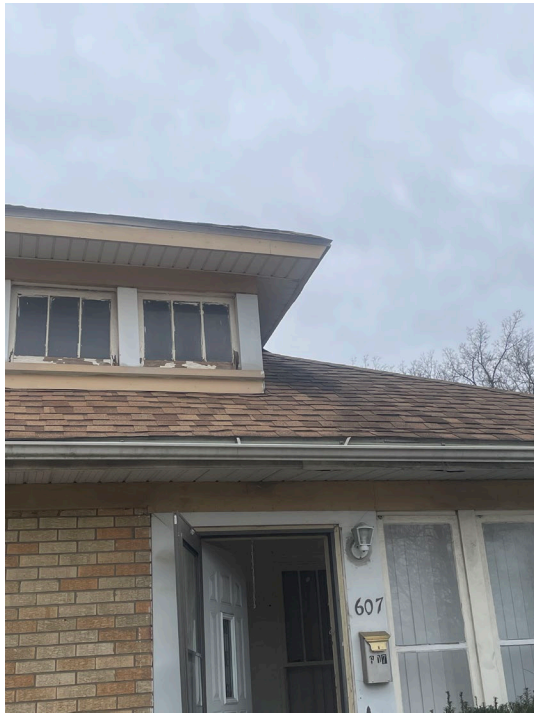
**Photo Location:**  
House Roof

| HA No. | Material Description | Location | Type <sup>(1)</sup> | Condition | Friable | % Asbestos* | # of Samples | Estimated Quantity <sup>(2)</sup> |
|---|---|---|---|---|---|---|---|---|
| 11 | Roofing Material (3 Layers) | Exterior | Misc. | Good | No | Asbestos Not Detected | 3 | N/A |

**Material Description:**  
Roofing Material (3 Layers)

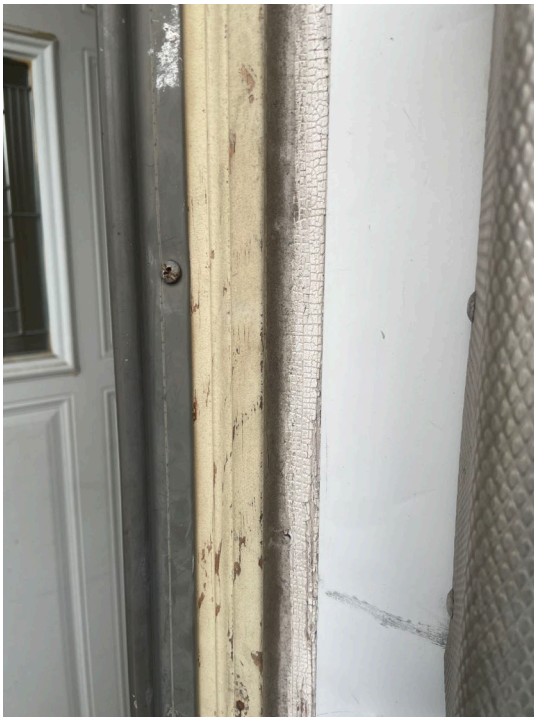
**Photo Location:**  
Entryway

| HA No. | Material Description | Location | Type <sup>(1)</sup> | Condition | Friable | % Asbestos* | # of Samples | Estimated Quantity <sup>(2)</sup> |
|---|---|---|---|---|---|---|---|---|
| 12 | Exterior Door Caulking (Grey) | Exterior | Misc. | Good | No | Asbestos Not Detected | 3 | N/A |

**Material Description:**  
Door Caulk

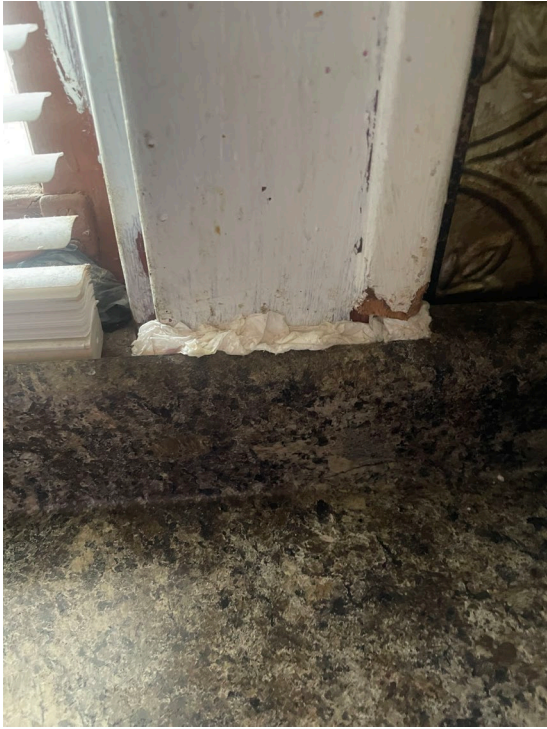
| | <b>Photo Location:</b><br>Kitchen | |

| HA No. | Material Description | Location | Type <sup>(1)</sup> | Condition | Friable | % Asbestos* | # of Samples | Estimated Quantity <sup>(2)</sup> |
|---|---|---|---|---|---|---|---|---|
| 5 | White Counter Caulk | Kitchen | Misc. | Good | No | Asbestos Not Detected | 3 | N/A |

| | <b>Material Description:</b><br>White Counter Caulk | |

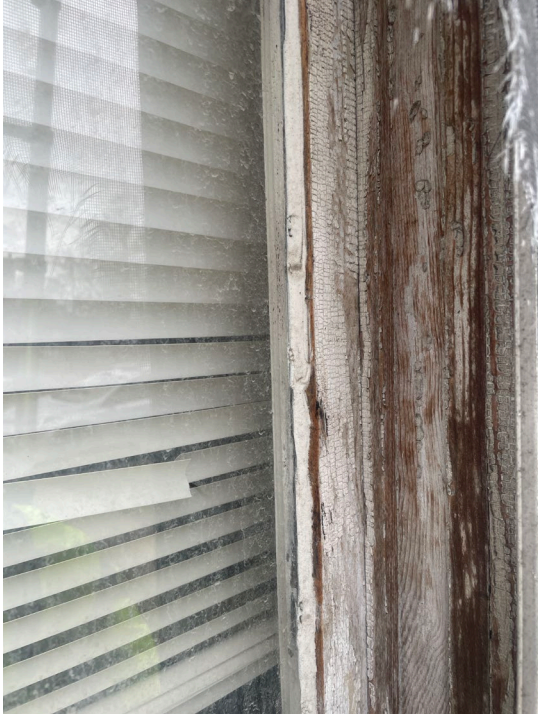
| | <b>Photo Location:</b><br>Exterior | |

| HA No. | Material Description | Location | Type <sup>(1)</sup> | Condition | Friable | % Asbestos* | # of Samples | Estimated Quantity <sup>(2)</sup> |
|---|---|---|---|---|---|---|---|---|
| 13 | Window Glazing (Grey) | Exterior | Misc. | Good | No | Asbestos Not Detected | 3 | N/A |

| | <b>Material Description:</b><br>Window Glazing | |

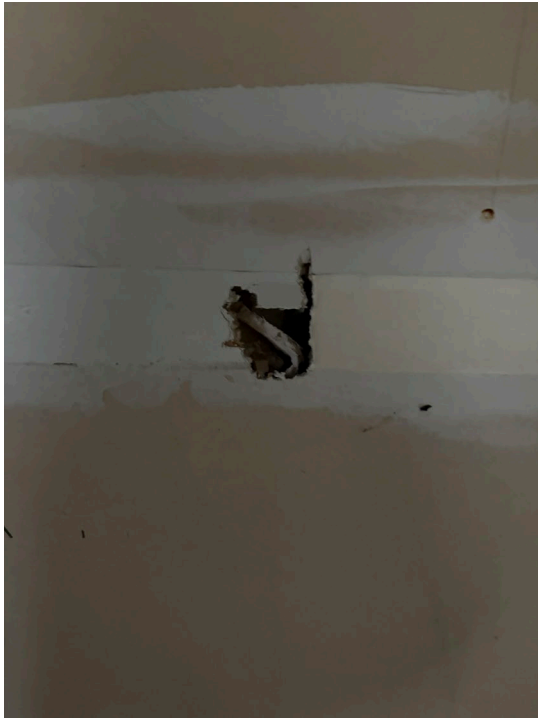
**Photo Location:**  
Basement

| HA No. | Material Description | Location | Type <sup>(1)</sup> | Condition | Friable | % Asbestos* | # of Samples | Estimated Quantity <sup>(2)</sup> |
|---|---|---|---|---|---|---|---|---|
| 7 | Drywall, Tape, and Compound | Basement | Misc. | Good | No | Asbestos Not Detected | 3 | N/A |

**Material Description:**  
Drywall System (Tape,  
Compound, and Drywall)
