ASBESTOS SURVEY REPORT

PTB 196-032
Asbestos Survey for Building Demolition (I-80)
507 Illinois Street, Joliet, Illinois
Region One/District One

August 8, 2025

Asbestos Survey Report
PTB 198-003
FAI-80 (I-80) over Des Plaines River Bridge
Job N. D-91-204-19
507 Illinois Street, Joliet, IL
Parcel No. 1P10103

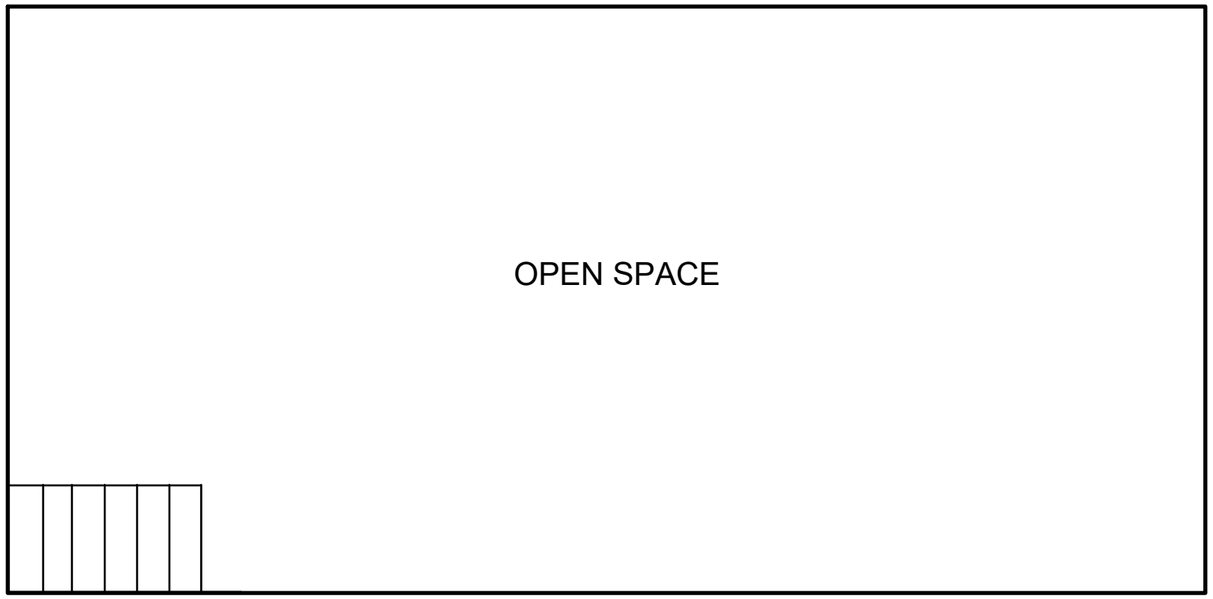
BASEMENT
SCALE = N.T.S.

*NO SUSPECT ACM WAS SAMPLED IN THE BASEMENT

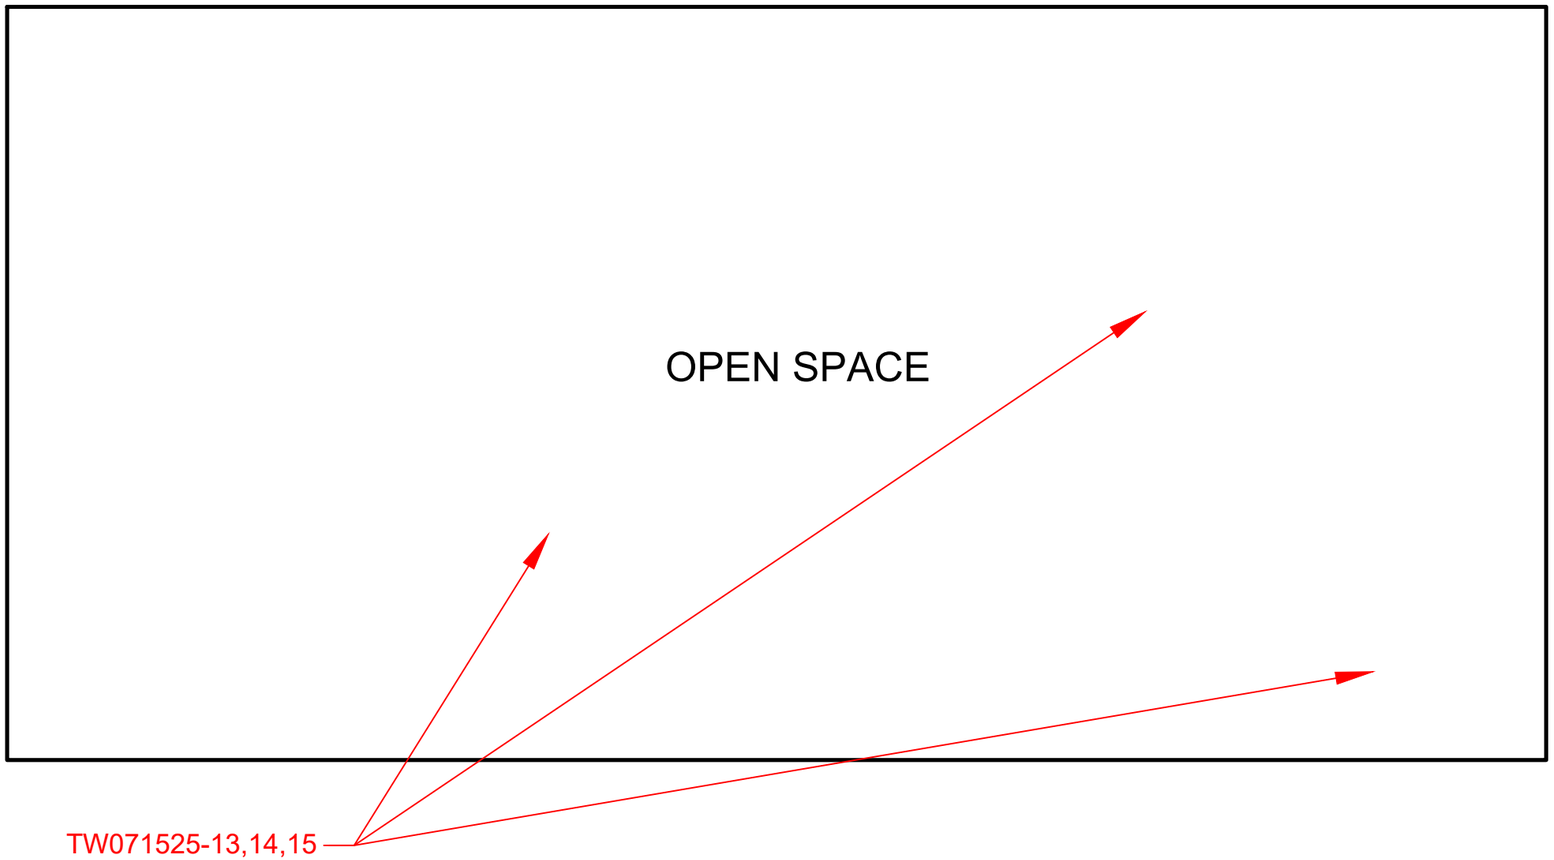
SL-3

RED SAMPLES TESTED POSITIVE FOR ASBESTOS

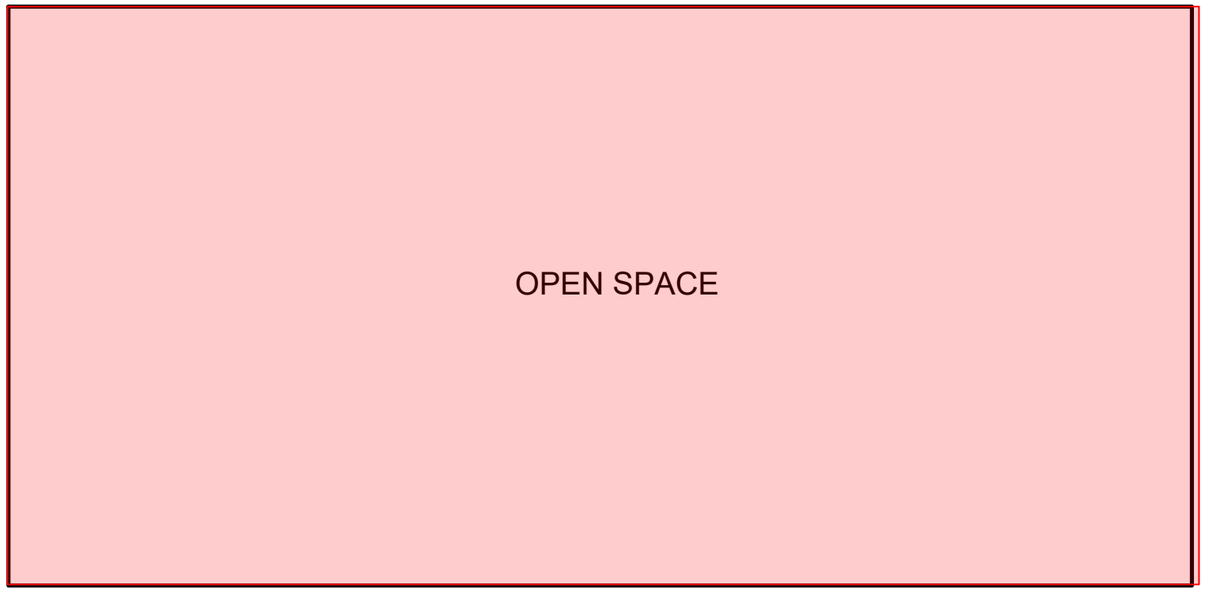
ACM-1

The laboratory reported that asbestos was Not Detected (ND) in the remaining bulk samples collected by GSG. **Exhibit 2, ACM Locations,** shows the approximate locations of ACMs present in the building.

VERMICULITE ATTIC INSULATION

All friable asbestos-containing building materials (ACBMs) identified shall be removed from any building(s) or other structures before demolition. Non-friable ACMs may be left in place, unless during demolition, the ACMs may become friable. If other suspect materials not referenced in this survey report, within or on the outside of the buildings, are identified, not listed in **Table 1**, such materials shall be assumed ACMs until the materials are inspected by a licensed asbestos inspector, sampled, and submitted for laboratory analysis. As the floor tile identified as asbestos containing is a Category I non-friable material which is not likely to become friable during demolition, it does not need to be removed prior to demolition.

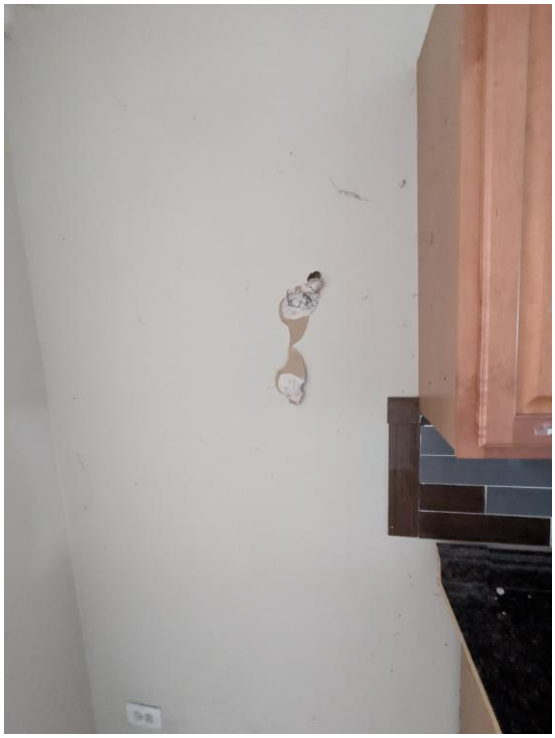
Photo Location:
Kitchen

Material Description:
Suspect ACM Drywall System

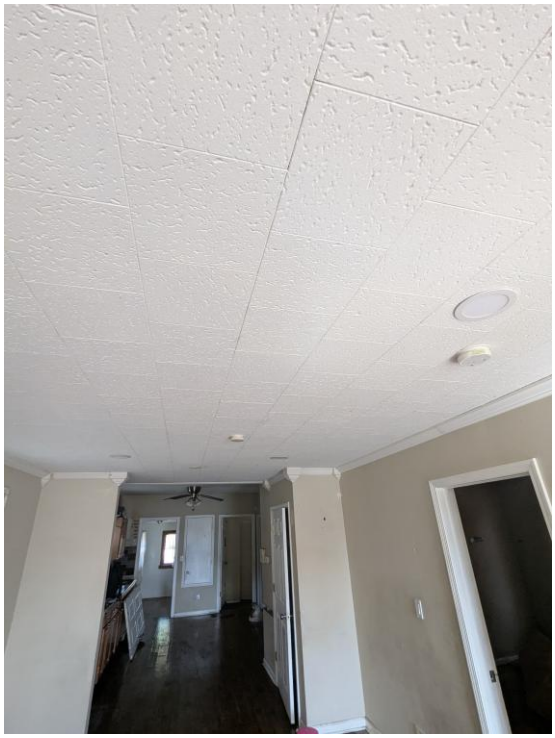
Photo Location:
Living Room

Material Description:
Suspect ACM 1’ x 1’ Ceiling Tile

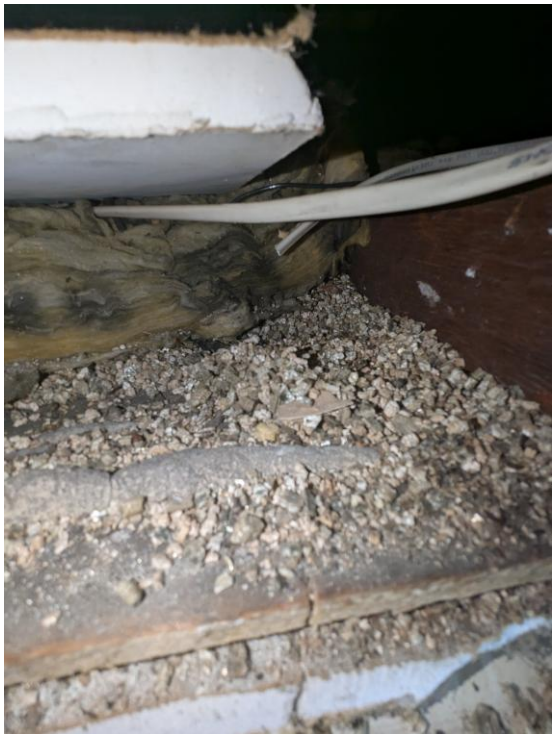
Photo Location:
Attic

The following **HAs were confirmed** to be **ACMs**:

- Vermiculite Insulation

Material Description:
Vermiculite Insulation – **Tested Positive for Asbestos**

GSG recommends the preparation of an asbestos abatement project design before any demolition. An asbestos abatement design plan and specifications should include information regarding the location of containments and barriers, type of sealant, and air sampling requirements and clearance during the asbestos abatement activities. The asbestos design plan and specifications shall be prepared and signed by an IDPH licensed asbestos project designer following Illinois regulations. Before starting any abatement activities, an Asbestos Abatement notification is required for all asbestos projects and must be applied for at least ten (10) working days before the start of the project. A building demolition notification is required for all demolition projects and must be applied for at least ten (10) working days before the start of the project.
